**The Hope Project, KOKO**

Photographs  
05 August 2020  
Not to scale

Job no. 146-89 Site Note 8 ADDENDUM Page11 © Copyright Hutton+Rostron 2020

## The Hope Project (KOKO): Timber floor structures condition Investigation

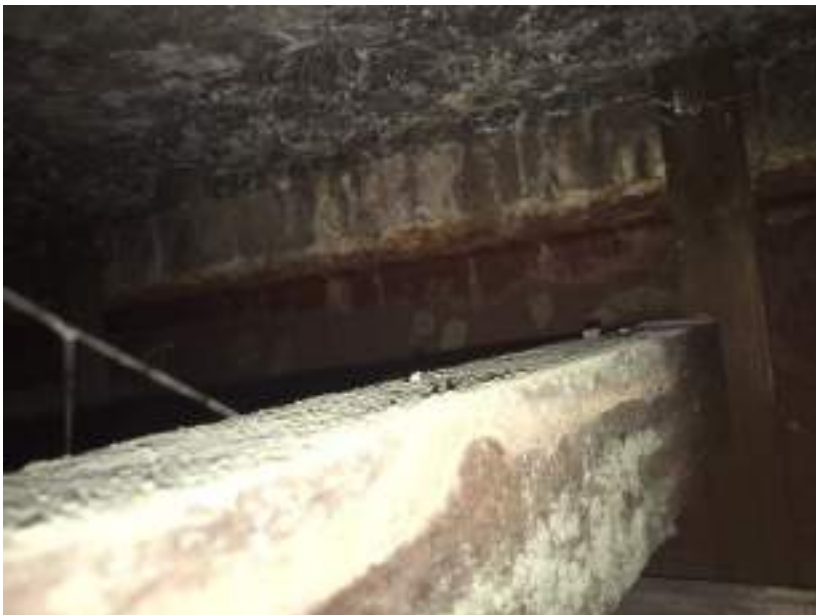
**Fig 24:**

Timber condition investigation; showing ceiling structures subject to inactive surface mould growth

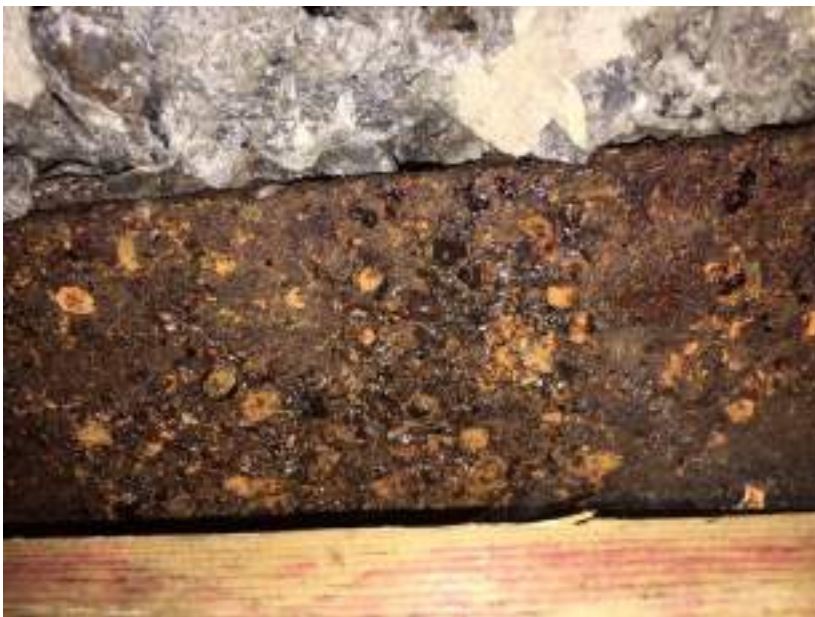
**Fig 28:**

Timber condition investigation; showing perimeter partially embedded RSJ to octagonal ceiling lights subject to fairly extensive surface corrosion, likely due to historic failure of flashings to flat roof above in the past

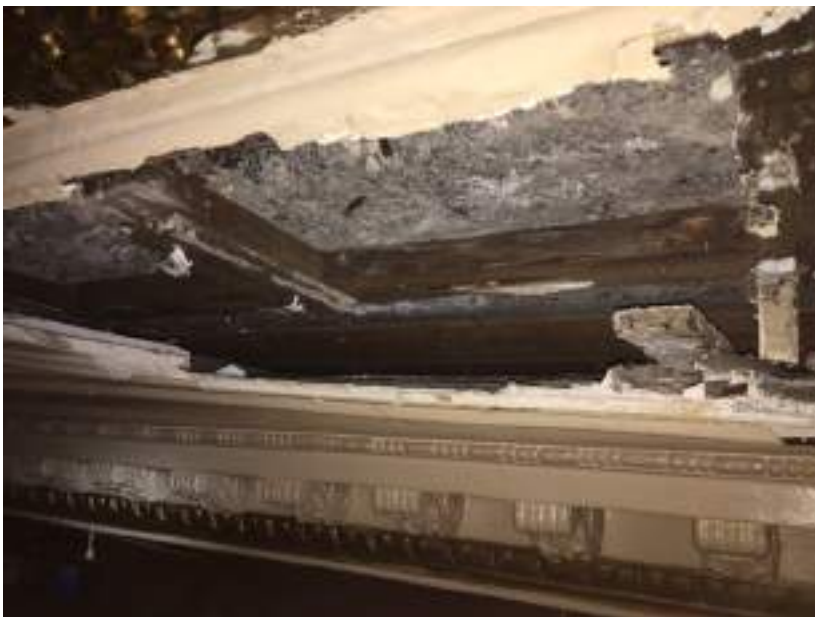
**Fig 30:**

Timber condition investigation; showing multiple generations of timber structures supporting decorative plaster and laths ceilings at south corner of RMG17. Note that cornice void with insufficient through ventilation

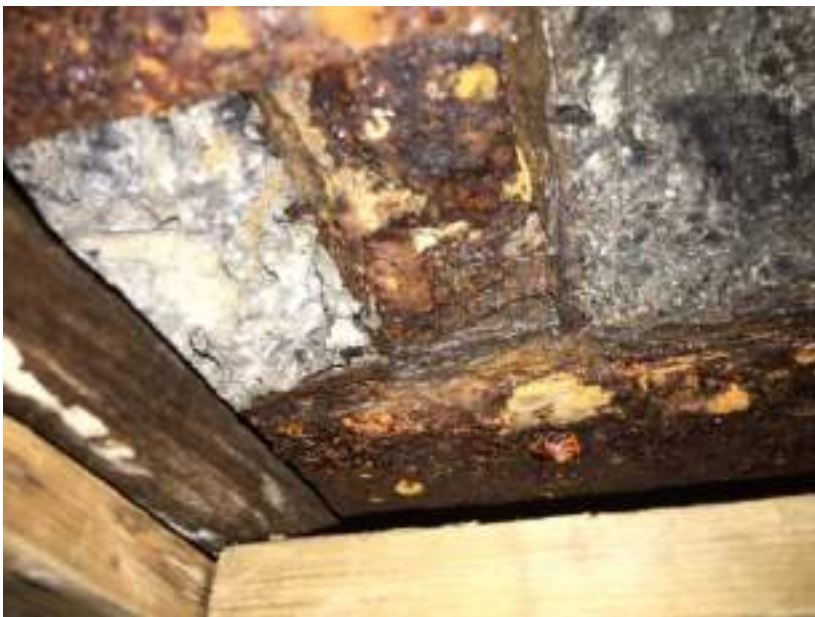
**Fig 32:**

Timber condition investigation; showing extensive surface corrosion to embedded steel elements within clinker concrete flat roof structures. Likely due to historic failure of finishes to flat roof above including flashings to ceiling lights in the past

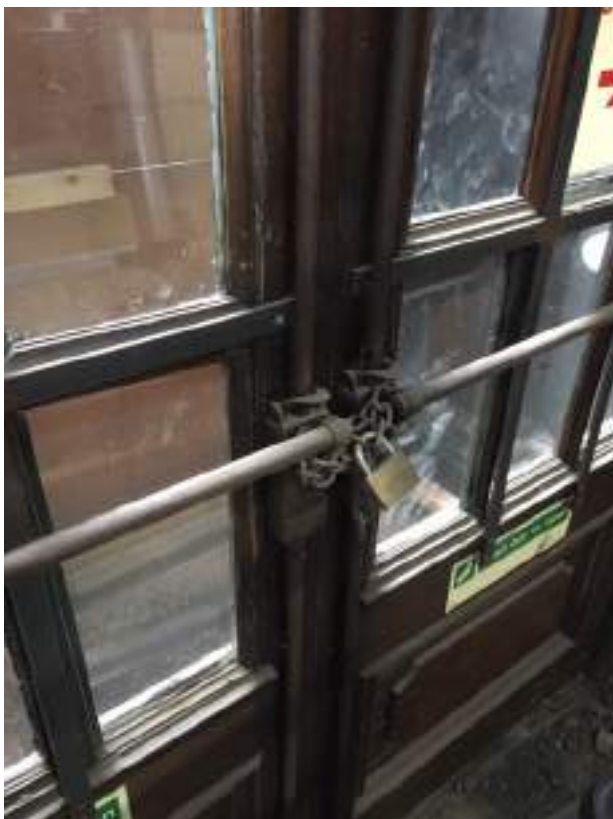
**Fig 34:**

Timber condition investigation; showing principal east elevation. South front doors chained shut and unable to be opened to aid ventilation

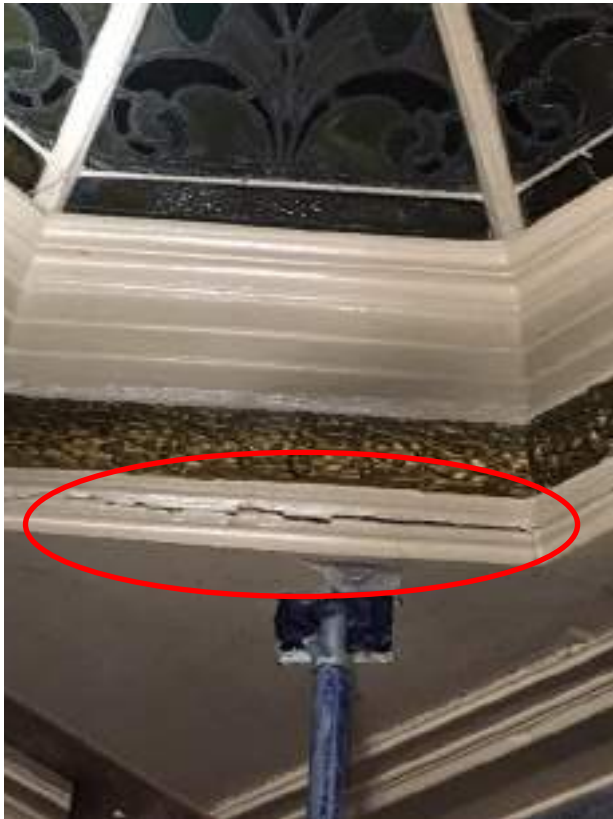
**Fig 35:**

North octagonal ceiling light with what appears to be later edition plasterboard finishes at spandrels subject to complete failure or delamination

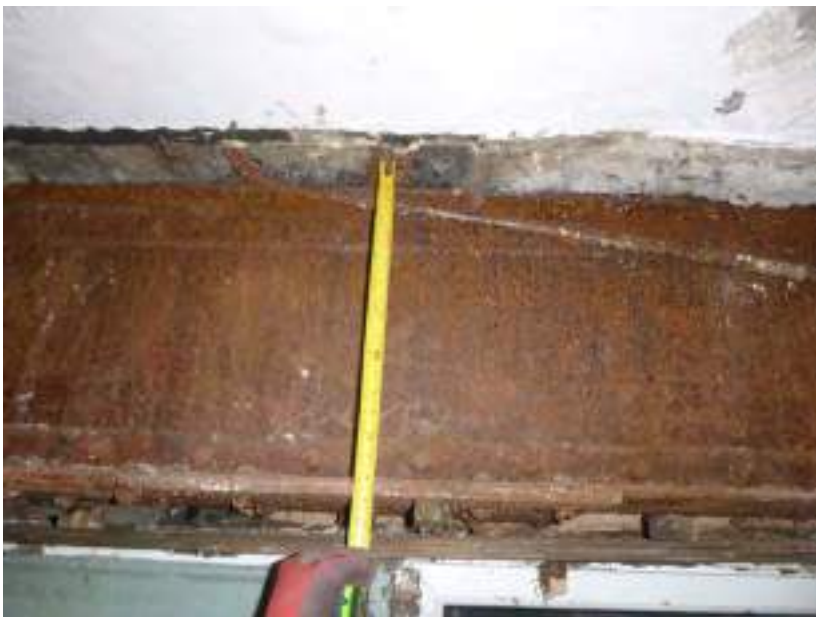
Floor structures, fourth floor, RM.4-02; showing solid floor structures at ~220mm depth. Solid floor structures were not the focus of this investigation

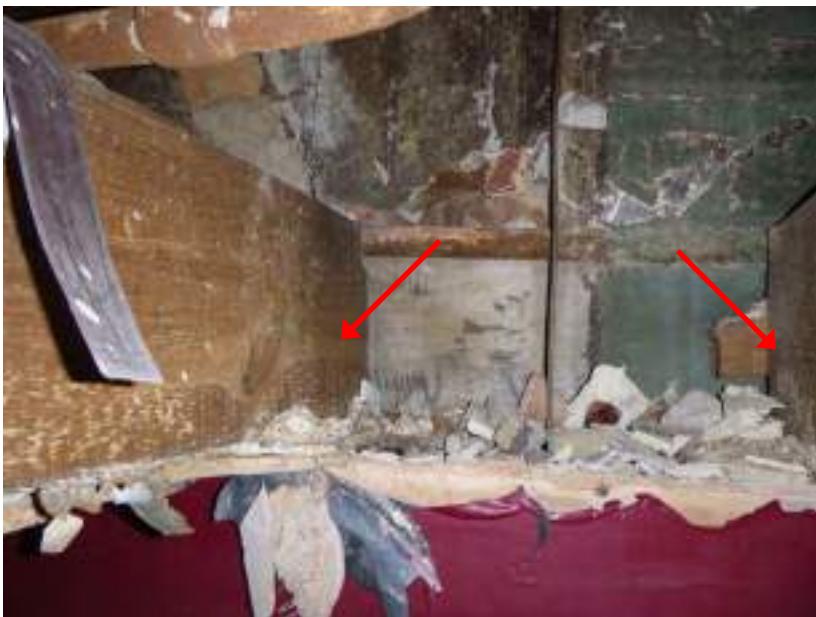
Floor structures, third floor, RM.3-16; showing image of historic floor area with new split level creating void beneath

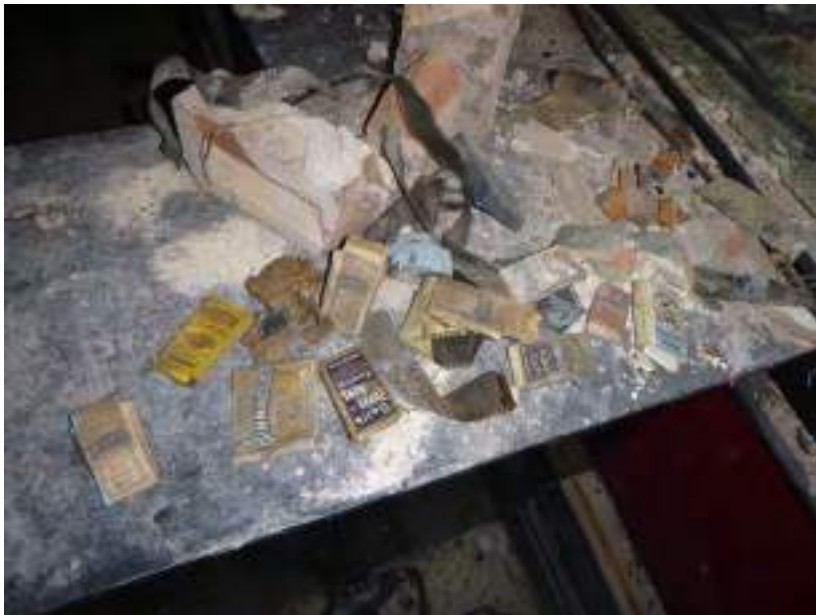
Floor structures, third floor, RM.3-14; showing historic defunct floor level forming ceiling structures to north area of bar. Note significant fire related water damage to non-historic plaster structures. Representative and vulnerable timber bearing ends were deep drilled and moisture probed. No structural decay detected, typical deep moisture contents raised at ~18 per cent and surface moisture contents at ~22 per cent which is high enough to support decay organisms

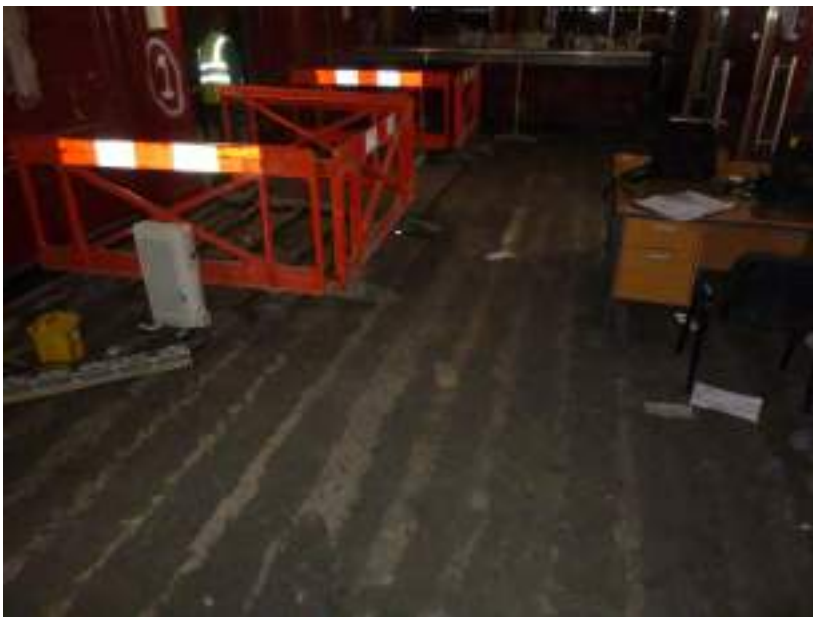
**Fig 17:**

Floor structures, second floor, RM.2-20; showing visibly fire related moisture damaged structures above vulnerable concealed floor structures

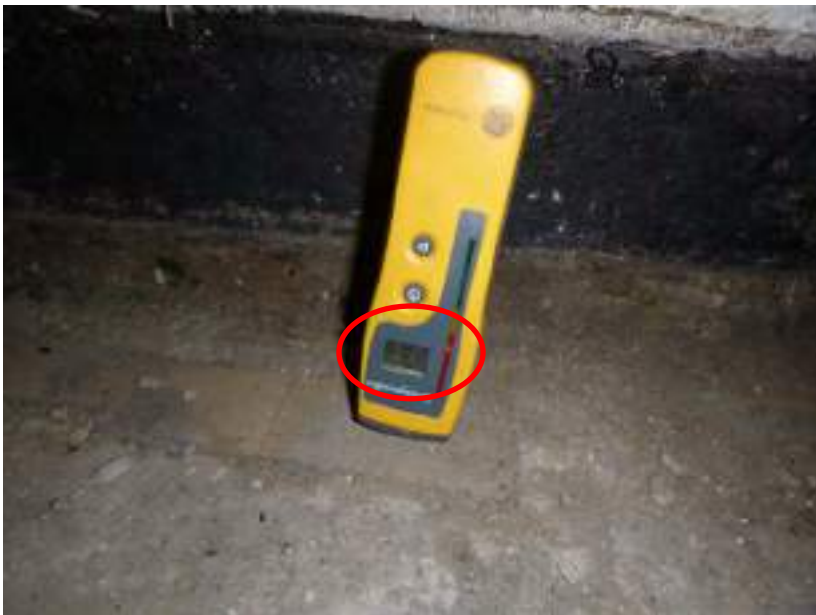
Floor structures, first floor, RM.1-12; showing typical detail of remaining floorboard grounding embedded into damp floor slab with visible superficial decay to its underside. Note floorboard nail fixings still visible

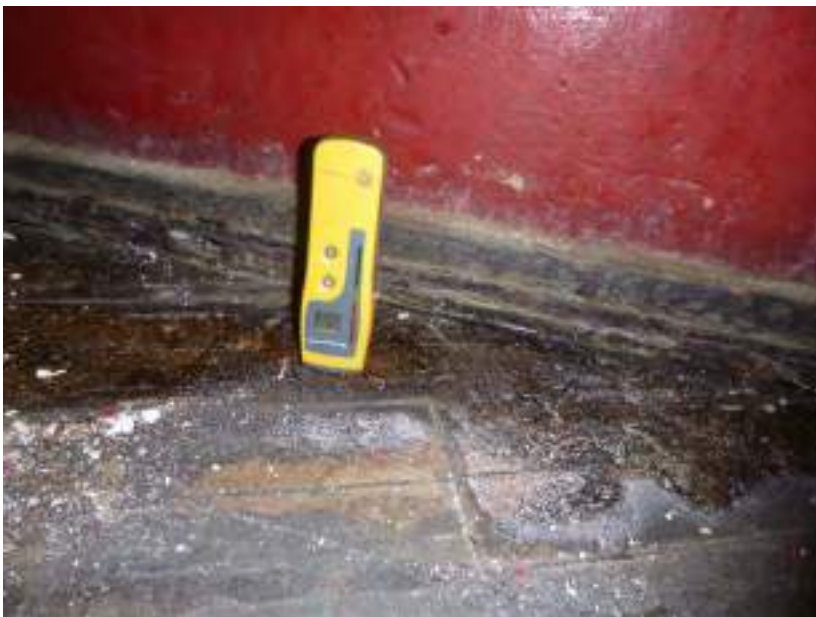
Floor structures, first floor, RM.1-12; showing partially exposed area of south floor structures between solid floor and balcony tiered floor. Surface content reading showing dry at ~14 per cent. However, inaccessible structures within void suspected of being damp and mould affected

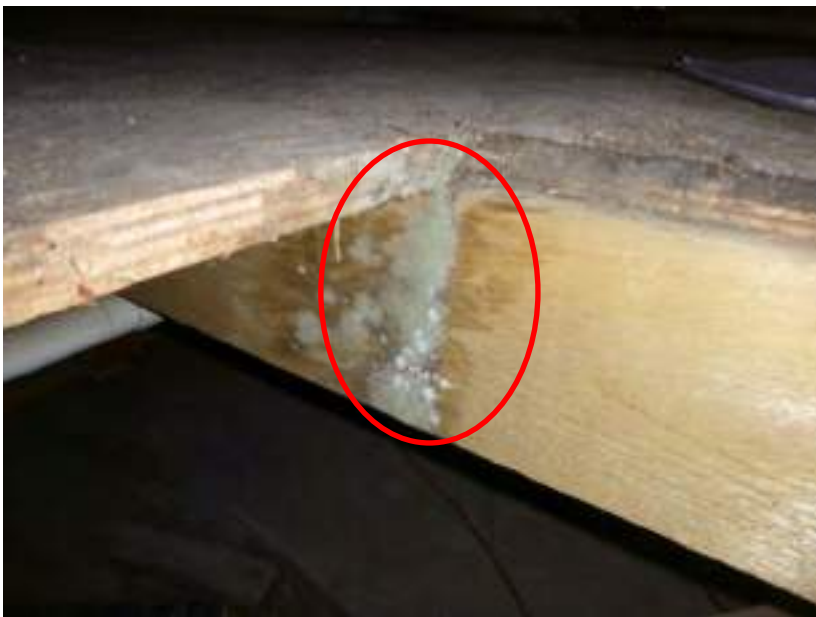
Floor structures, first floor balcony, RM.1-11; showing north area of bar with timbers within floor void visibly subject to surface mould growth as a result of recent moisture penetration and inadequate ventilation

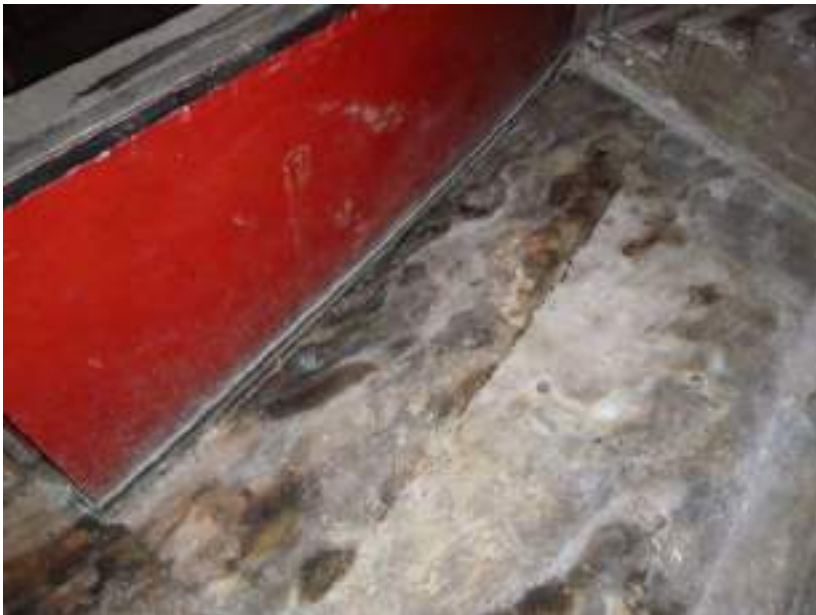
Floor structures, first floor balcony, RM.1-11; showing south area of bar with timbers within floor void visibly subject to surface mould growth as a result of recent moisture penetration and inadequate ventilation

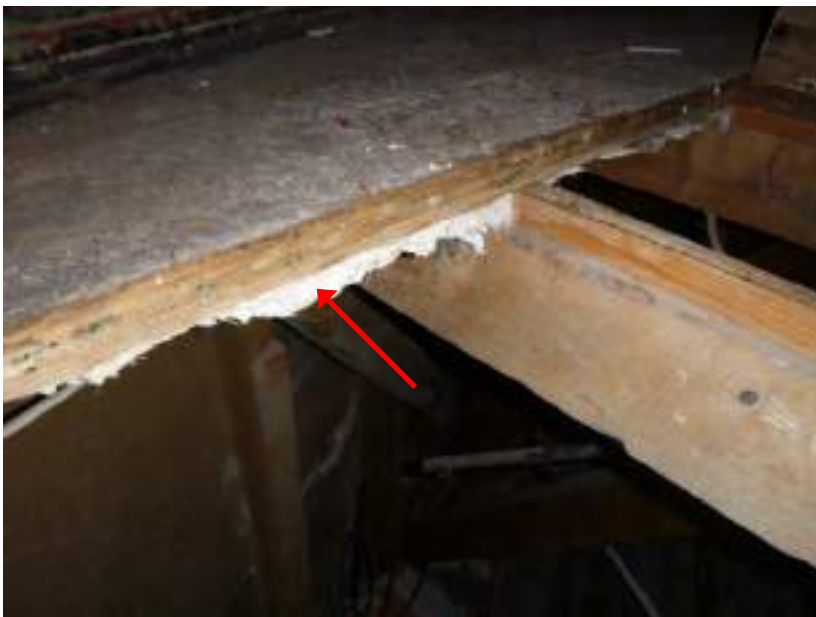
Floor structures, first floor balcony, RM.1-11; showing south area subject to visible water and salts damage. Floorboards showing moisture contents at ~29 per cent

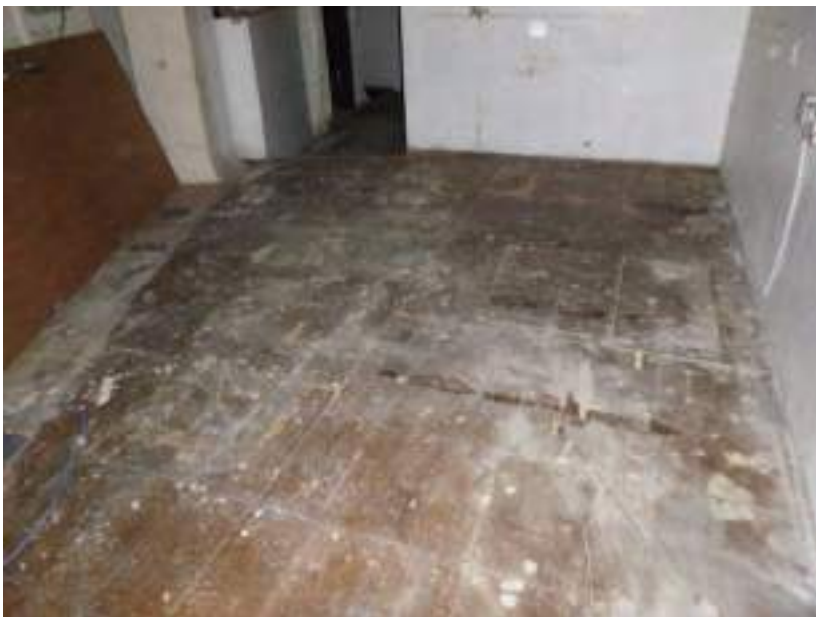
Floor structures, Ground floor, RM.G-13; showing south-east area adjacent to DG-35. Note visible water collecting within cavity in solid floor structures as a result of the fire related water penetration. Door joinery highly vulnerable to decay in this area

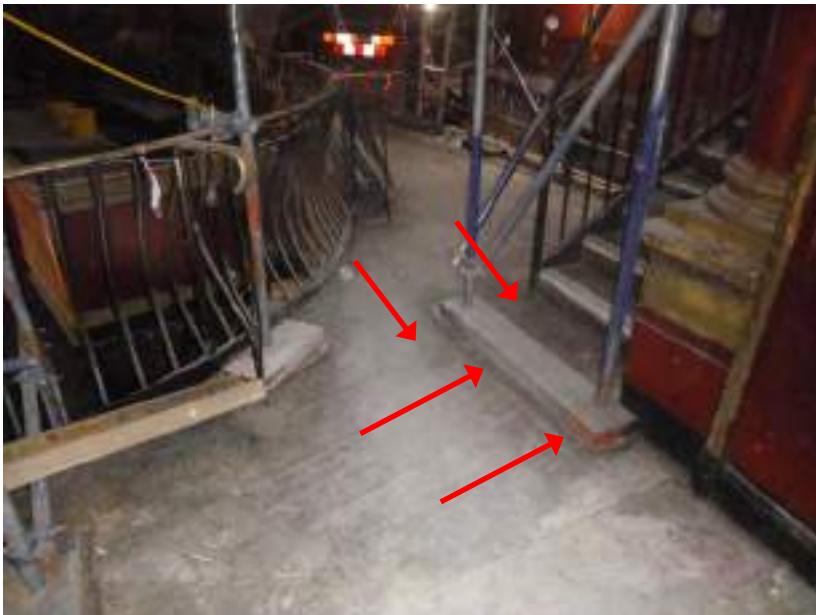
Floor structures, Ground floor balcony, RM.G-10; showing vulnerable timber element within floor void with a surface moisture content at ~26 per cent. Which is high enough to support decay organisms

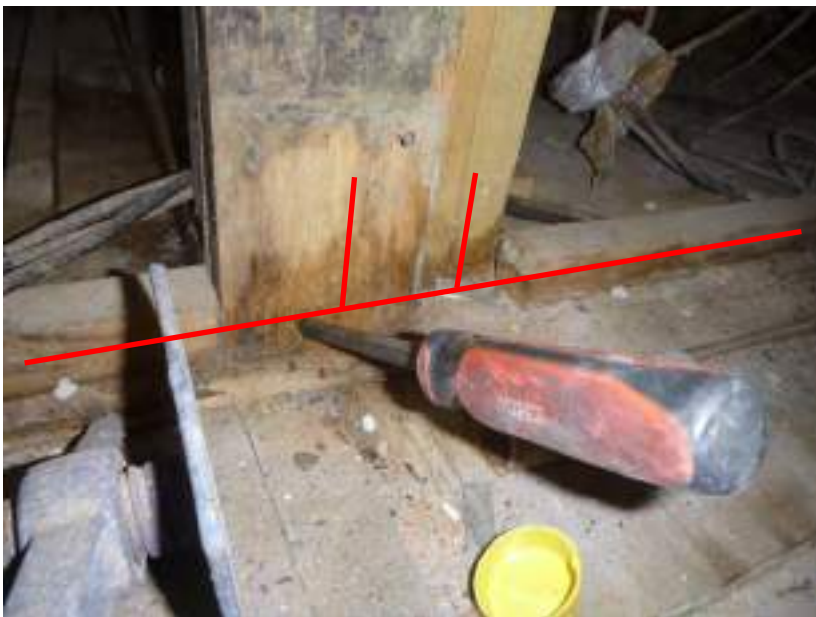
Floor structures, Basement floor, RM.B -11; showing stage floor structure with finishes visibly damp. Note multiple (<4no.) layers of impermeable membrane/floor finishes to stage floor. These all appeared to be trapping/retaining moisture and may be creating the conditions for damp and decay to structures beneath

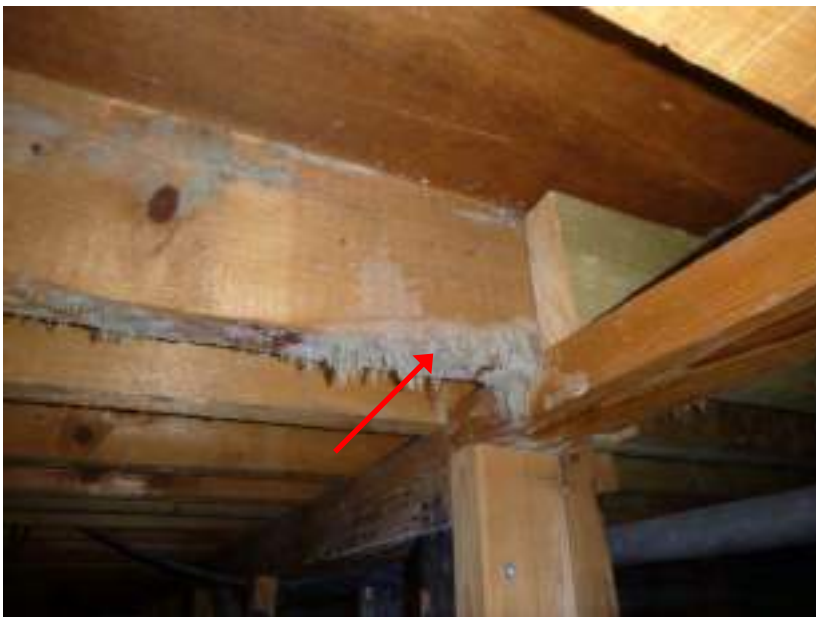
Floor structures, Basement floor, RM.B -11; showing typical view of stage floor structures from below. Note visible active surface mould growth suggestive of damp conditions and inadequate ventilation

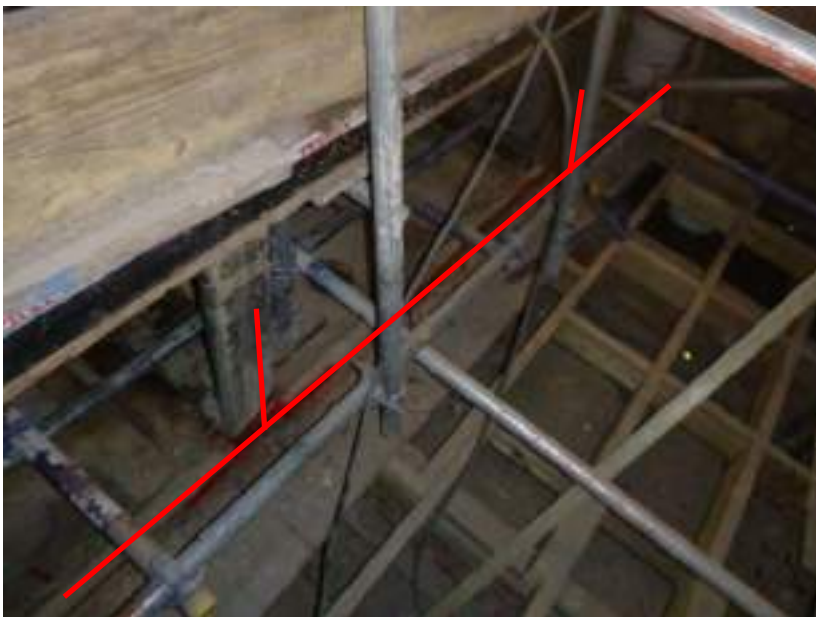
Floor structures, Basement floor, RM.B -11; showing stage floor structures west perimeter stud work subject to active decay at post feet and horizontal plate elements. Timber moisture contents at ~30+ per cent

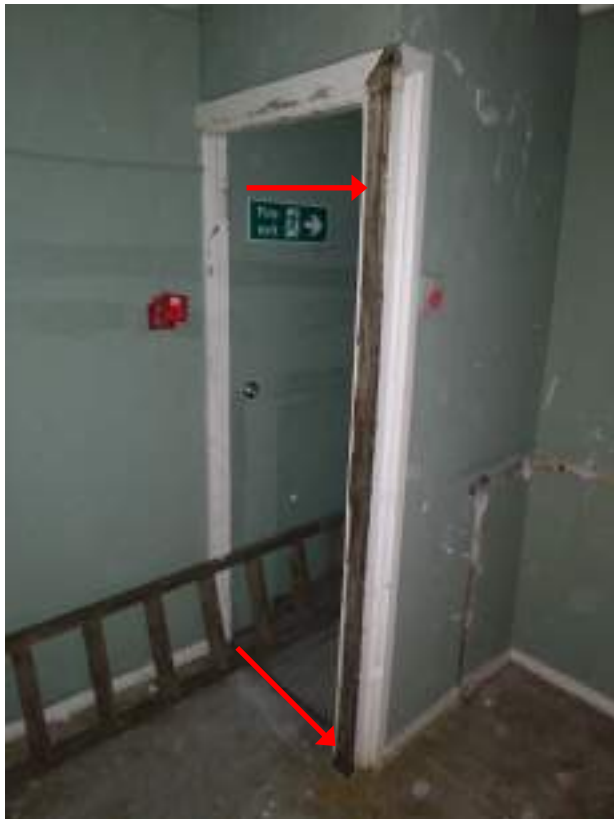
Architrave was missing from the west side, and moisture contents of frame elements behind high enough, at the time of survey, for decay to occur, at over 20 per cent w/w

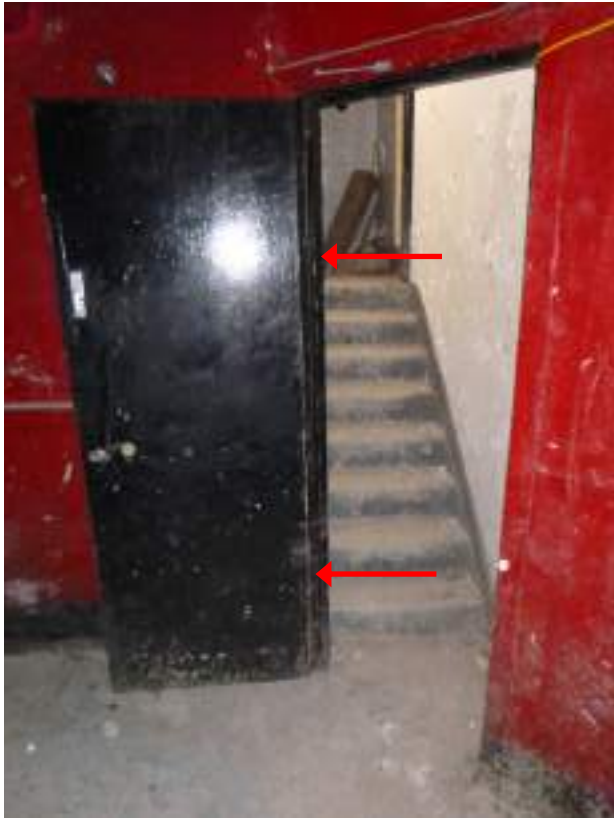
The south door jamb was loose and detached from embedded timber grounds or masonry. This was not deemed a direct result of water penetration during fire-fighting efforts, but most likely related to historic issues with dampness

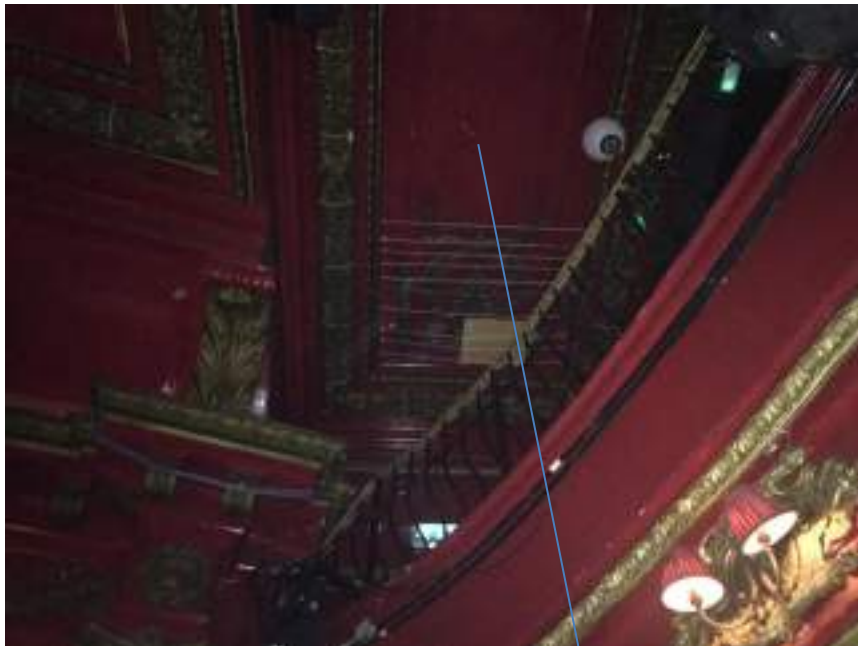
Rectangular shaped soffit believed to be badly affected by water ingress.
