Catherine Hassall
Historic Paint Specialist

Historic paint schemes

KOKO THEATRE

An examination of the historical paint schemes

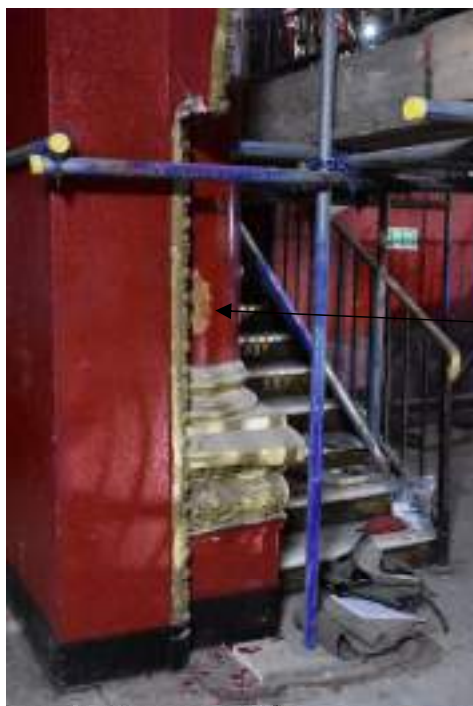
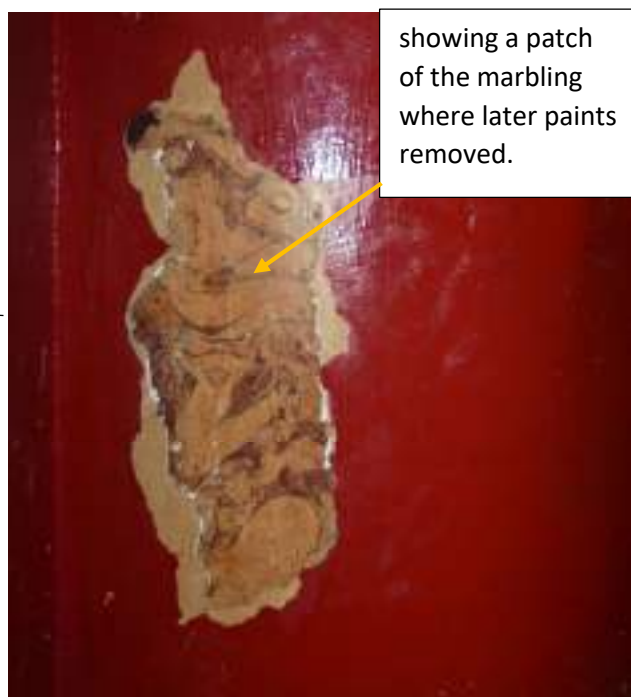
The marbling on the columns was done in traditional technique with alternate layers of paint and glaze.

showing a patch of the marbling where later paints removed.

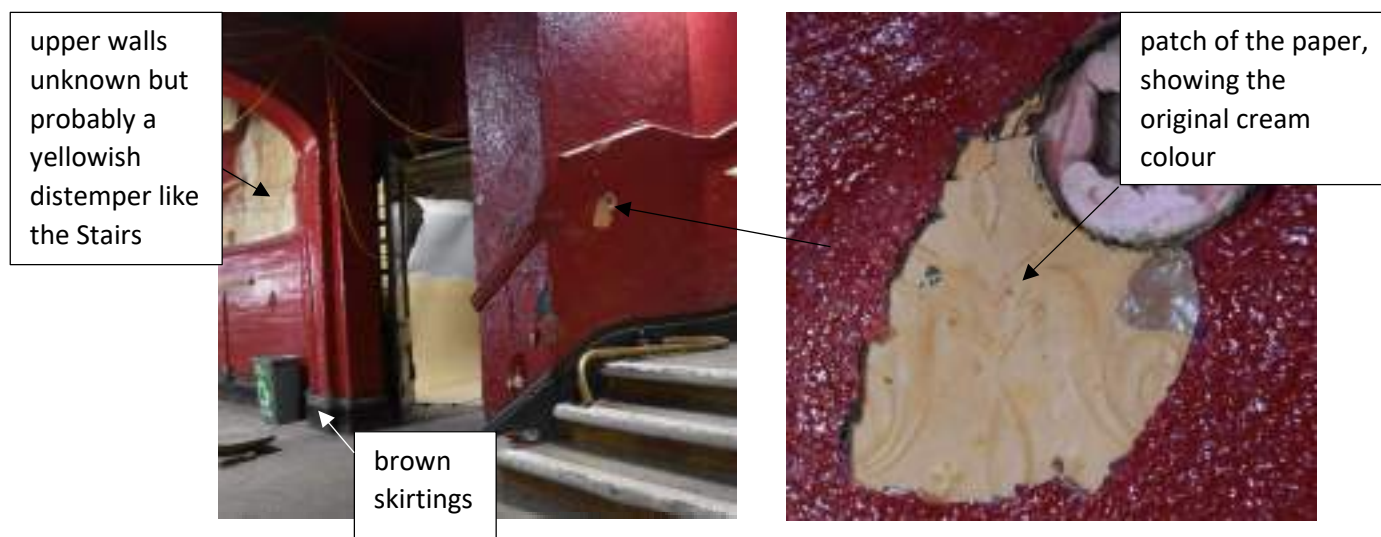
Remains of the embossed paper can be seen at the base of the stairs, and it probably continued down into the ground floor Lobby

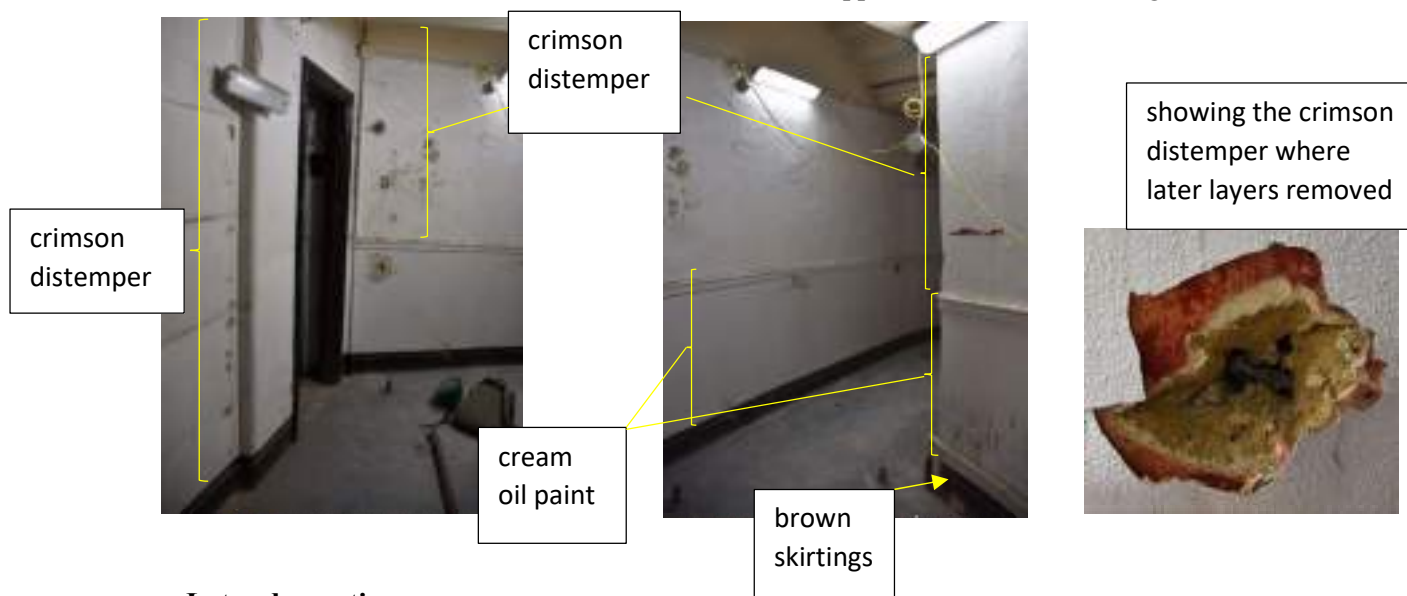
On the west wall, which does not have a dado rail, the red was applied from floor to ceiling

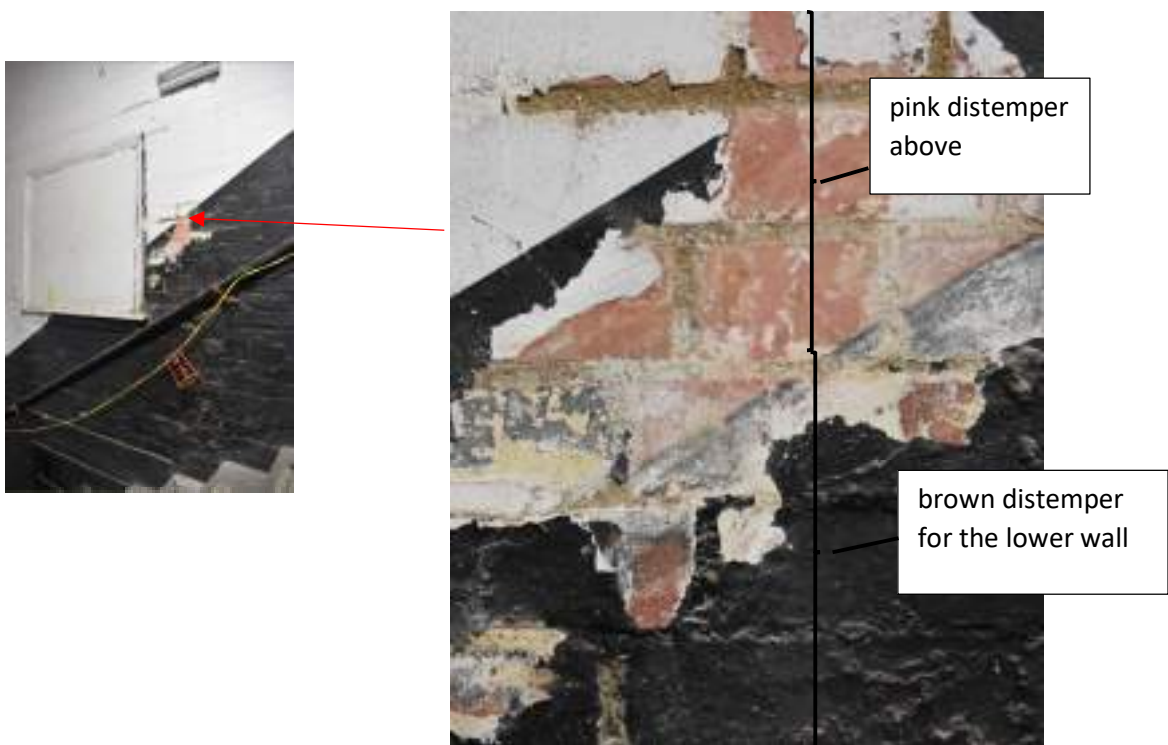
On the south wall, between the first and second floor, a patch of this decoration can be seen where later schemes have been partly cleaned off.

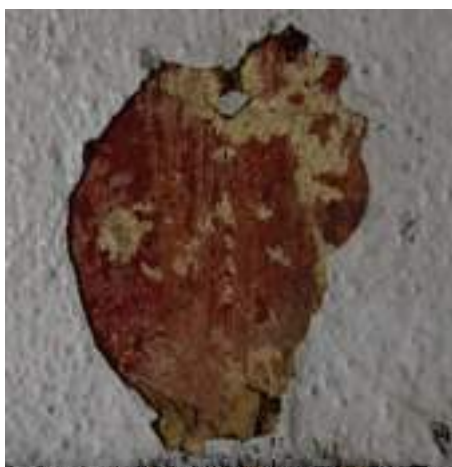
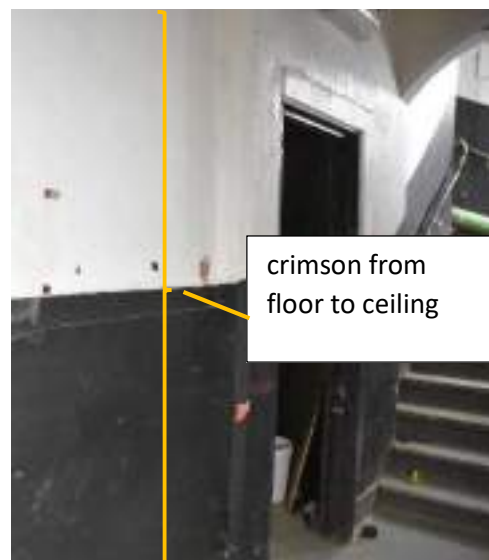
At basement level, patches of it have been revealed where later layers have flaked off

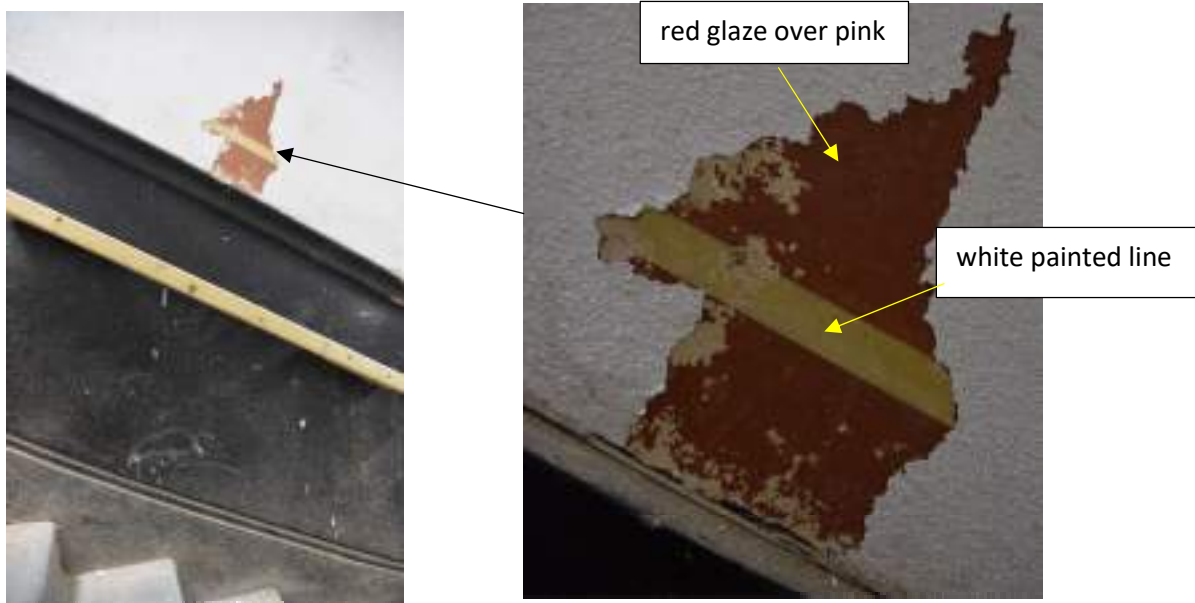
Where later layers have been removed and the scheme is revealed, the white band now looks yellow, but this is due to the discoloured varnish.

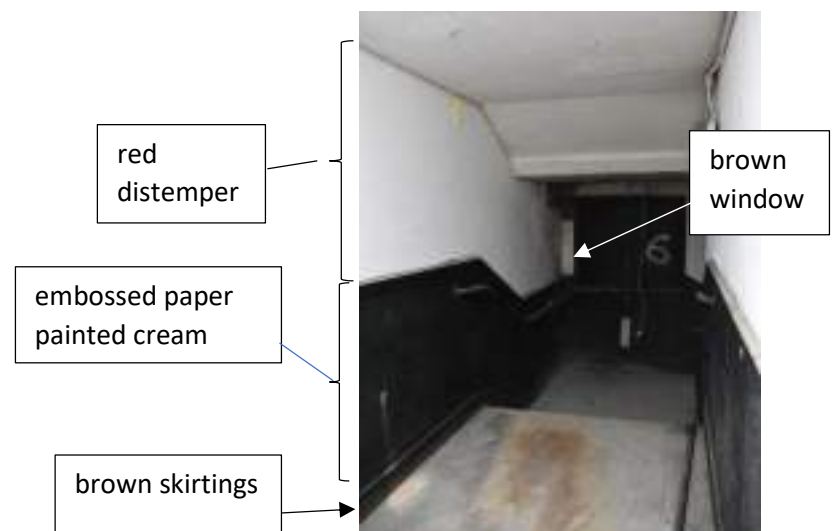
The upper part of the wall was painted with a reddish distemper. This was later washed off, but the lime plaster was stained. A similar staining was not found on the walls of 1.16.

The red distemper which was used here was based on iron oxide and is not the same as the crimson distemper used in the Auditorium, on the Balconies and on the South Stairs.

The plaster today looks pink, because most of the distemper has been lost, but it was once a strong red colour.

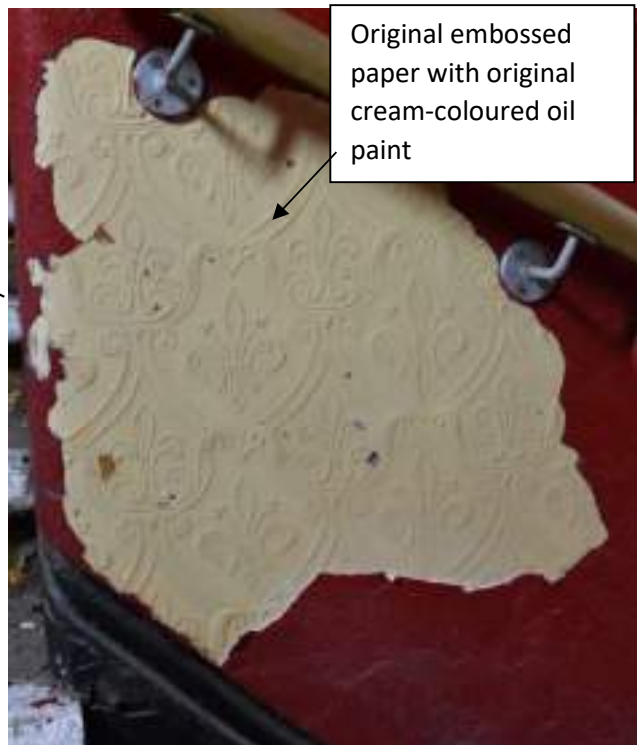
Original embossed
paper with original
cream-coloured oil
paint

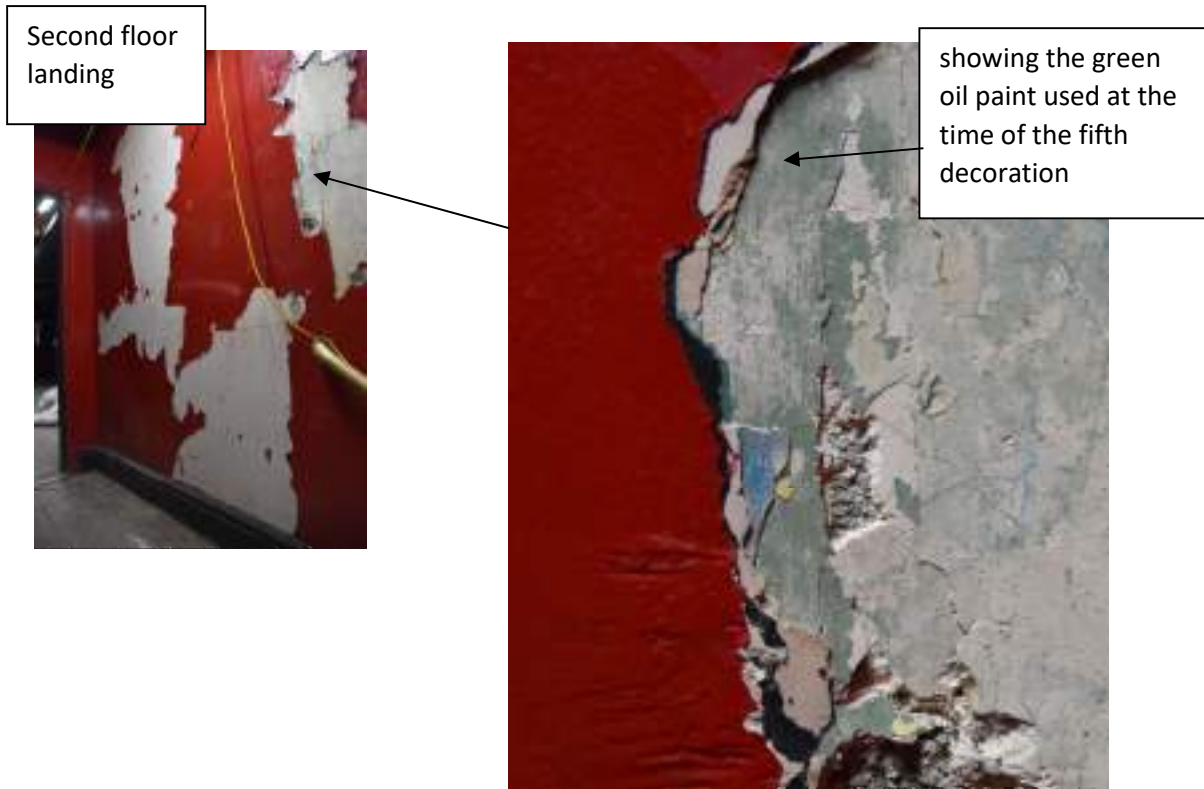
Between the first and second floor the embossed paper was peeled off the lower part of the wall and then the walls from ceiling to skirting were painted green.

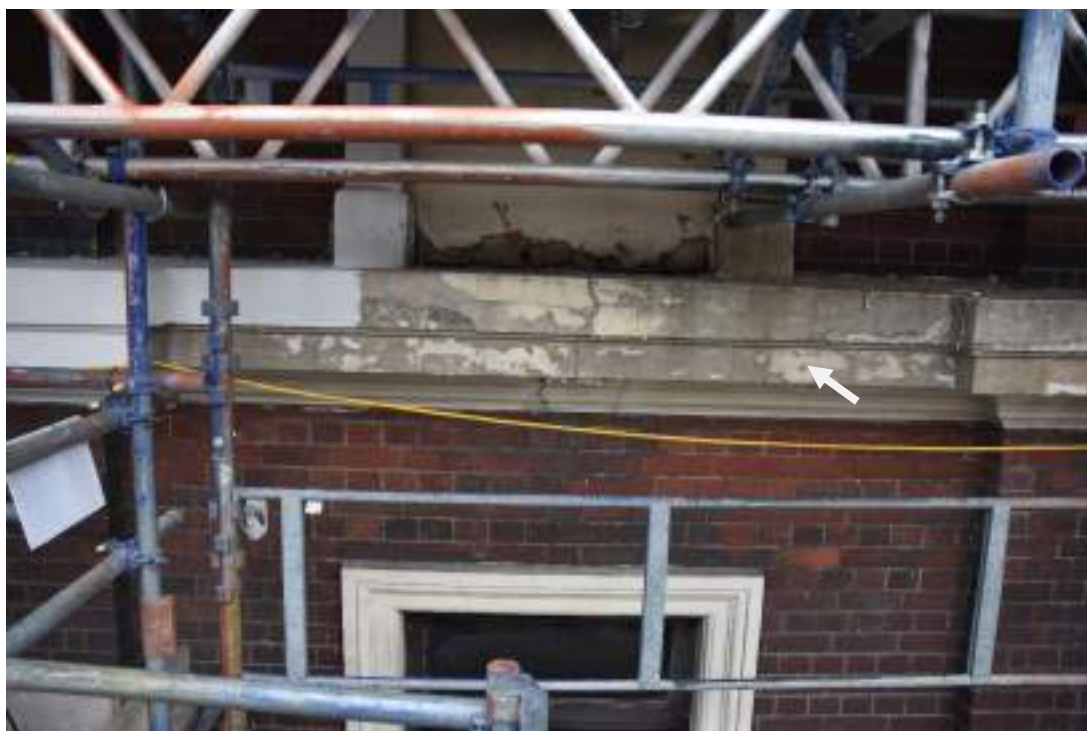
Remains of that paint can be seen today on parts of the south string course

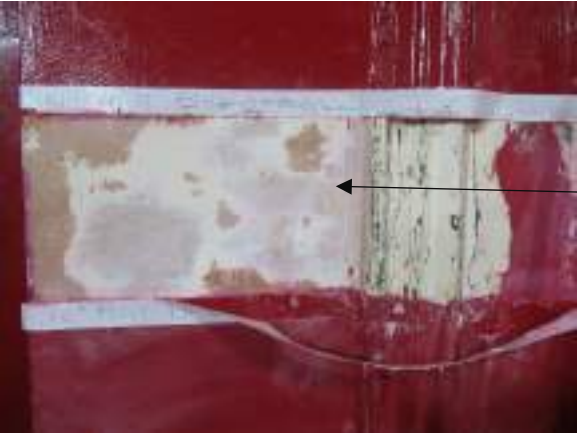
<p>Dwell time overnight. Existing paint was softened to some degree. Difficulty in removing by hand due to underlying paint coats. Superheated steam required to make removal more effective. Partial paint removal revealed underlying substrate to be "roman cement" stucco.</p>
3	Kling strip	1

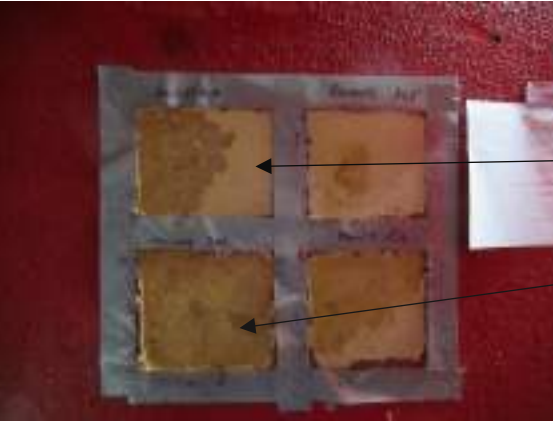
4		1 st application

<p>Dwell time overnight. All products easily removed upper layers. Solvistrip and Tavec 201 loosened underlying cream paint coat sufficiently to scrape off by hand. Conclusion- Tavec 201 or Solvistrip the most suitable products</p>

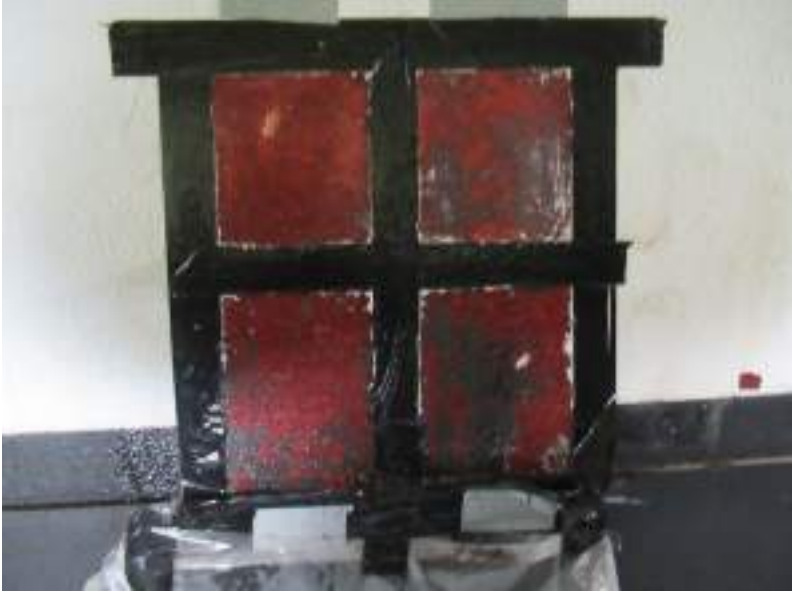
Location	Products	Application	Photo ref.	Notes
7

<p>Dwell time overnight</p> <p>All products successful in removing upper layers back to underlying dark red base, however, Solvistrip and Tavec 201 were easier to remove by hand. Still some residue left on paint layers. Decision to apply a second coat.</p>
7		2 nd
