Asbestos Survey Report

ASBESTOS SURVEY
REPORT NO: A-44387 – ISSUE 6

DATE ISSUED: 06/08/2020

Site Address:
KoKo Night Club
Heritage Areas Survey
1A Camden High St
London
NW1 7JE

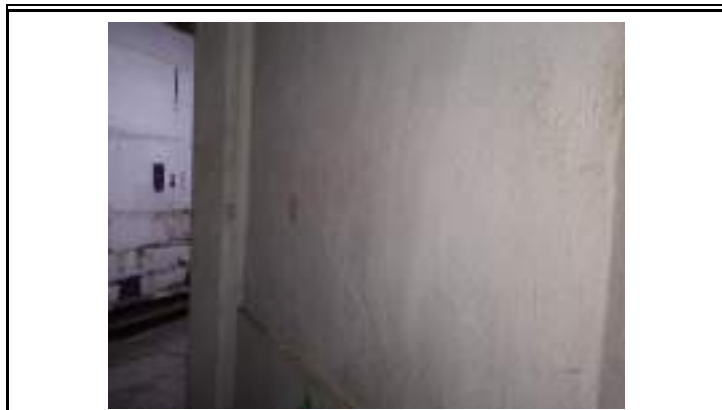
Inspection no:	S001	Type:	Sampled
Room/Area	Basement. RM.B-19 [001]		
Location/Element	Paint to walls and ceiling		
Notes			
Product Type	N/A	Score:	N/A
Damage/Deterioration	N/A	Score:	N/A
Surface Treatment	N/A	Score:	N/A
Asbestos Type	NAD	Score:	N/A
Extent	5 m ²		
Recommended Action	N/A	Total Score	0

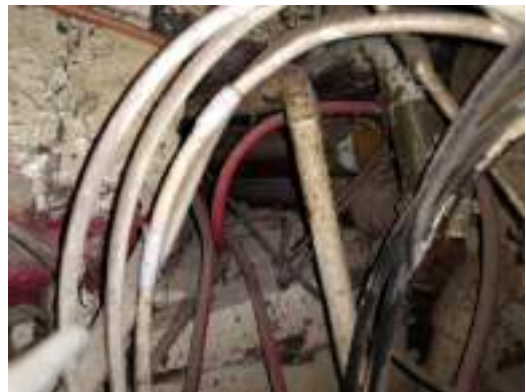
Inspection no:	S002	Type:	Sampled
Room/Area	Basement. RM.B-33 [002]		
Location/Element	Debris where pipes pass through wall		
Notes			
Product Type	N/A	Score:	N/A
Damage/Deterioration	N/A	Score:	N/A
Surface Treatment	N/A	Score:	N/A
Asbestos Type	NAD	Score:	N/A
Extent	0.1 m ²		
Recommended Action	N/A	Total Score	0

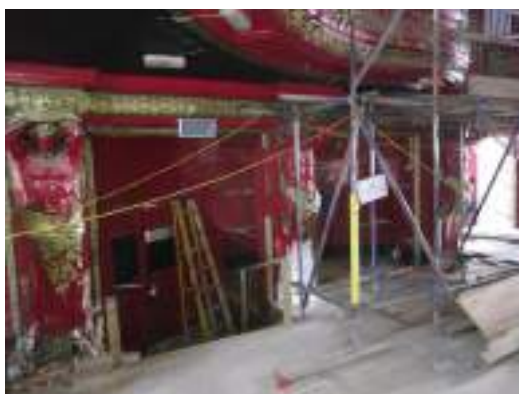
Inspection no: N015
Room/Area Basement. RM.B-16 [005]
Location/Element North side walls. Statues and covings
Notes No access behind statues and covings due to heritage.
Product Type N/A
Damage/Deterioration N/A
Surface Treatment N/A
Asbestos Type
Extent
Recommended Action N/A

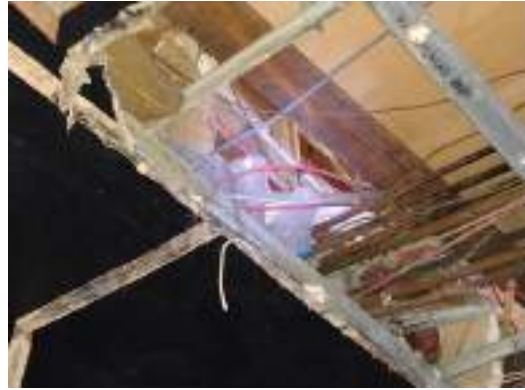
Inspection no:	R006	Type:	Referred Sample
Room/Area	Basement. RM.B-16 [005]		
Location/Element	Insulating board within ceiling		
Notes			
Product Type	Insulating Board	Score:	2
Damage/Deterioration	High Damage	Score:	3
Surface Treatment	Partially Unsealed	Score:	2
Asbestos Type	Amosite	Score:	2
Extent	50 m ²		
Recommended Action	Remove	Total Score	9

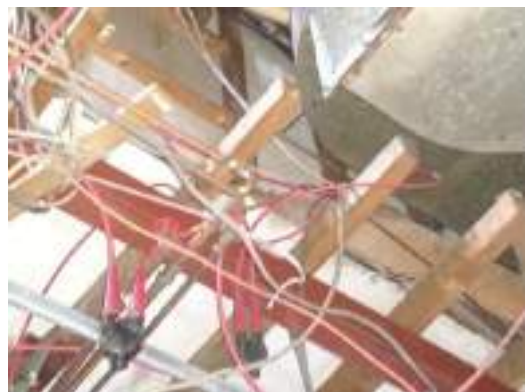
Inspection no:	S006	Type:	Sampled
Room/Area	Basement. RM.B-16 [005]		
Location/Element	Insulating board within ceiling		
Notes			
Product Type	Insulating Board	Score:	2
Damage/Deterioration	High Damage	Score:	3
Surface Treatment	Partially Unsealed	Score:	2
Asbestos Type	Amosite	Score:	2
Extent	50 m ²		
Recommended Action	Remove	Total Score	9

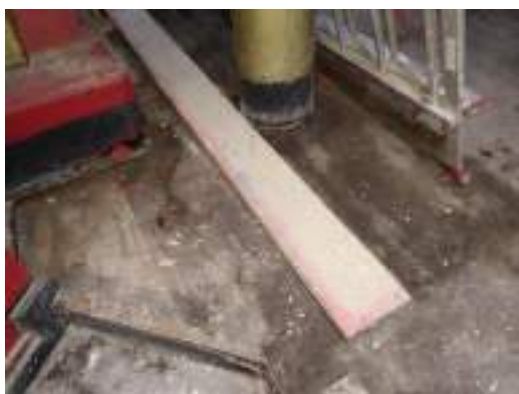
Inspection no:	S008	Type:	Sampled
Room/Area	Basement. RM.B-16 [005]		
Location/Element	Insulating board debris to floor near column		
Notes			
Product Type	Insulating Board Debris	Score:	2
Damage/Deterioration	High Damage	Score:	3
Surface Treatment	Partially Unsealed	Score:	2
Asbestos Type	Amosite	Score:	2
Extent	2 m ²		
Recommended Action	Remove	Total Score	9

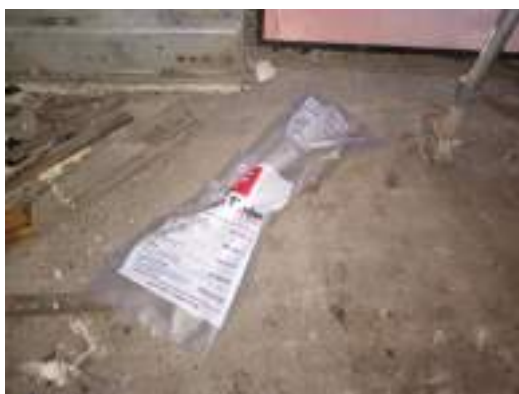
Inspection no:	S010	Type:	Sampled
Room/Area	Basement. RM.B-16 [005]		
Location/Element	Loose panels within rubble bag		
Notes			
Product Type	Insulating Board Debris	Score:	2
Damage/Deterioration	High Damage	Score:	3
Surface Treatment	Partially Unsealed	Score:	2
Asbestos Type	Amosite	Score:	2
Extent	1 m ²		
Recommended Action	Remove	Total Score	9

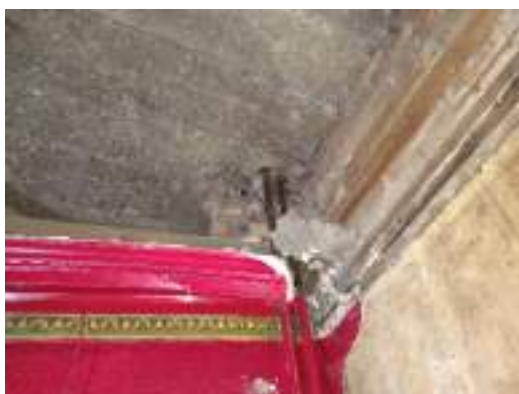
Inspection no:	S019	Type:	Sampled
Room/Area	Ground Floor. RM.G-11 [023]		
Location/Element	Shuttering where pipes pass through ceiling		
Notes			
Product Type	Insulating Board	Score:	2
Damage/Deterioration	Medium Damage	Score:	2
Surface Treatment	Partially Unsealed	Score:	2
Asbestos Type	Chrysotile	Score:	1
Extent	0.1 m ²		
Recommended Action	Remove	Total Score	7

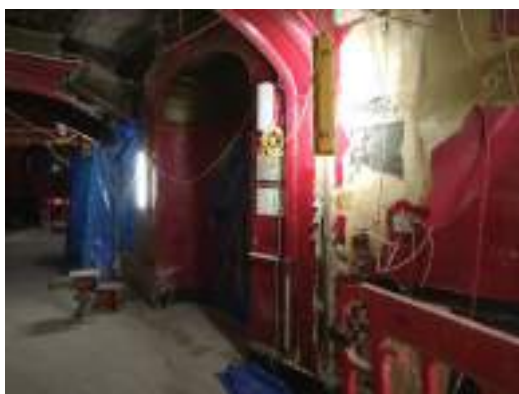
Inspection no:	S307	Type:	Sampled
Room/Area	Ground Floor. RM.G-11 [023]		
Location/Element	Textured coating to walls under paint		
Notes			
Product Type	Textured Coating	Score:	1
Damage/Deterioration	Low Damage	Score:	1
Surface Treatment	Sealed	Score:	1
Asbestos Type	Chrysotile	Score:	1
Extent	80 m ²		
Recommended Action	Remove	Total Score	4

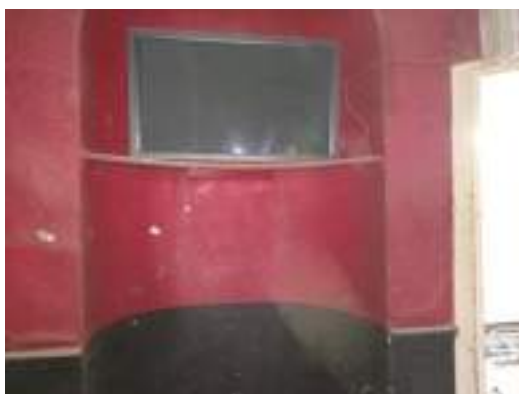
Inspection no:	S309	Type:	Sampled
Room/Area	Ground Floor. RM.G-11 [023]		
Location/Element	Textured coating to walls under paint		
Notes			
Product Type	Textured Coating	Score:	1
Damage/Deterioration	Low Damage	Score:	1
Surface Treatment	Sealed	Score:	1
Asbestos Type	Chrysotile	Score:	1
Extent	80 m ²		
Recommended Action	Remove	Total Score	4

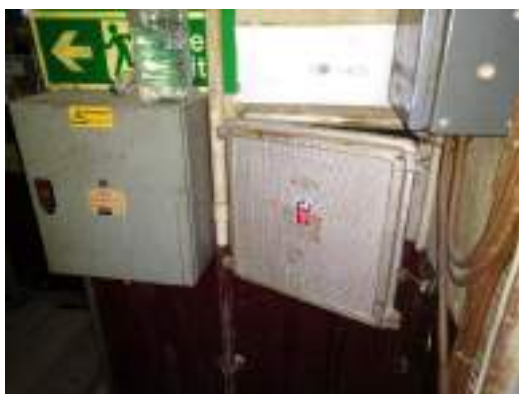
Inspection no:	S026	Type:	Sampled
Room/Area	Ground Floor. RM.G-16 [035]		
Location/Element	Textiles within electrical units		
Notes			
Product Type	Textile Flash Guard	Score:	2
Damage/Deterioration	Low Damage	Score:	1
Surface Treatment	Sealed	Score:	1
Asbestos Type	Chrysotile	Score:	1
Extent	4 units no		
Recommended Action	Remove	Total Score	5

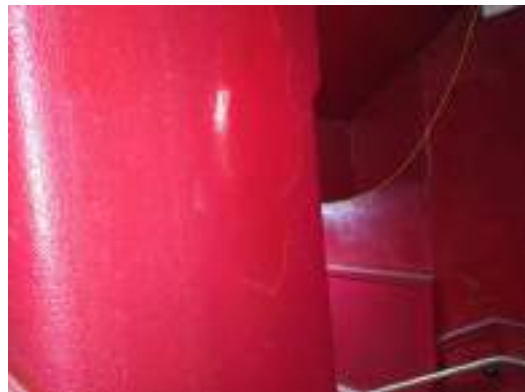
Inspection no:	R307	Type:	Referred Sample
Room/Area	Ground Floor. RM.G-14 [036]		
Location/Element	Textured paint to walls		
Notes			
Product Type	Textured Coating	Score:	1
Damage/Deterioration	Low Damage	Score:	1
Surface Treatment	Sealed	Score:	1
Asbestos Type	Chrysotile	Score:	1
Extent	50 m ²		
Recommended Action	Remove	Total Score	4

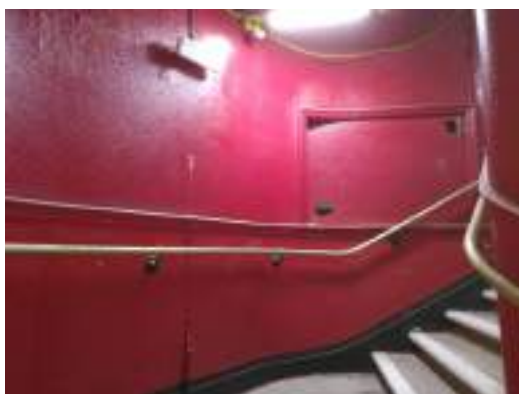
Inspection no:	S306	Type:	Sampled
Room/Area	Ground Floor. RM.G-14 [036]		
Location/Element	Textured coating under paint		
Notes			
Product Type	Textured Coating	Score:	1
Damage/Deterioration	Low Damage	Score:	1
Surface Treatment	Sealed	Score:	1
Asbestos Type	Chrysotile	Score:	1
Extent	15 m ²		
Recommended Action	Remove	Total Score	4

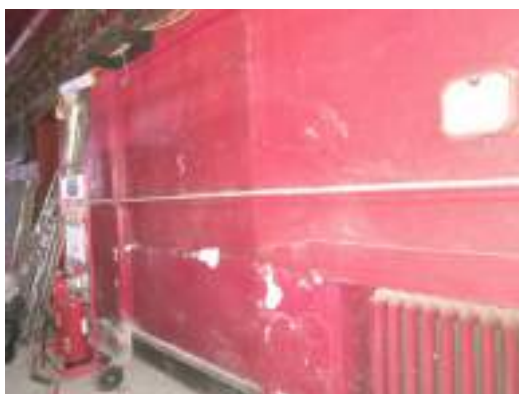
Inspection no:	S260	Type:	Sampled
Room/Area	1st Floor. RM.1-12 [037]		
Location/Element	Textured coating under paint		
Notes			
Product Type	Textured Coating	Score:	1
Damage/Deterioration	Low Damage	Score:	1
Surface Treatment	Sealed	Score:	1
Asbestos Type	Chrysotile	Score:	1
Extent	100 m ²		
Recommended Action	Remove	Total Score	4

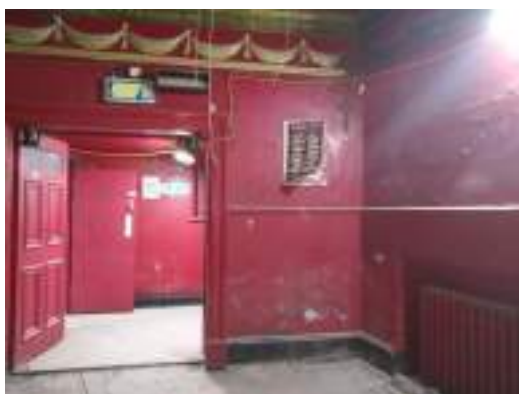
Inspection no:	S263	Type:	Sampled
Room/Area	1st Floor. RM.1-12 [037]		
Location/Element	Textured coating under paint		
Notes			
Product Type	Textured Coating	Score:	1
Damage/Deterioration	Low Damage	Score:	1
Surface Treatment	Sealed	Score:	1
Asbestos Type	Chrysotile	Score:	1
Extent	20 m ²		
Recommended Action	Remove	Total Score	4

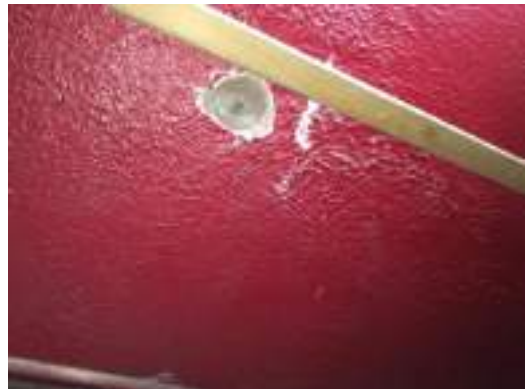
Inspection no:	R258	Type:	Referred Sample
Room/Area	1st Floor. RM.1-11 [038]		
Location/Element	Textured paint to brick walls		
Notes			
Product Type	Textured Coating	Score:	1
Damage/Deterioration	Medium Damage	Score:	2
Surface Treatment	Sealed	Score:	1
Asbestos Type	Chrysotile	Score:	1
Extent	30 m ²		
Recommended Action	Remove	Total Score	5

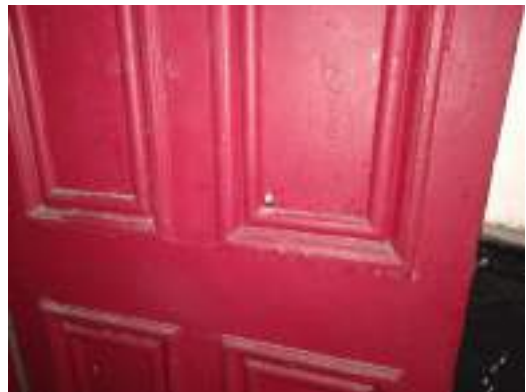
Inspection no:	S028	Type:	Sampled
Room/Area	1st Floor. RM.1-16 [039]		
Location/Element	Infill panels to doors		
Notes			
Product Type	Insulating Board	Score:	2
Damage/Deterioration	Low Damage	Score:	1
Surface Treatment	Sealed	Score:	1
Asbestos Type	Chrysotile	Score:	1
Extent	2 no		
Recommended Action	Remove	Total Score	5

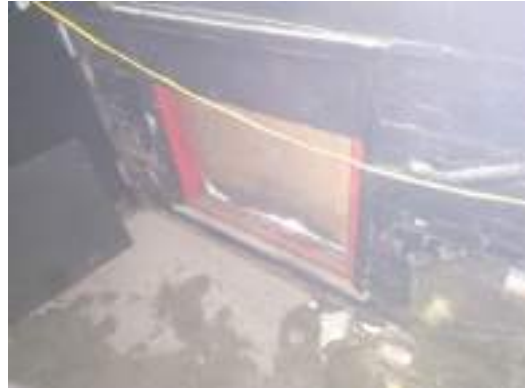
Inspection no:	N/A	Type:	N/A
Room/Area	3rd Floor. W3-08E [094]		
Location/Element	Window		
Notes	Limited access gained. External inspection, timber board, not accessed due to scaffolding. Internal inspection, timber window to solid walls, timber sill, timber boards, MMMF insulation.		
Product Type	N/A	Score:	N/A
Damage/Deterioration	N/A	Score:	N/A
Surface Treatment	N/A	Score:	N/A
Asbestos Type		Score:	N/A
Extent			
Recommended Action	N/A	Total Score
