hazard: outline method statement

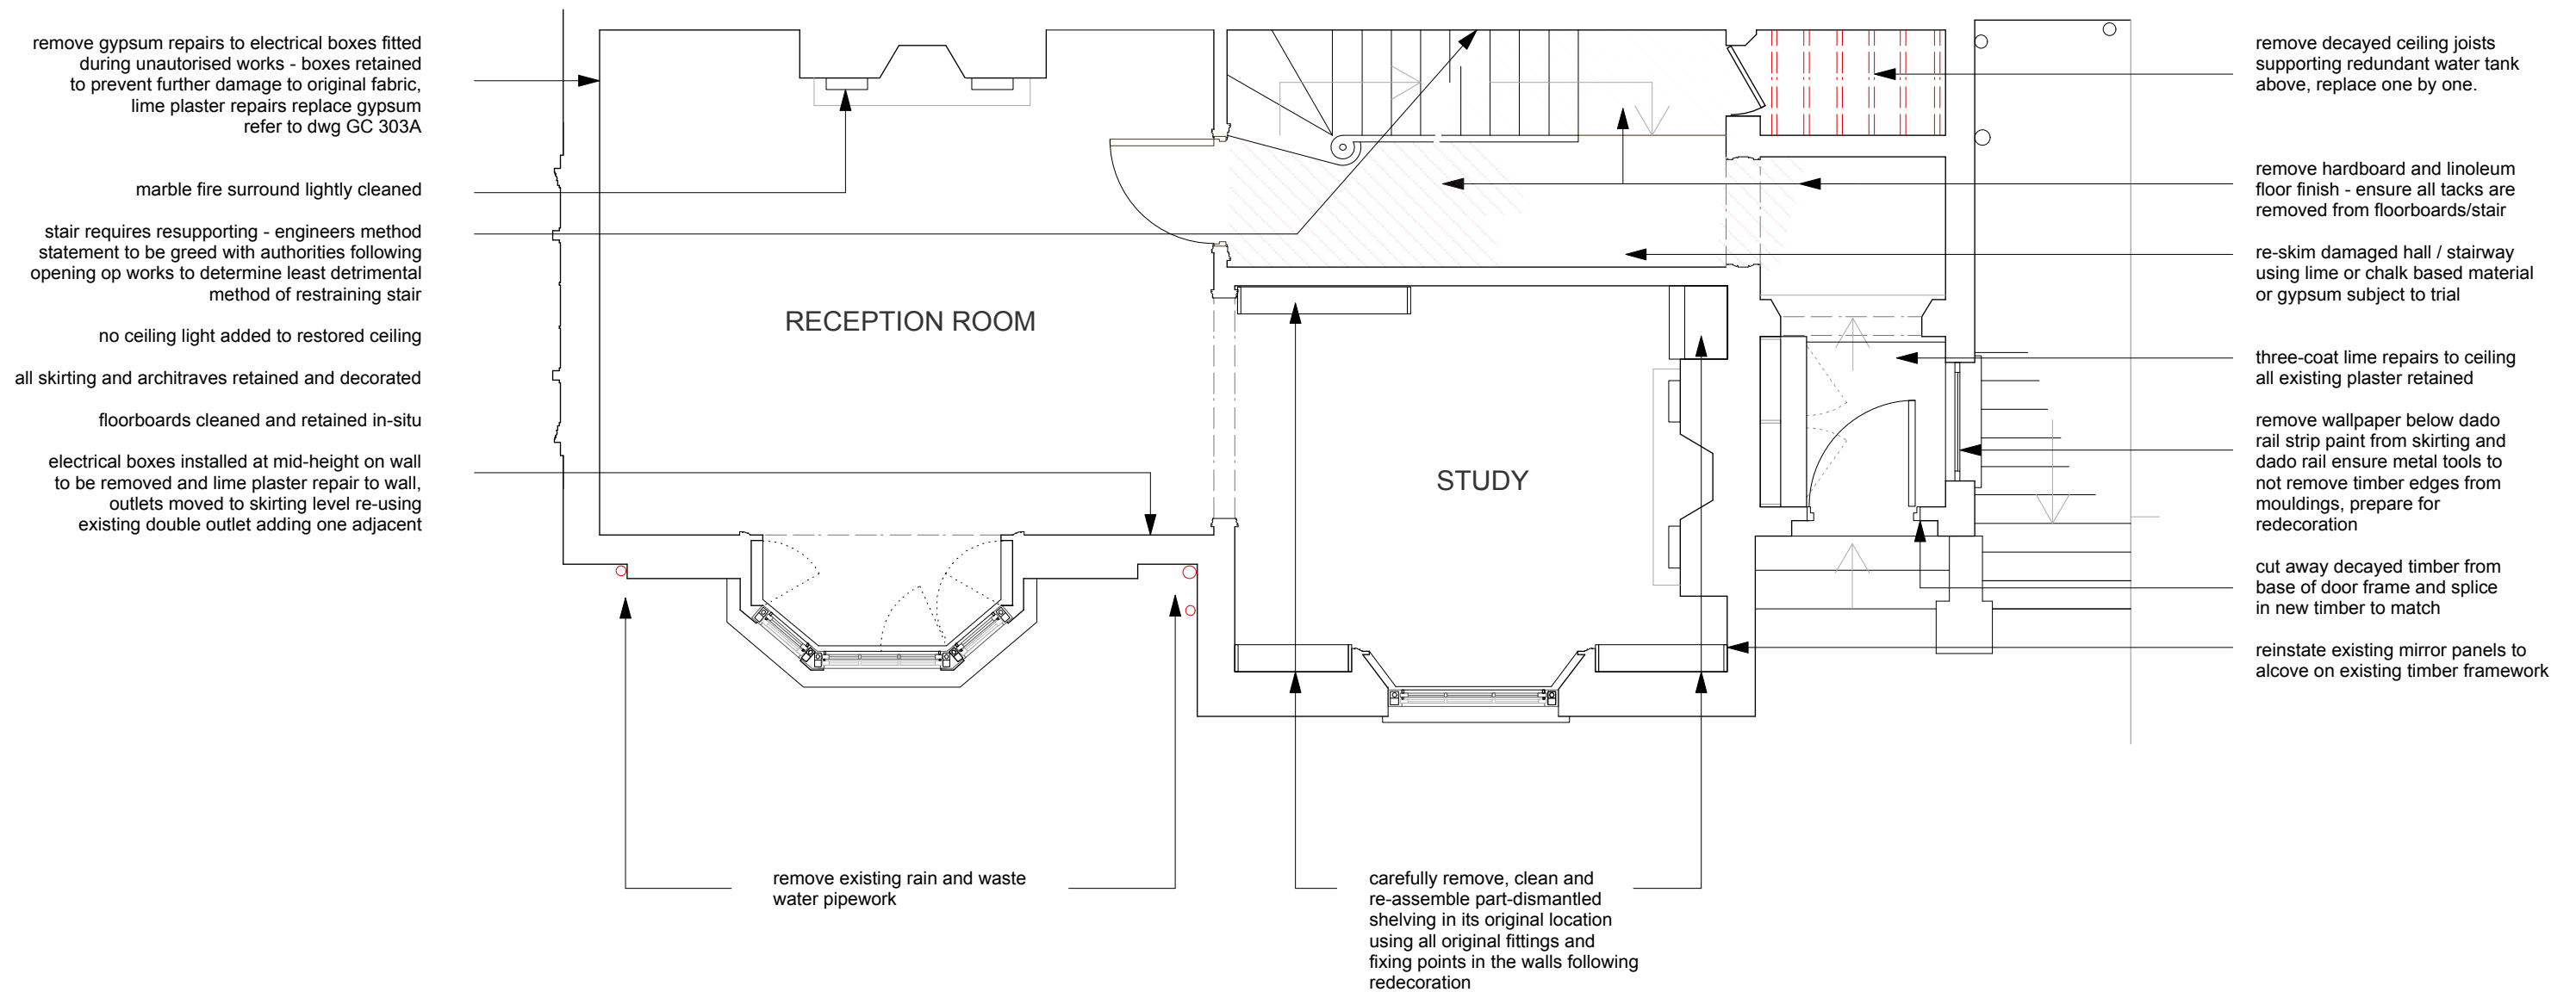
Risk Assessment to identify safe removal and replacement of badly decayed joists supporting redundant metal water tank to cloakroom - propping required, replace joist at a time, ensure adequate bearing to masonry. Inspect condition of tank and under-roof during operation.

Ensure certified full scaffold by specialist installer with correctly positioned lifts to allow safe removal of ironware and PVC pipes. Re-use fixing points where possible, repair all holes/minor damage with Roman cement. Retain all ironware for re-use if joints are clean and corrosion is not significant.
