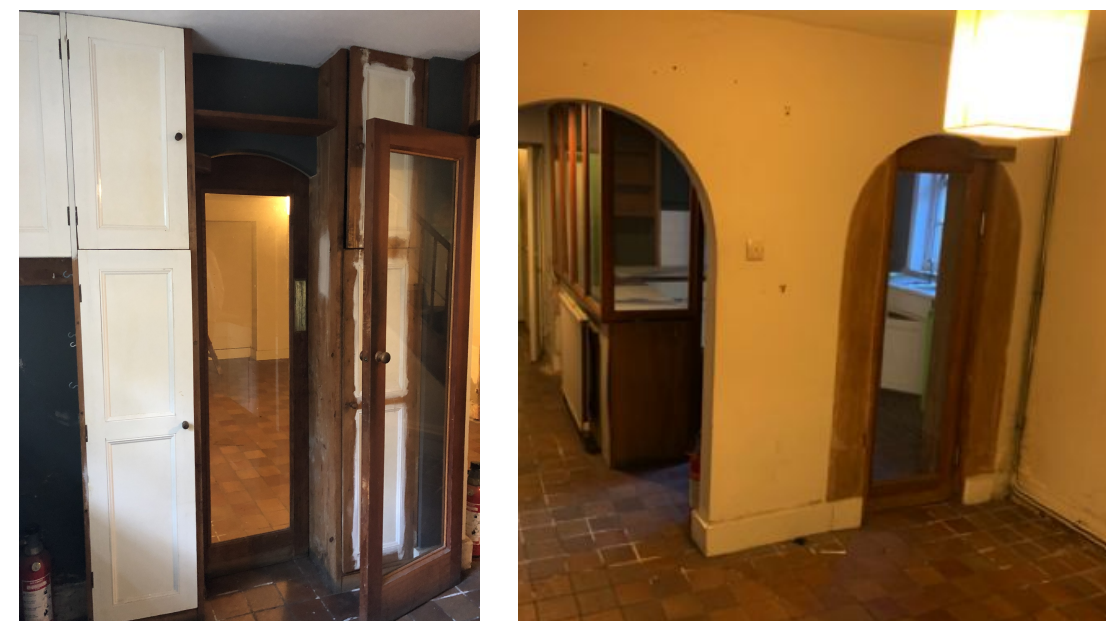
kitchen infill photographed prior to unauthorized removals 2019

1. addition of glazed screen, arch infill door and cupboards documented by Alan Bennett as expedient installation to contain kitchen smells
2. dining room view showing expedient plywood infill
3. partly white painted timber joinery
4. no fire protection or compartmentation

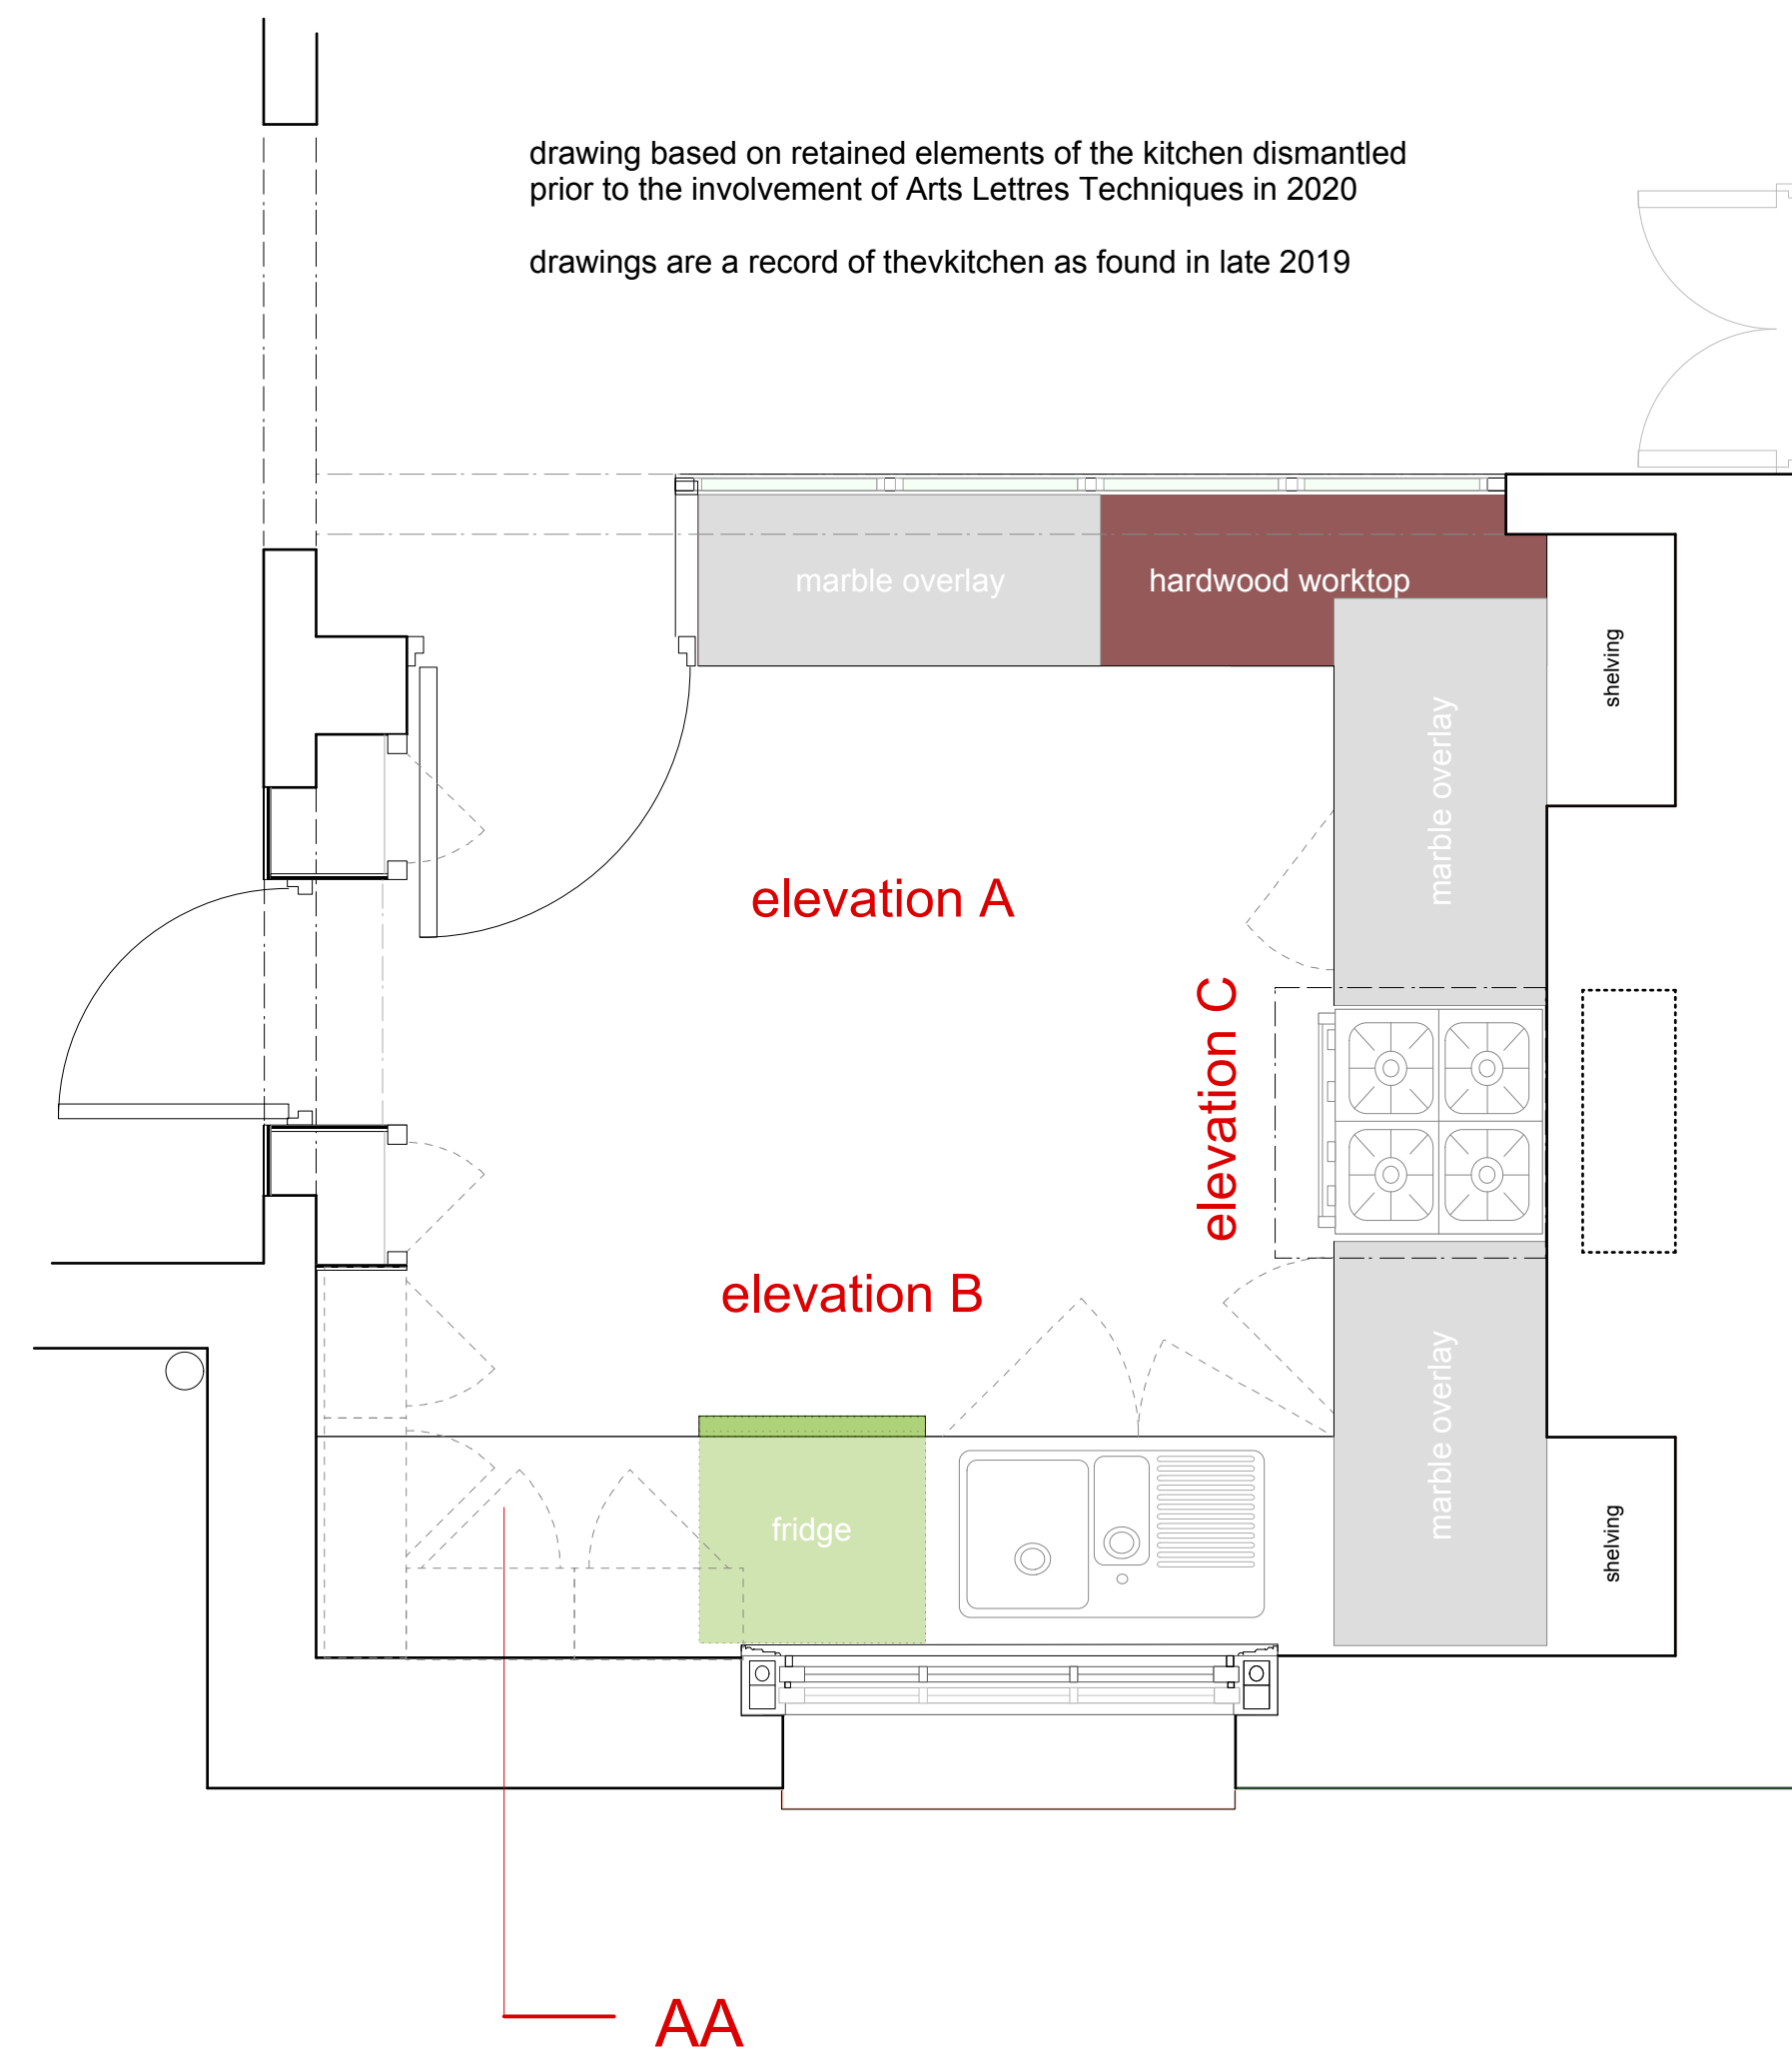
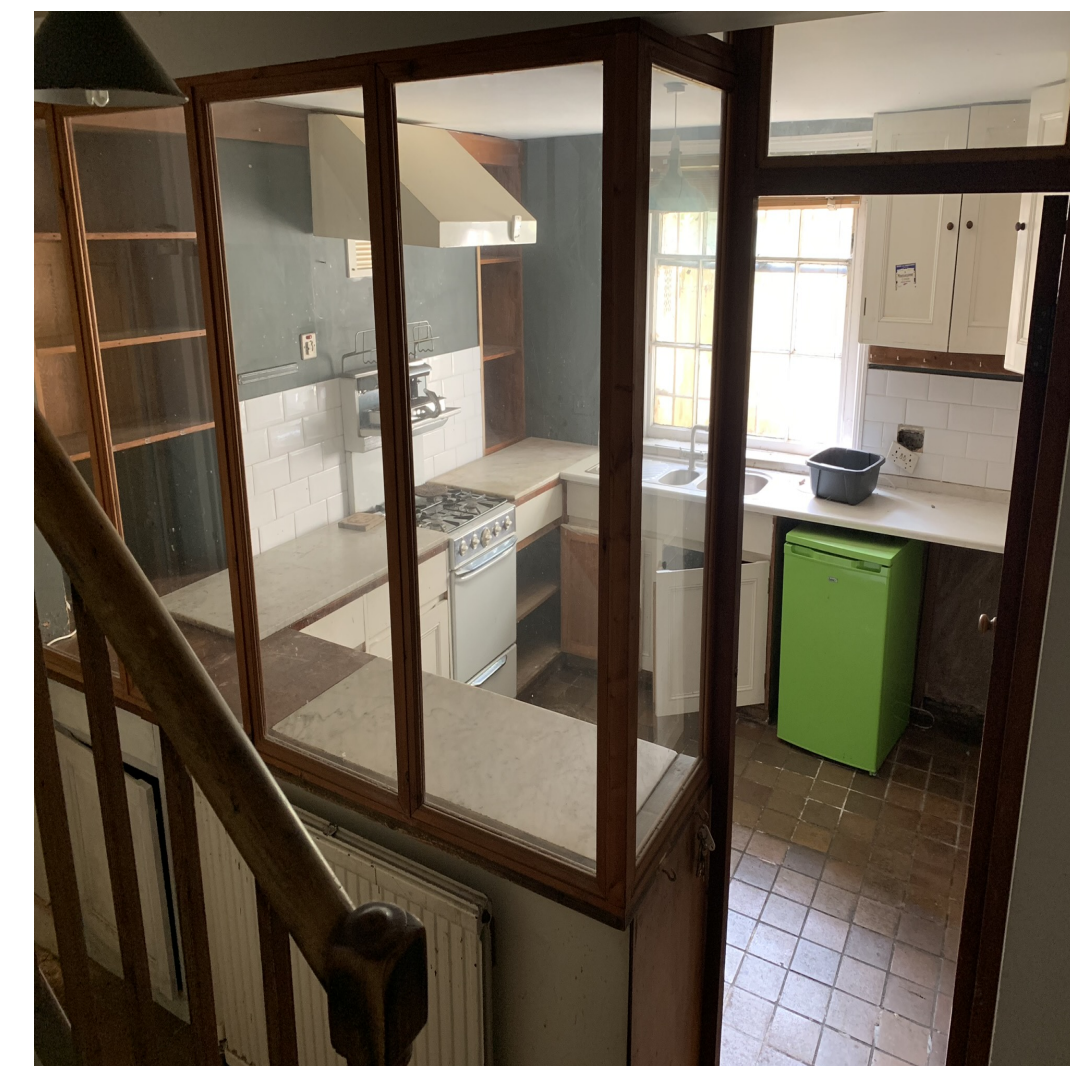
kitchen photographed prior to unauthorized removals 2019

1. replacement 2006+ 'Vola' style mixer tap with small double bowl sink
2. replacement white melamine sink worktop with two reclaimed hardwood worktops with Carrera marble overlay slabs
3. white painted timber joinery, omission of joinery adjacent to sink unit with modern green refrigerator
4. tiled walls c. 2006+ adjacent to gas cooker

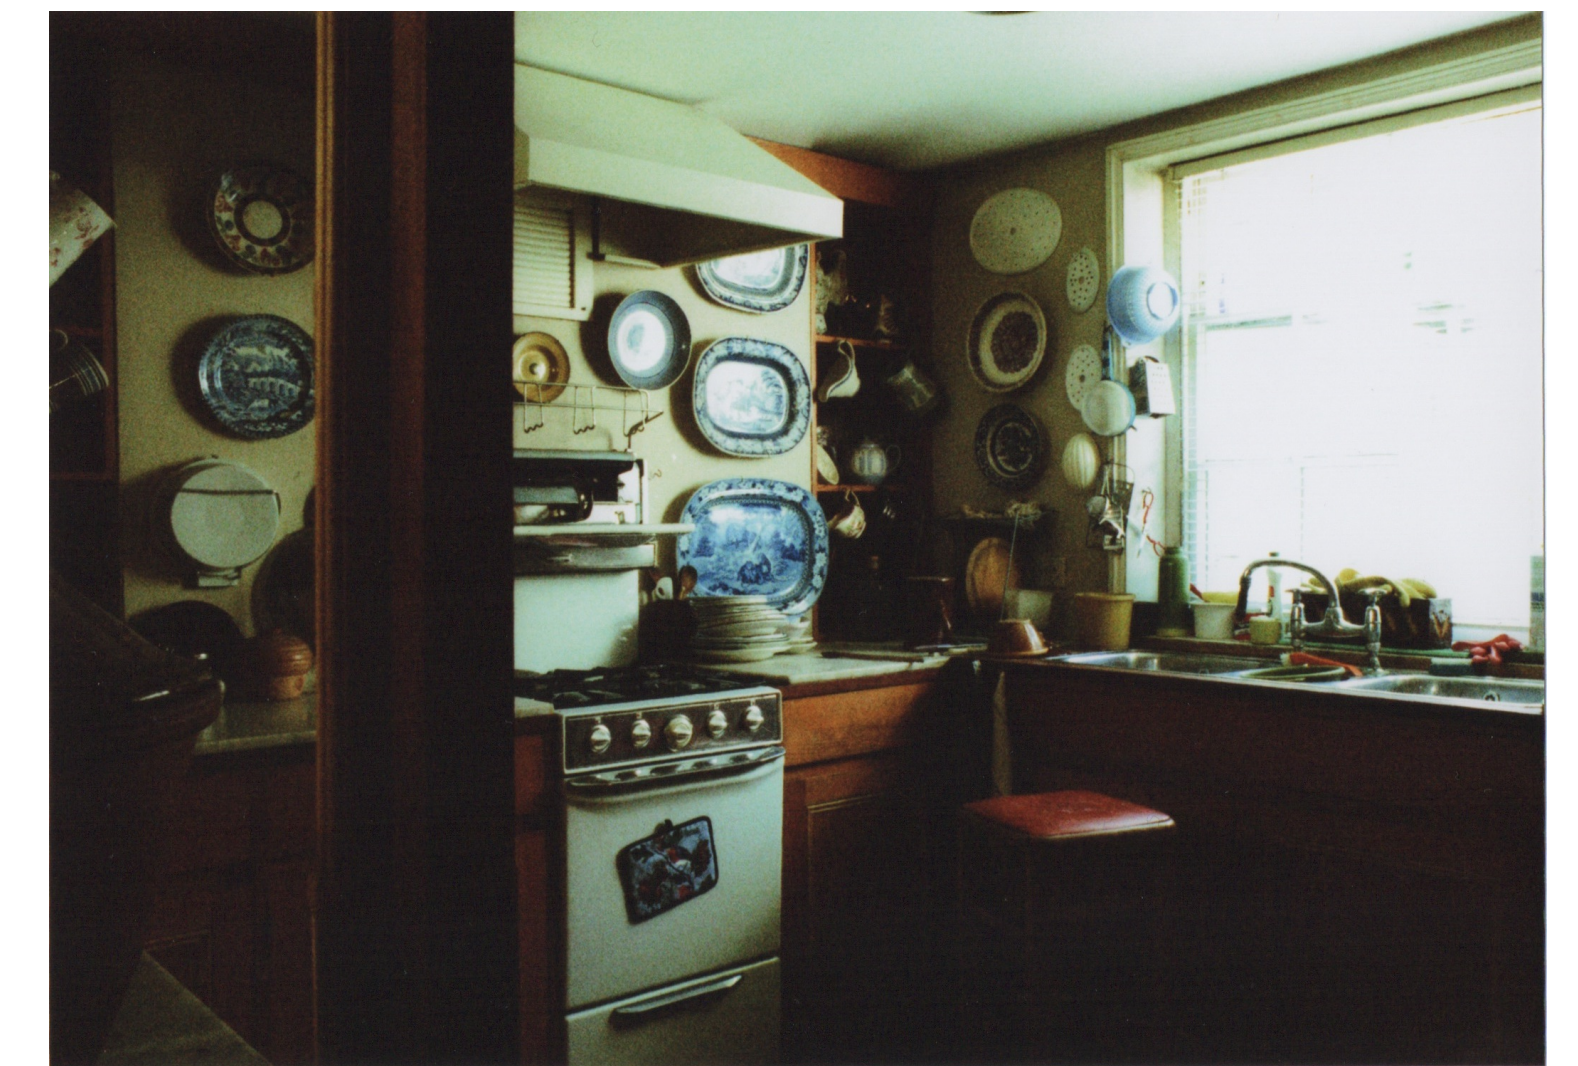
kitchen photographed during Alan Bennett's residency est. 1990's

1. original 1969 mixer tap with stainless steel double bowl sink and drainer
2. reclaimed hardwood worktops throughout with reclaimed Carrera marble overlay slabs
3. stained natural timber joinery throughout
4. painted walls adjacent to gas cooker
