7 ST JOHNS WOOD PARK, CAMDEN

APPENDIX DOCUMENT

APPENDIX 3.0:
Drainage report

STRUCTURAL ENGINEER STATEMENT

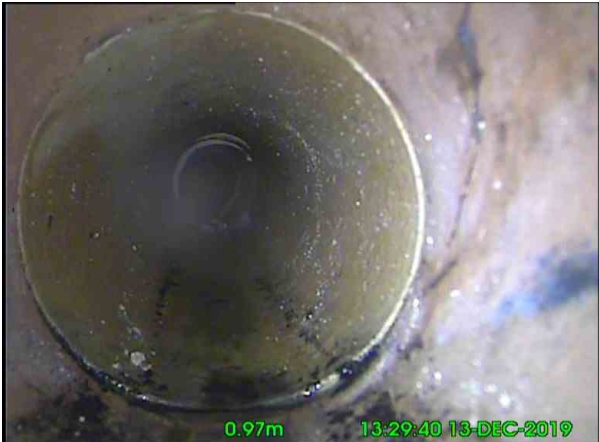
1, 00:00:22, 0.97 m

Fracture, circumferential at joint from 12 o'clock to 12 o'clock

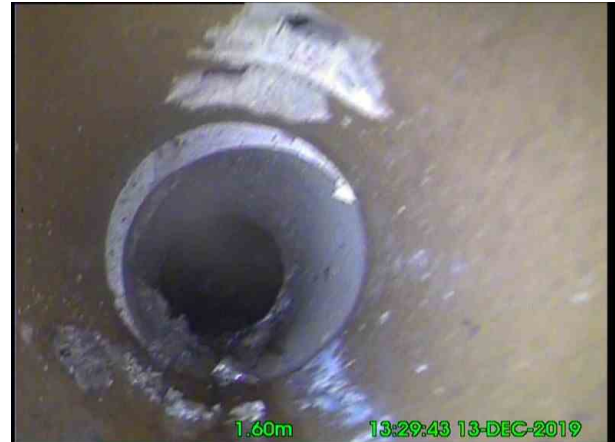
2, 00:00:25, 1.53 m

Hole in drain or sewer at 1 o'clock

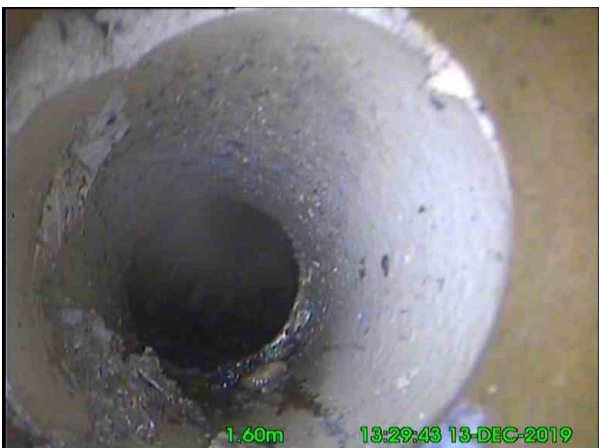
3, 00:00:26, 1.60 m

Joint displaced, large

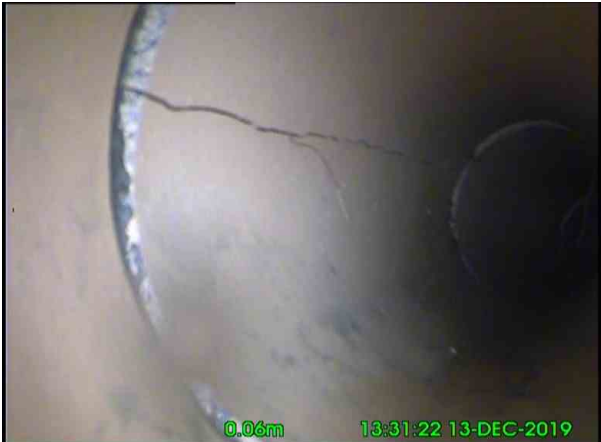
1, 00:00:15, 0.01 m
Fracture, longitudinal at joint at 10 o'clock, start

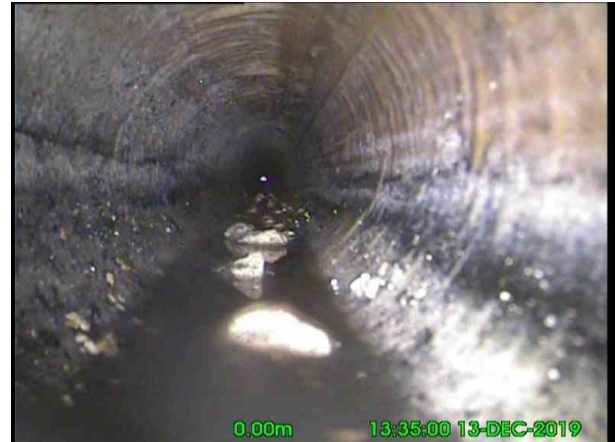
2, 00:00:10, 0.01 m

Settled deposits, coarse, 5% cross-sectional area loss, start, STONES

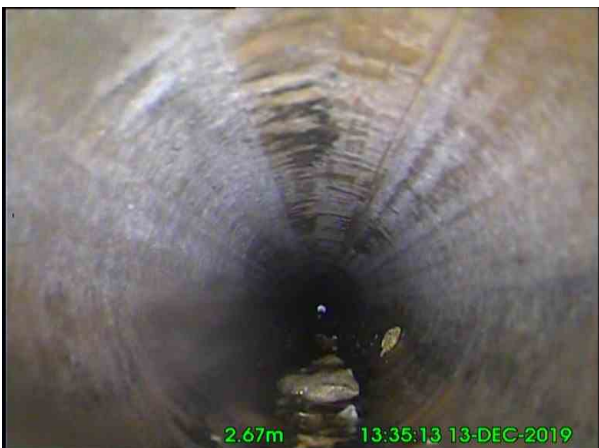
3, 00:00:24, 2.67 m

Settled deposits, coarse, 5% cross-sectional area loss, start, STONES

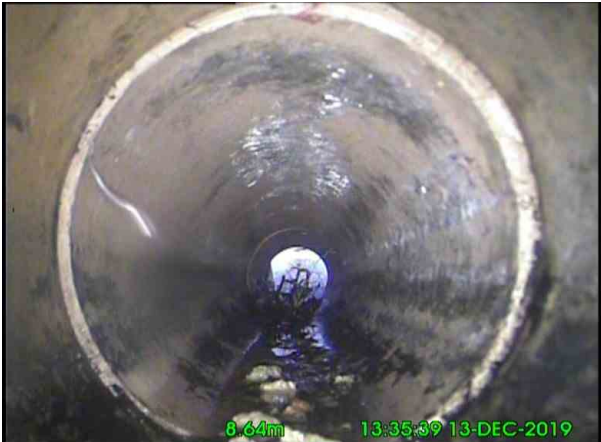
5, 00:00:50, 8.64 m
Roots, tap at joint

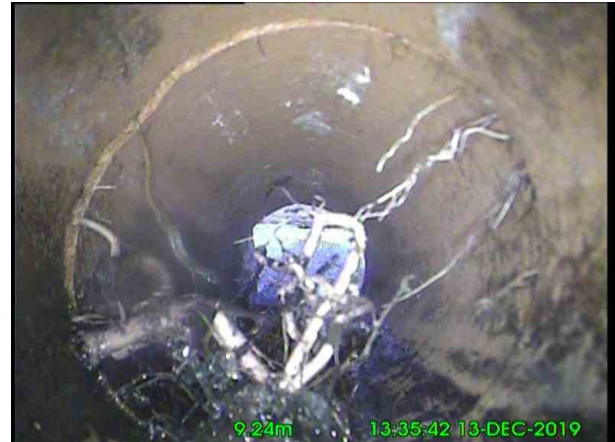
6, 00:00:52, 9.24 m
Roots, fine at joint

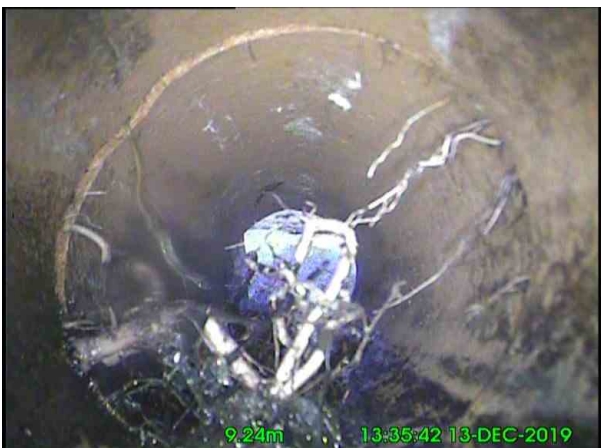
7, 00:00:52, 9.24 m
Deformed sewer or drain, 10%

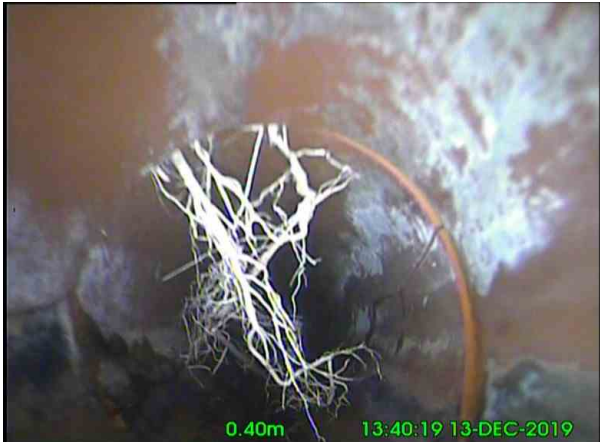
1, 00:00:12, 0.14 m
Fracture, longitudinal at joint at 9 o'clock

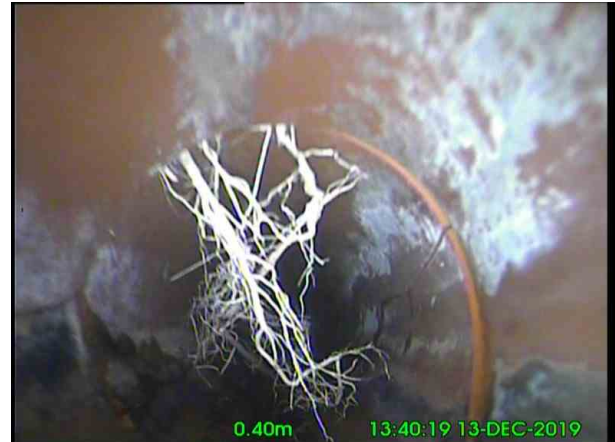
2, 00:00:12, 0.32 m
Roots, tap at joint

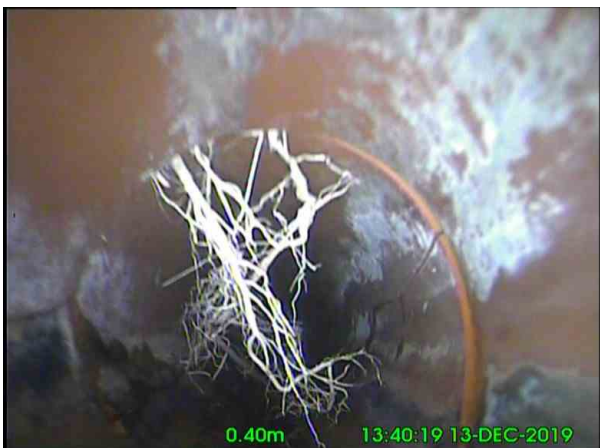
3, 00:00:12, 0.32 m
Fracture, longitudinal at joint at 3 o'clock

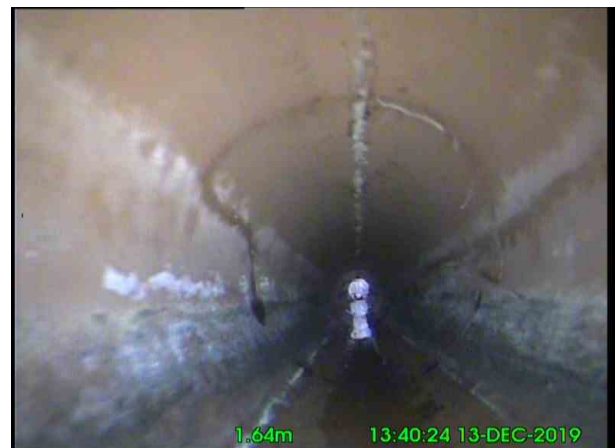
4, 00:00:18, 1.64 m
Fracture, circumferential from 9 o'clock to 3 o'clock

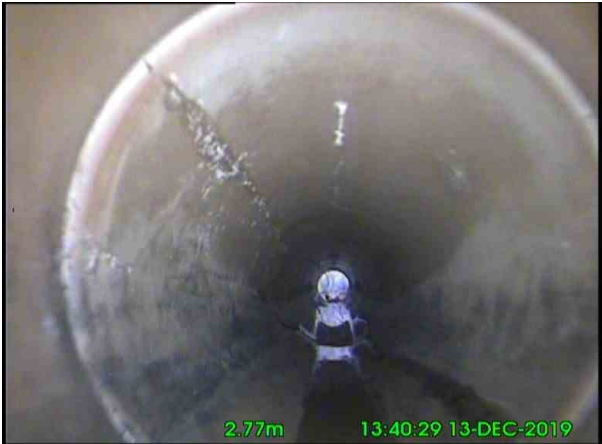
5, 00:00:23, 2.77 m
Fracture, longitudinal at joint at 11 o'clock, start

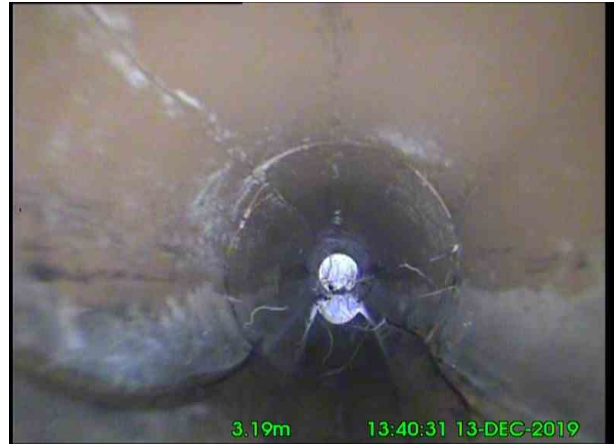
6, 00:00:24, 3.19 m
Fracture, longitudinal at 5 o'clock, start

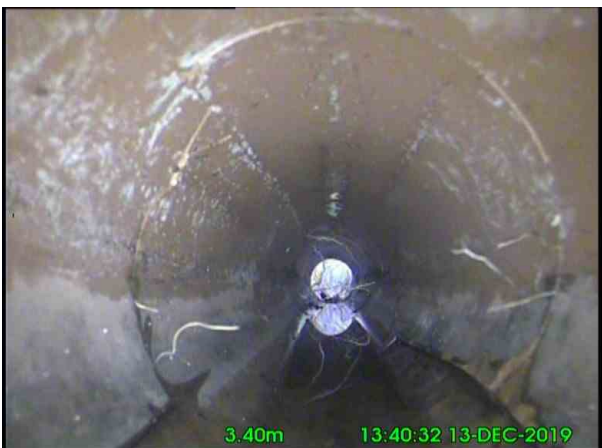
7, 00:00:25, 3.40 m
Roots, fine at joint

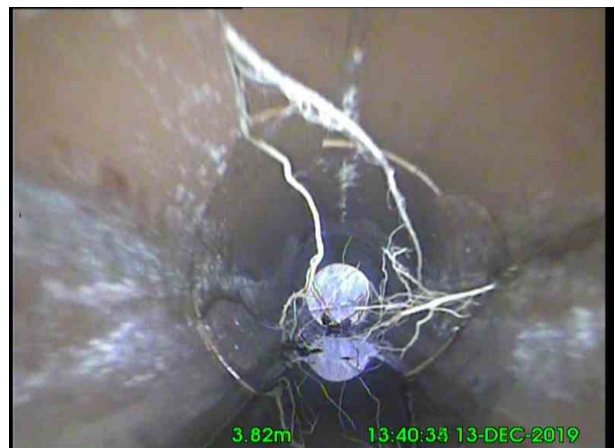
8, 00:00:28, 3.82 m
Roots, tap

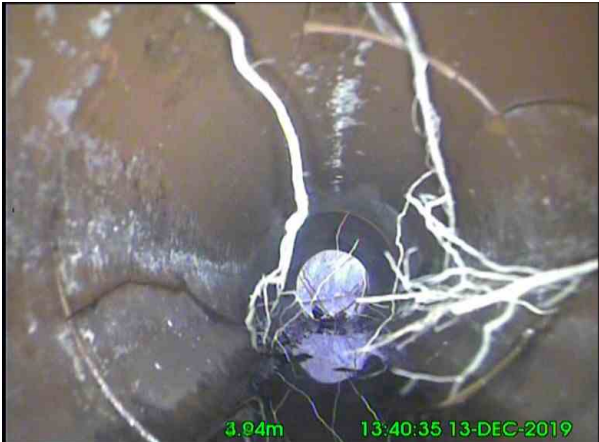
9, 00:00:29, 3.94 m
Fractures, multiple from 12 o'clock to 12 o'clock

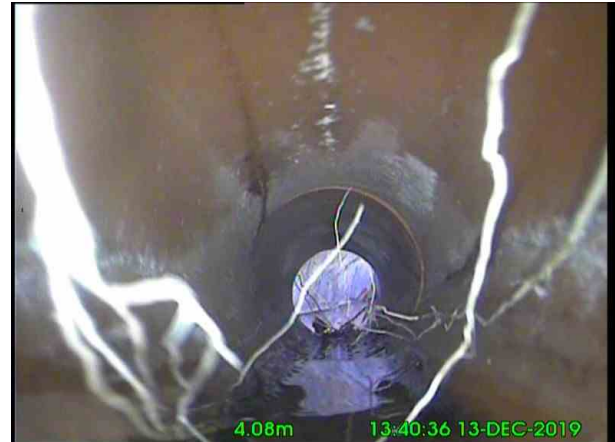
10, 00:00:29, 4.08 m
Fracture, longitudinal at 7 o'clock, start

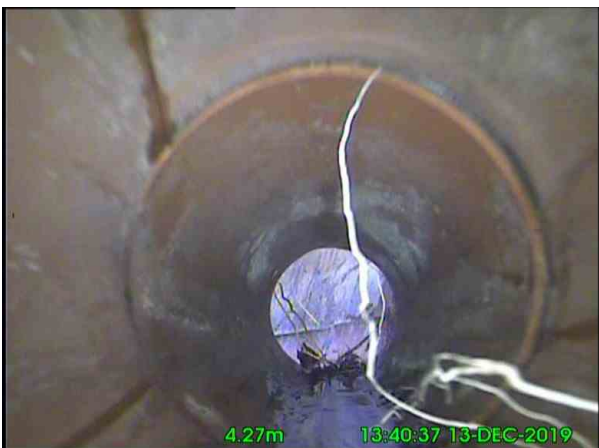
11, 00:00:30, 4.27 m
Roots, tap at joint

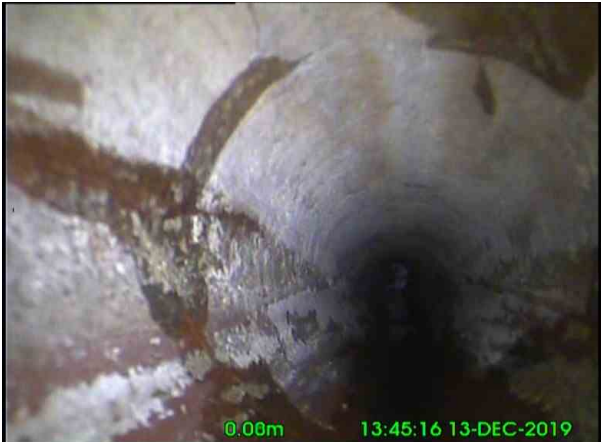
1, 00:00:12, 0.01 m
Fracture, circumferential from 7 o'clock to 12 o'clock

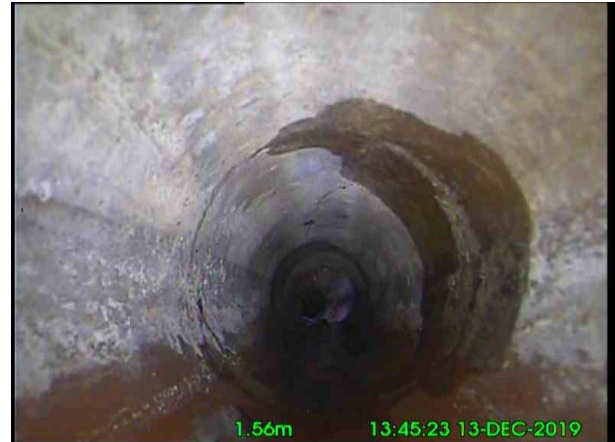
2, 00:00:18, 1.56 m
Fracture, longitudinal at joint at 12 o'clock, start

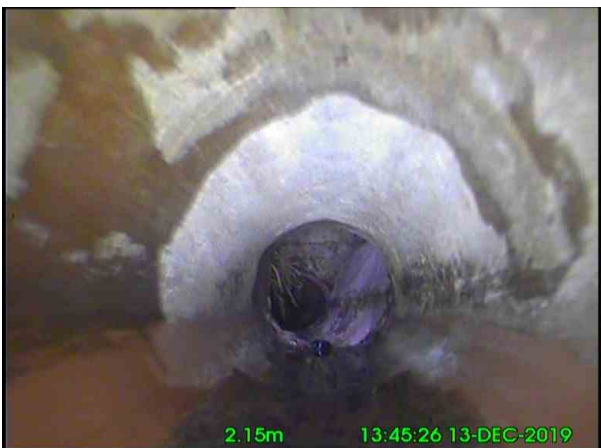
3, 00:00:22, 2.15 m
Fracture, circumferential from 7 o'clock to 3 o'clock

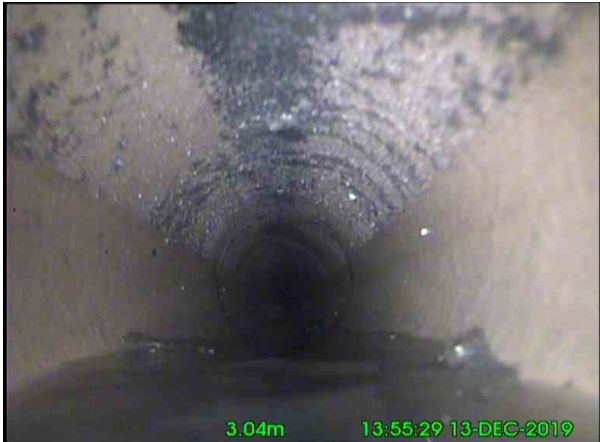
1, 00:00:27, 3.04 m
Settled deposits, fine, 5% cross-sectional area loss, start

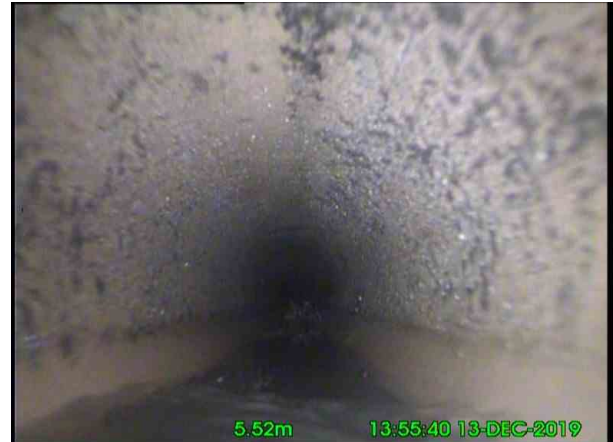
2, 00:00:37, 5.52 m
Settled deposits, fine, 5% cross-sectional area loss, start

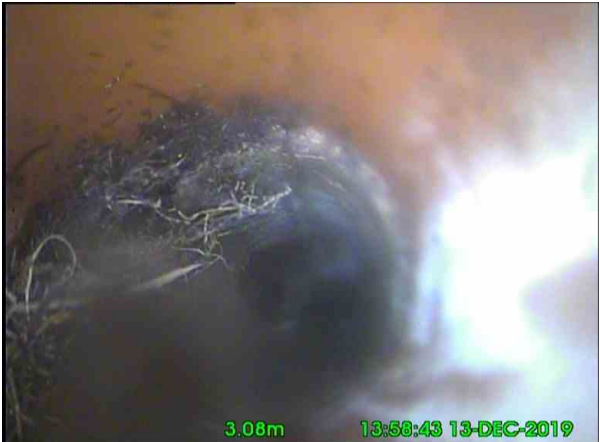
1, 00:00:24, 3.08 m
Roots, mass at joint, 10% cross-sectional area loss

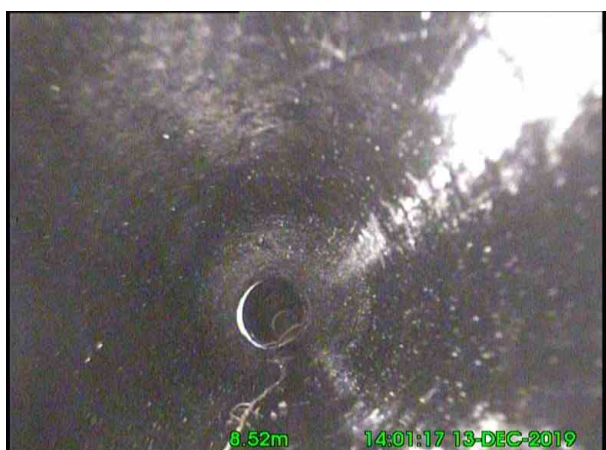
3, 00:01:01, 8.16 m
Roots, fine, start

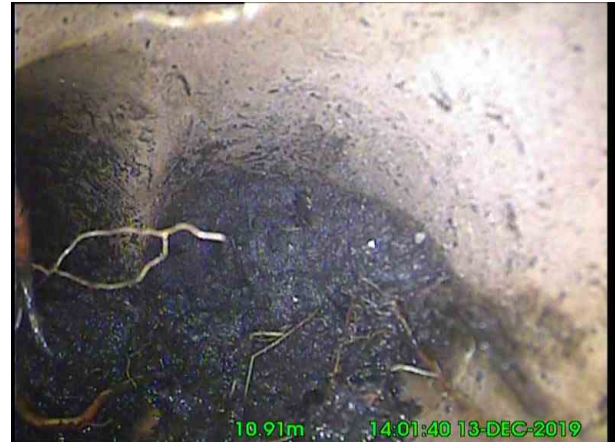
6, 00:01:23, 10.92 m
Settled deposits, fine, 100% cross-sectional area loss, SILT

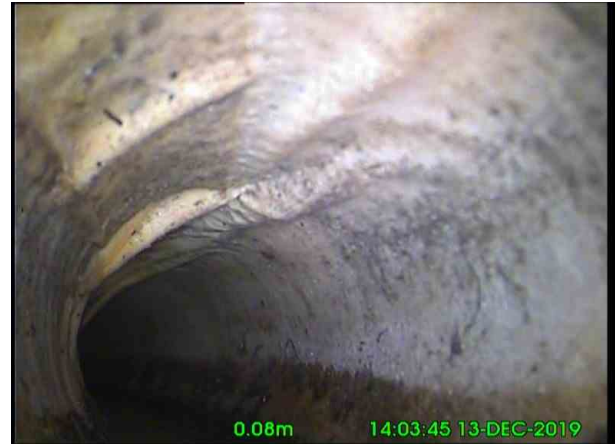
2, 00:00:13, 0.08 m

Defective lining, wrinkled (complex) from 9 o'clock to 3 o'clock, start

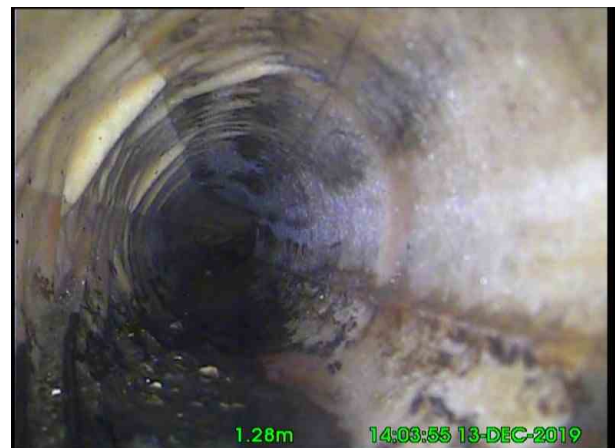
4, 00:00:23, 1.17 m

Settled deposits, fine, 5% cross-sectional area loss, start

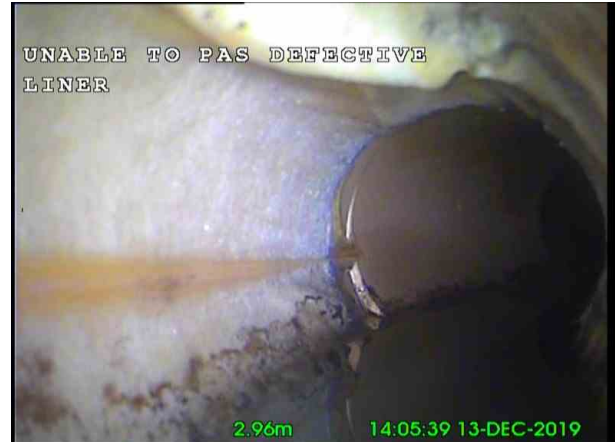
6, 00:01:10, 2.96 m
Survey abandoned, UNABLE TO PASS DAMAGE LINER
