**31 Daleham Gardens, London, NW3 5BU**

**Initial Structural Survey of**

**Fire Damaged Building**

**40420–R01**

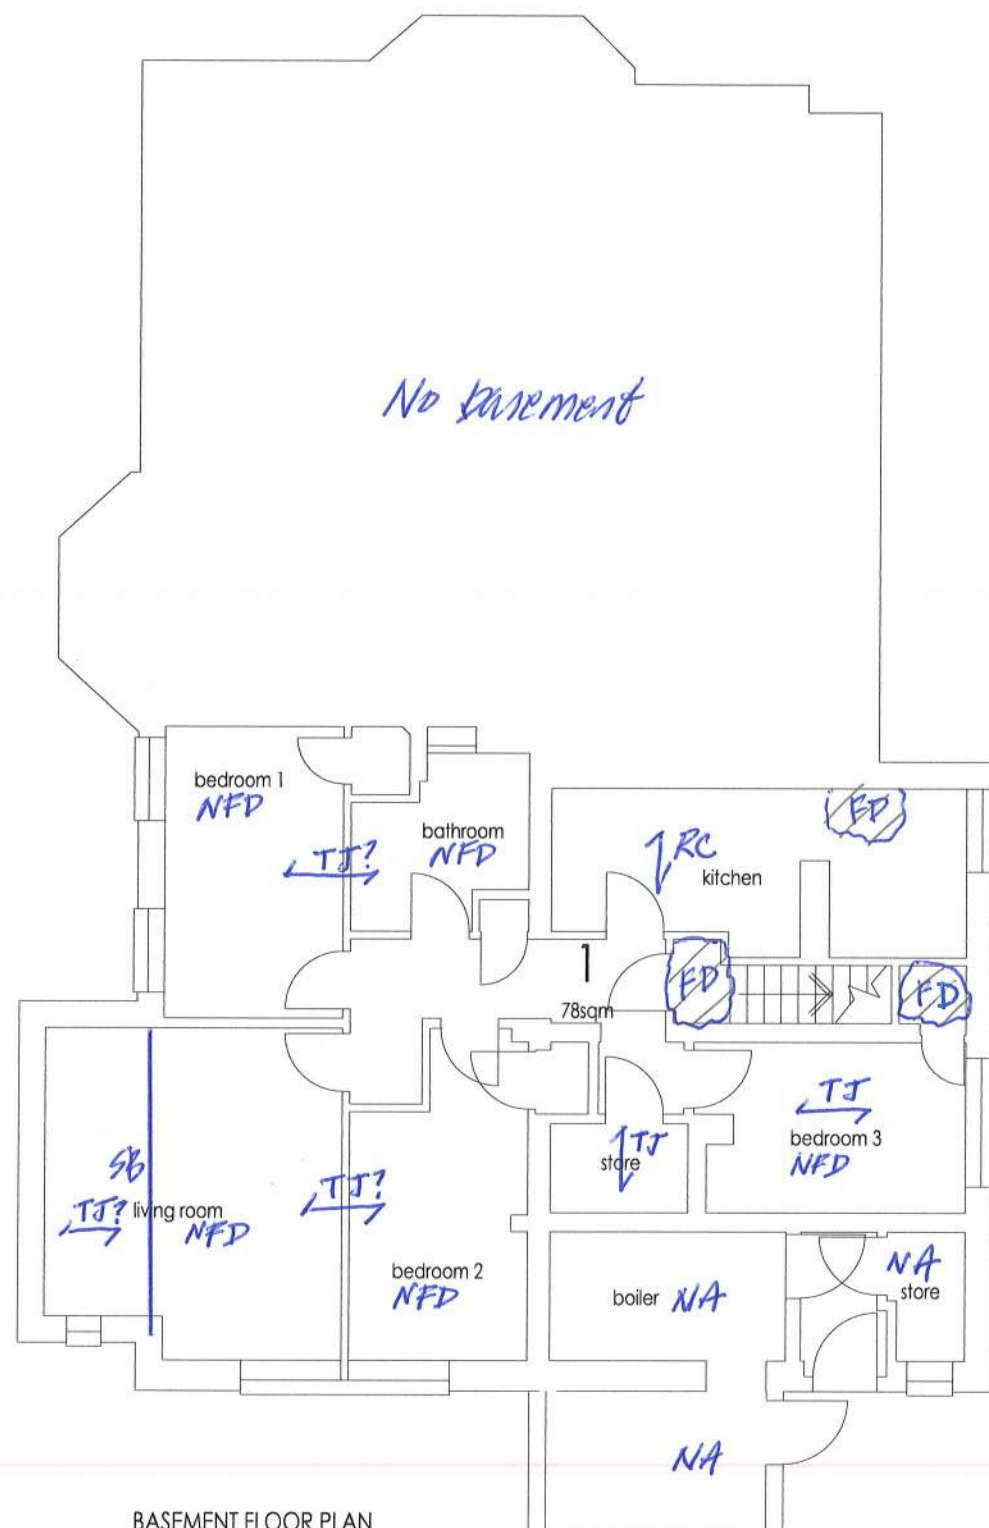
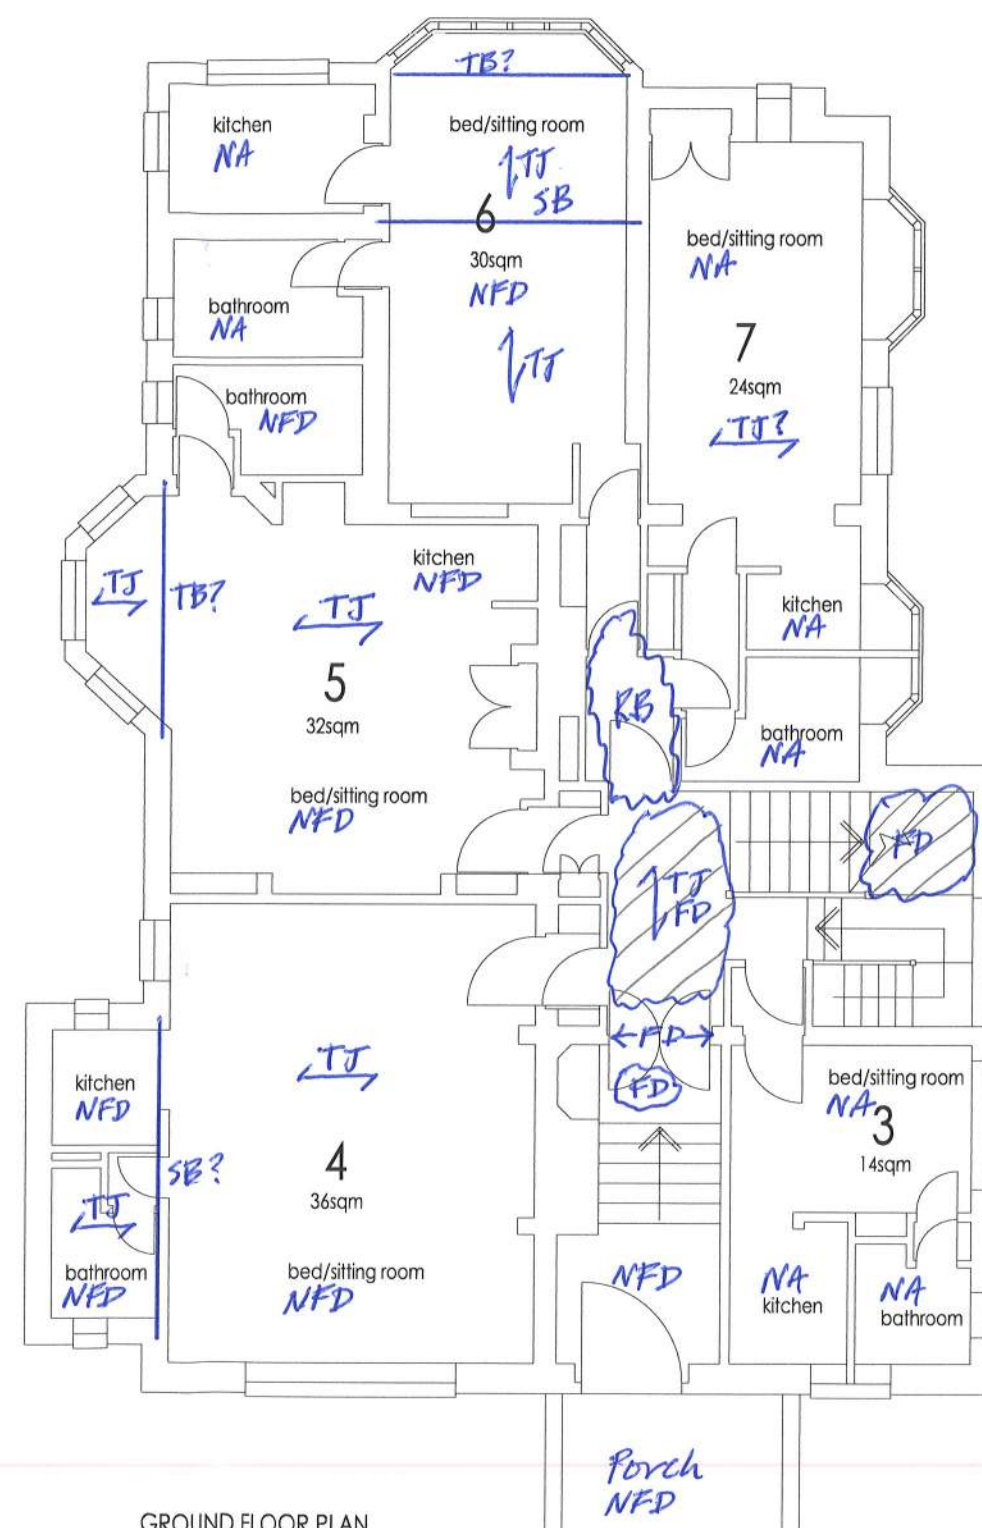
Amendments  
**L&C Engineers**  
Results of Initial Survey  
40420/SK/01  
MND 30/09/20

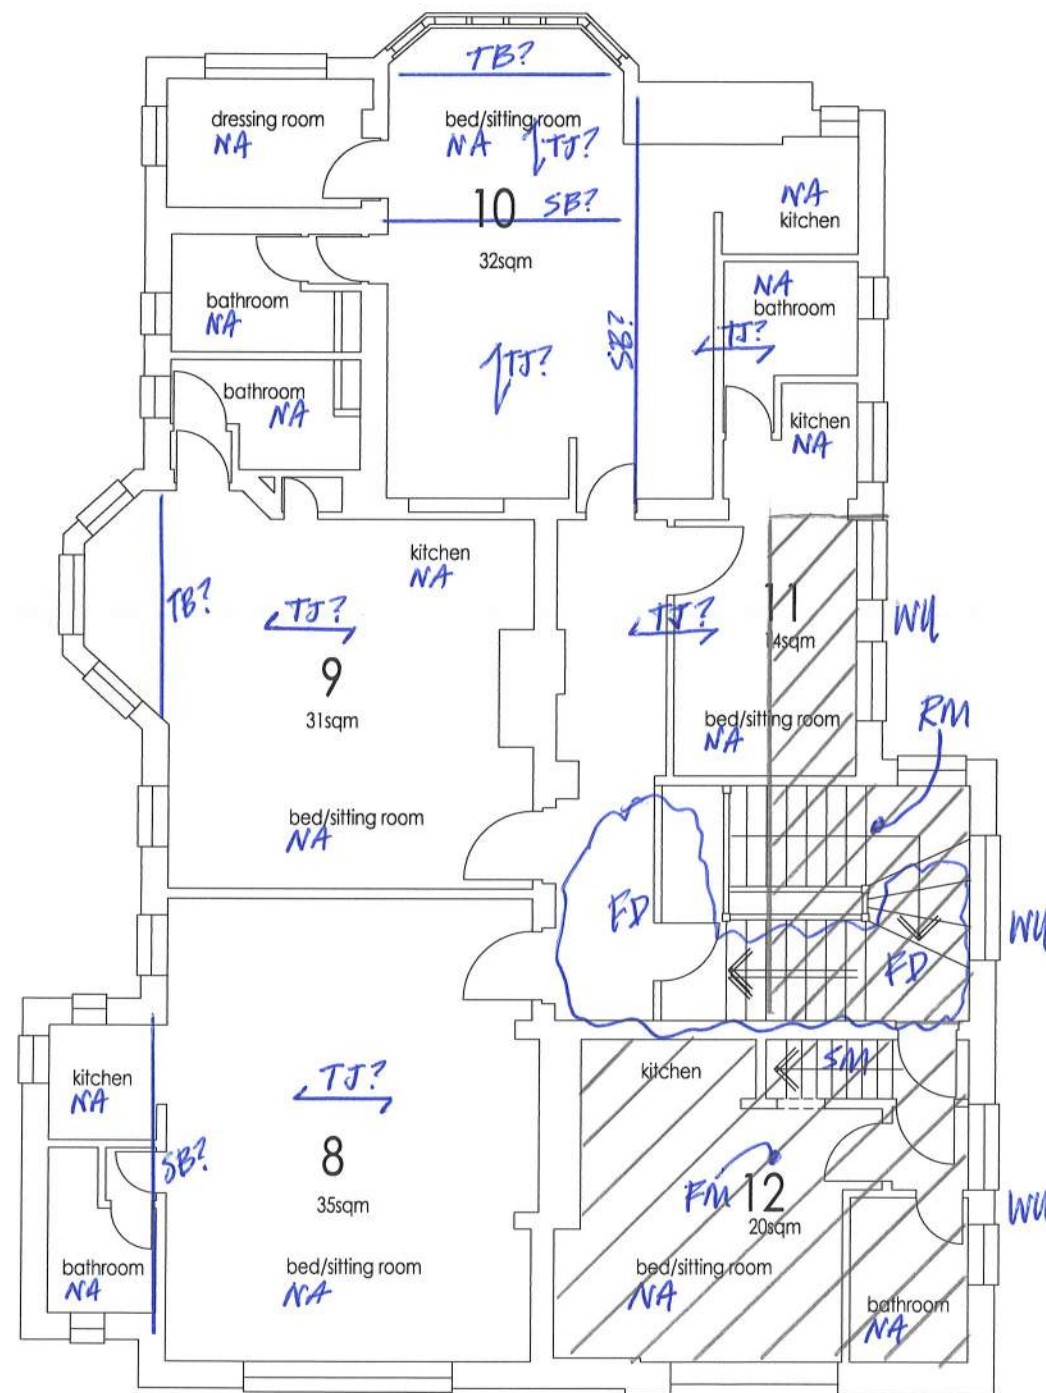
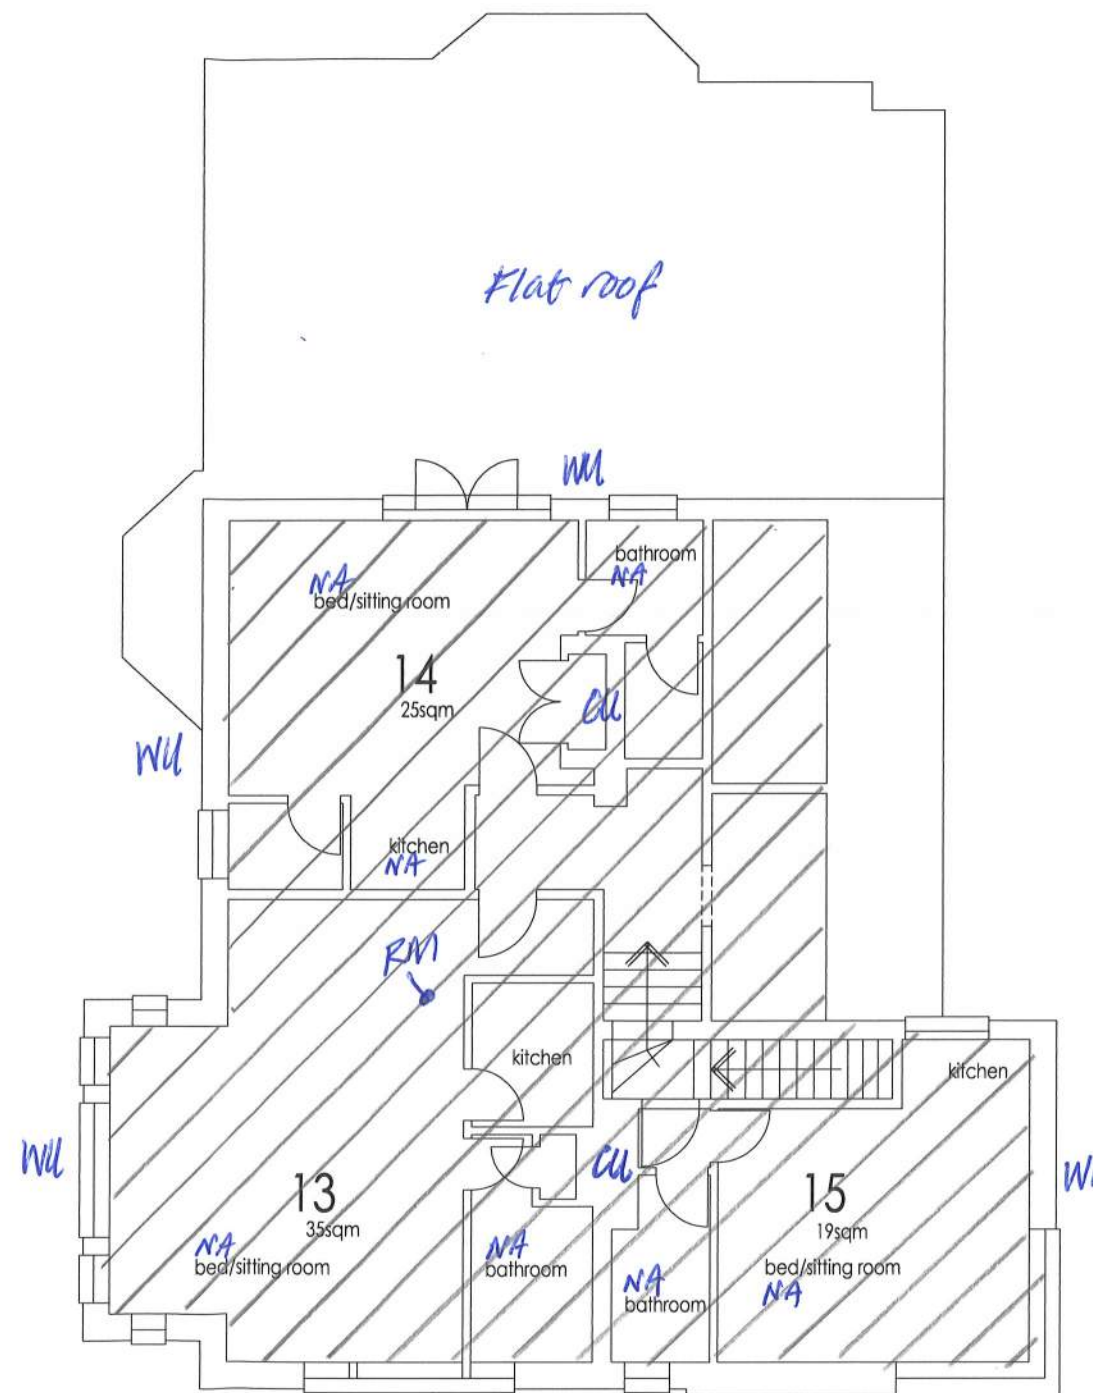
Amendments  
L+C Engineers  
Results of Initial Survey  
40420/SK/02  
MND 30/09/20

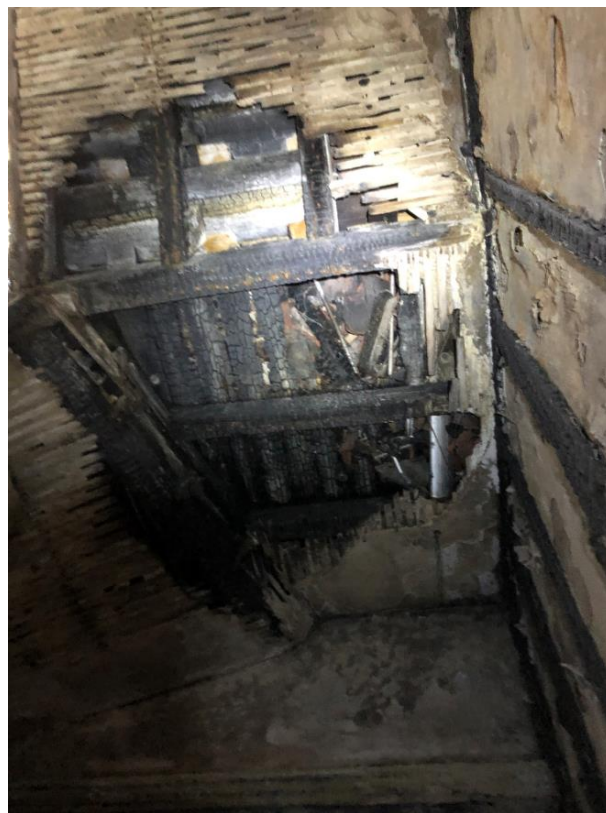
| Basement Level Apartment | Room | Accessible | Structural Fire Damage Observed | Location of Damage | Photograph Number |
|---|---|---|---|---|---|
| 1 | Cupboard below stair | Yes | Yes | Stair flight above ceiling | 6 |

Photo 6 - Apartment 1 bedroom 3 cupboard  
underside of stair

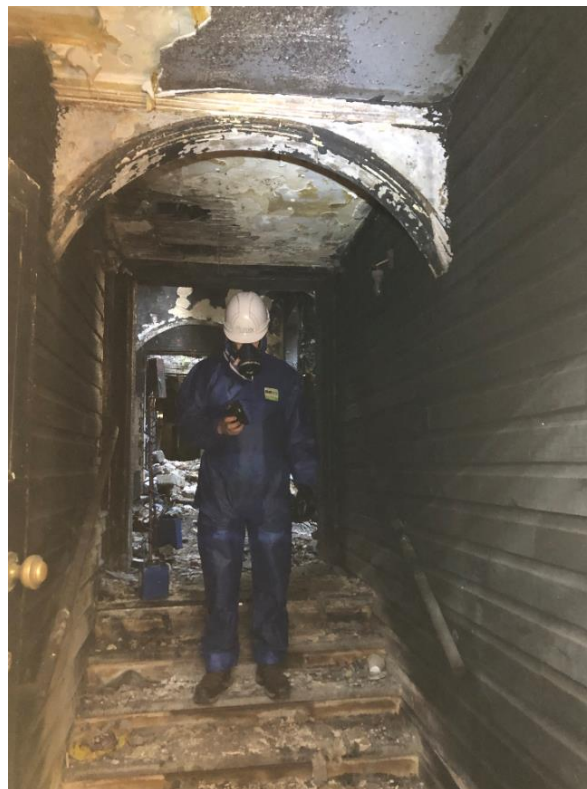
At ground floor there is smoke damage but little evidence of structural fire damage in most areas. However, there is significant charring of a load bearing door frame around the main entrance door that supports the first floor joists above. It was not possible to access apartment 3 due to fire damage of the ground floor in the entrance to the apartment. Apartments 4 and 5 were accessible and had no evidence of structural fire damage. There is rubble present on in the entrance hall to apartments 6 and 7 that has fallen from above. There was no access to apartment 7 due to the entrance door being blocked by the belonging of the previous occupier. Our findings at ground floor level are summarised in the table below and photographs are included at Appendix B.

| Ground Floor Apartment | Room | Accessible | Structural Fire Damage Observed | Location of Damage | Photograph Number |
|---|---|---|---|---|---|
| | Entrance hall | Yes | Yes | Load bearing door frame | 8 |

Photo 8 - Main entrance hall

The load bearing door frame that supports the first floor joists should be propped using Acrow props with double scaffold head and sole boards at basement and ground floor levels. Refer to sketch number 40420/SK/TW/01 for details of propping required.

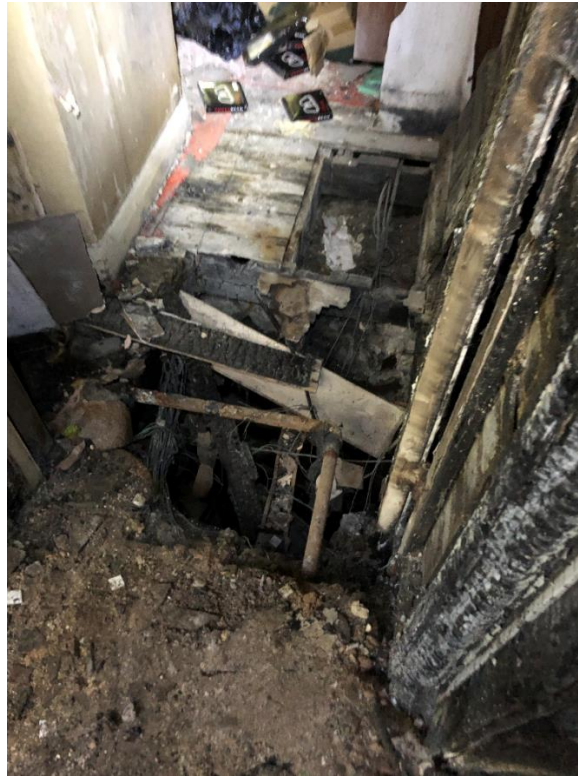
| Ground Floor Apartment | Room | Accessible | Structural Fire Damage Observed | Location of Damage | Photograph Number |
|---|---|---|---|---|---|
| 3 | All | No | Yes | Entrance to apartment | 9 |

Photo 9 - Apartment 3 fire damaged in entrance

In view of the condition of the existing building we consider that access to the basement and most of the ground floor can be permitted. Care should be taken when using the stair from ground floor to basement level and we recommend only one person at a time on the stair. Access should not be permitted to apartment 3 due to fire damaged floor in the entrance and apartment 7 due to the entrance door being blocked.

The fire damaged area of the ground floor in the entrance to apartment 3 should be locally removed and replaced to enable access to the apartment. Refer to sketch number 40420/SK/TW/01 for details.

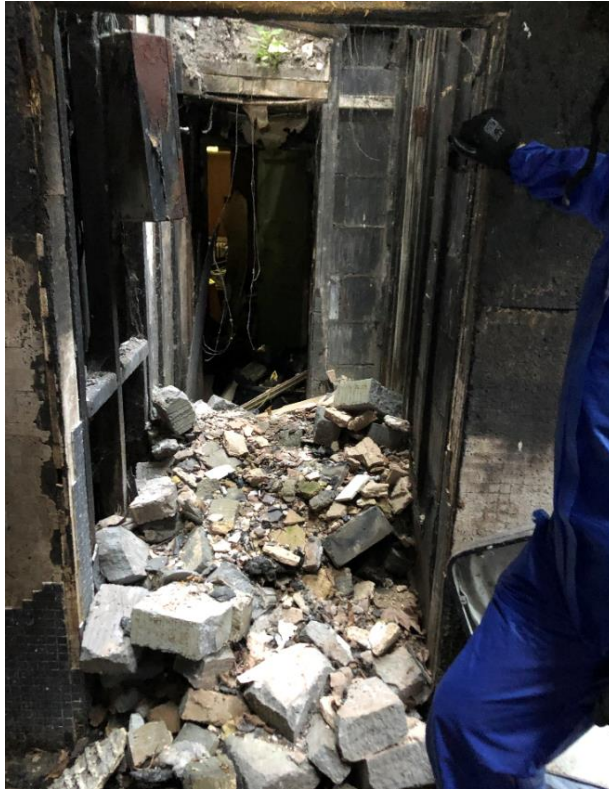
| 6 | Entrance hall | Yes | Yes | Rubble on floor fallen from above | 13 |

Photo 13 - Apartment 6 rubble build up in entrance

An asbestos management contractor should carry out soft strip and ACM removal to apartments 1 to 10. It will also be necessary to remove the rubble build up in the entrance to apartment 6 in order to gain access. Access will not be possible to apartment 11 and 12 due to the dangerous condition of the roof and second floor structure above.

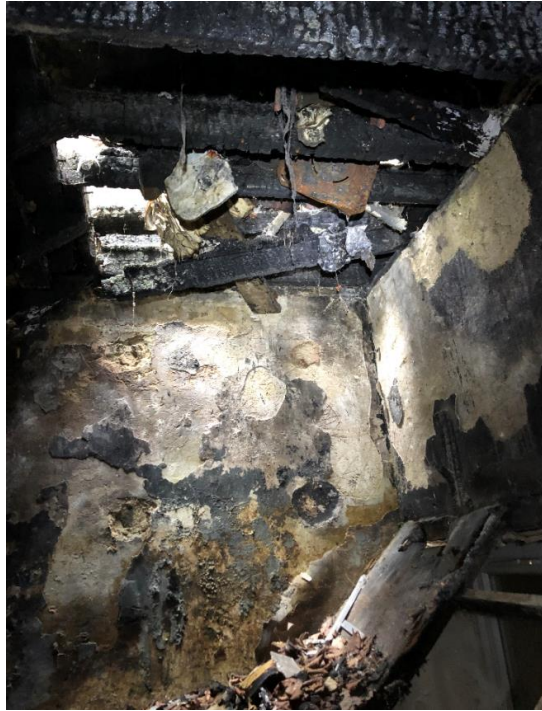
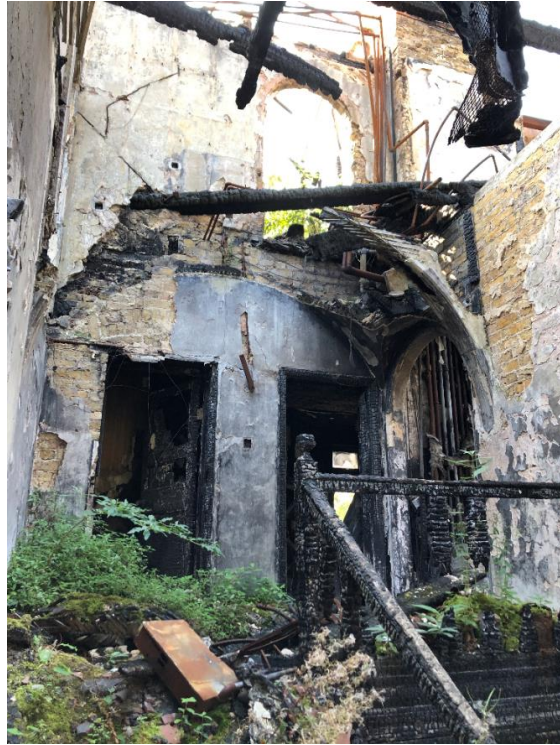
| | Stair to first floor | No | Yes | Extensive | 15 to 18 |

The stair from ground to first floor has severe fire damage and is supporting fallen debris most of the way up. We would not recommend using this stair as it is likely to collapse if it subject to additional loads. The first floor landing is also severely fire damaged and has very little remaining integrity, as shown in photograph 18.

Photo 15 - Stair from ground to first floor underside of half landing

Photo 16 - Stair from ground floor to first floor

Photo 17 - Stair from ground to first floor

The stair from ground to first floor and the first floor landing are not suitable for use and barriers should be installed to prevent people from accessing these areas. The apartments at first floor should not be accessed at present.

The existing first floor landing and stair from first to ground floor should be demolished as they are unsafe for use. Edge protection should be provided at first floor and ground floor prior to demolition.

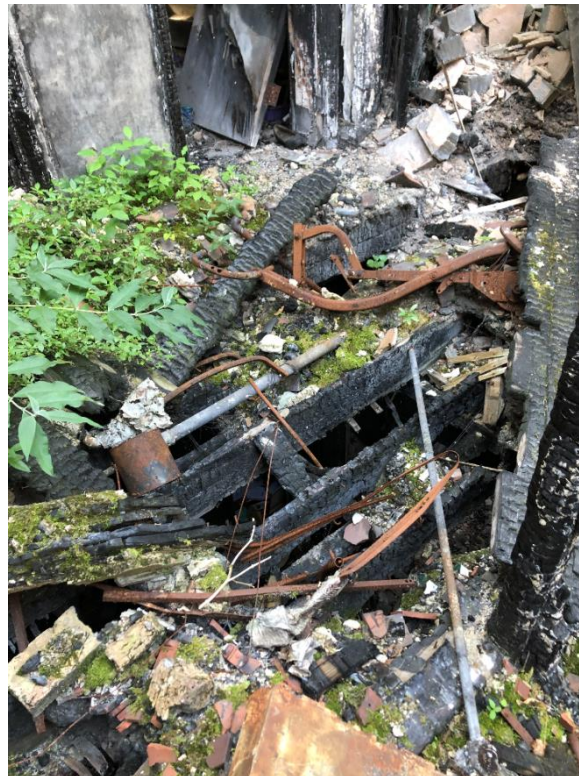
Photo 18 - First floor landing

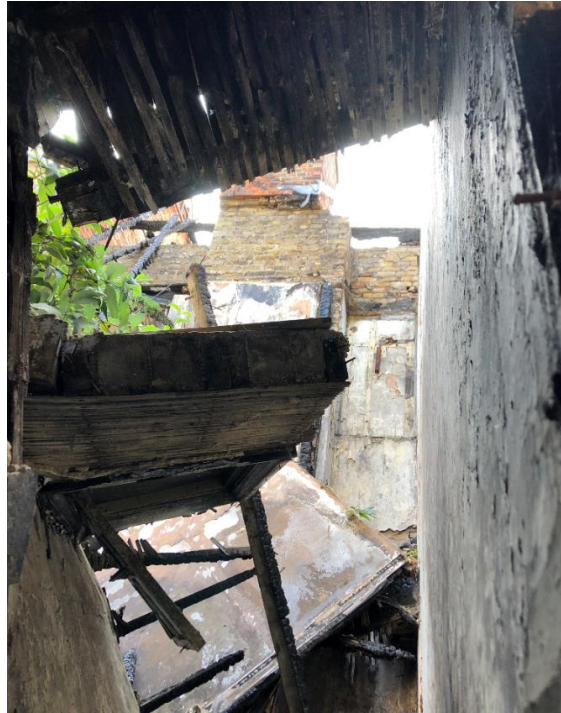
It was not possible to access any of the rooms at first or second floor due to the condition of the stair and landing area. From part way up the stair we could see that the second floor and roof above apartment 12 have collapsed as shown in photograph 19. We could also see that the floor above apartments 8 and 9 appeared to be present. It can be seen from Google maps that the second floor roof to the rear extension is present and may be relatively undamaged by the fire. However, it would be necessary to access apartment 10 through the rear elevation window in order to confirm its condition. The main roof above apartments 13, 14 and 15 has been largely destroyed by the fire.

Photo 19 - Apartment 12 view of second floor and roof

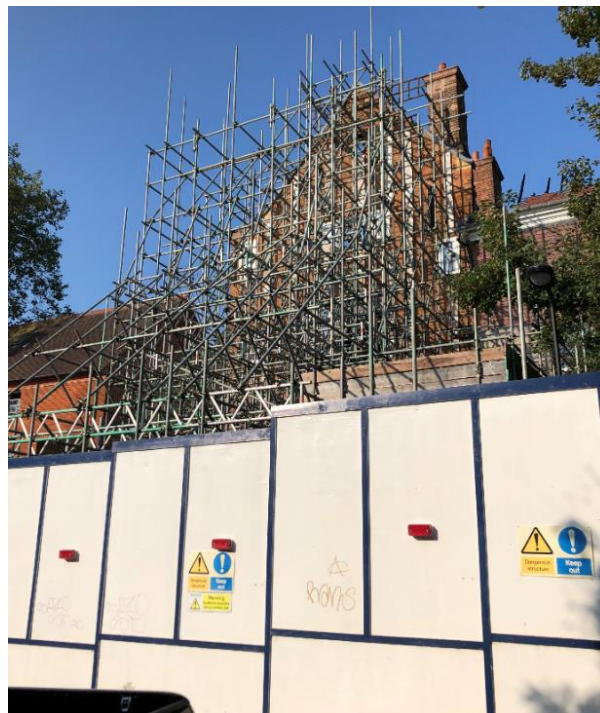
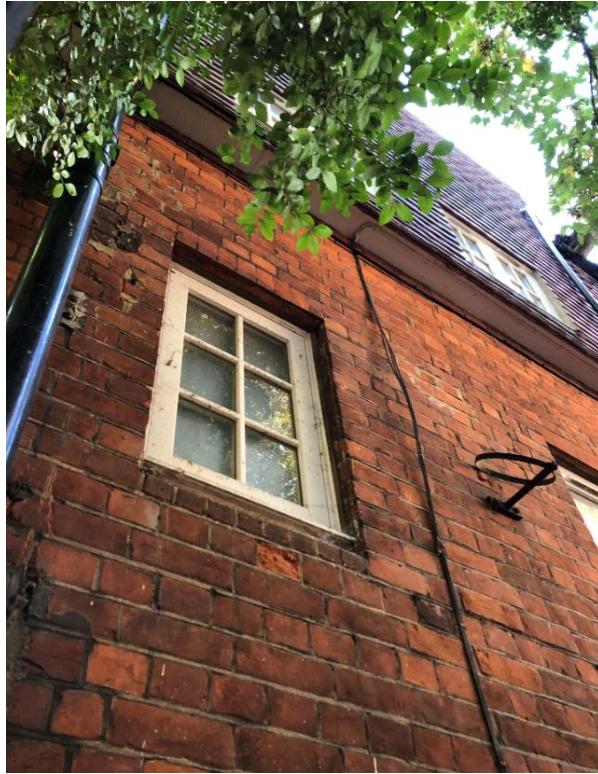
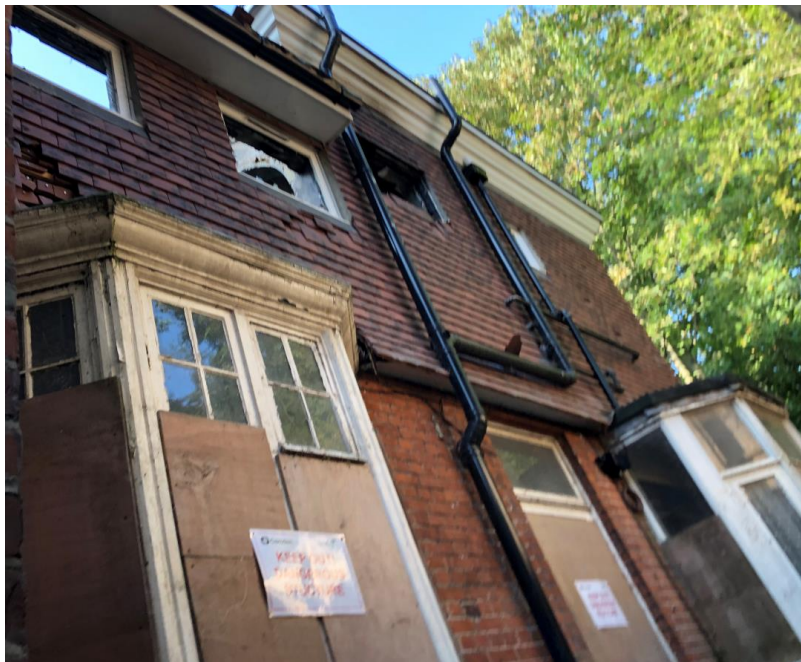
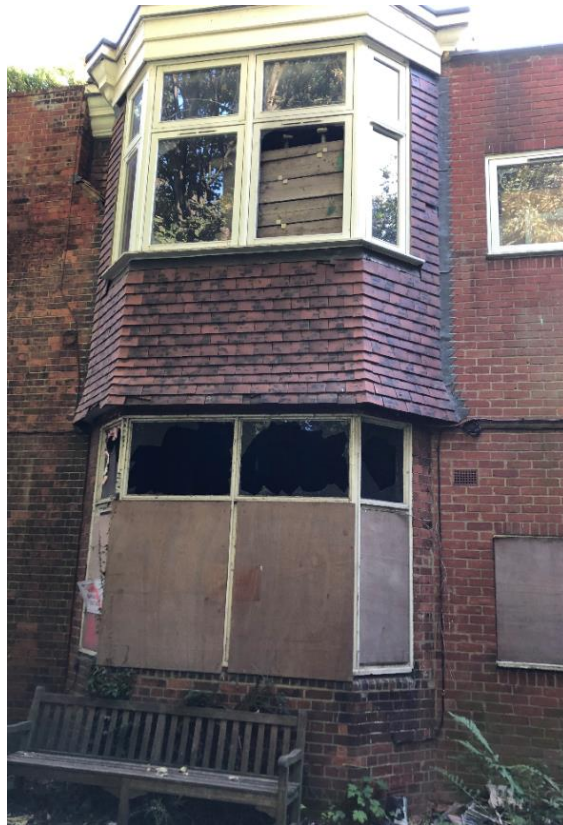
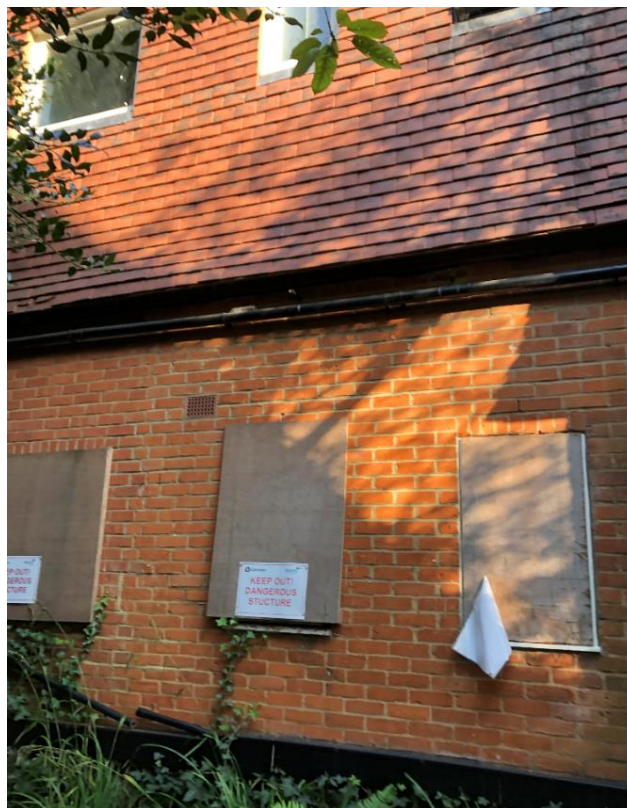
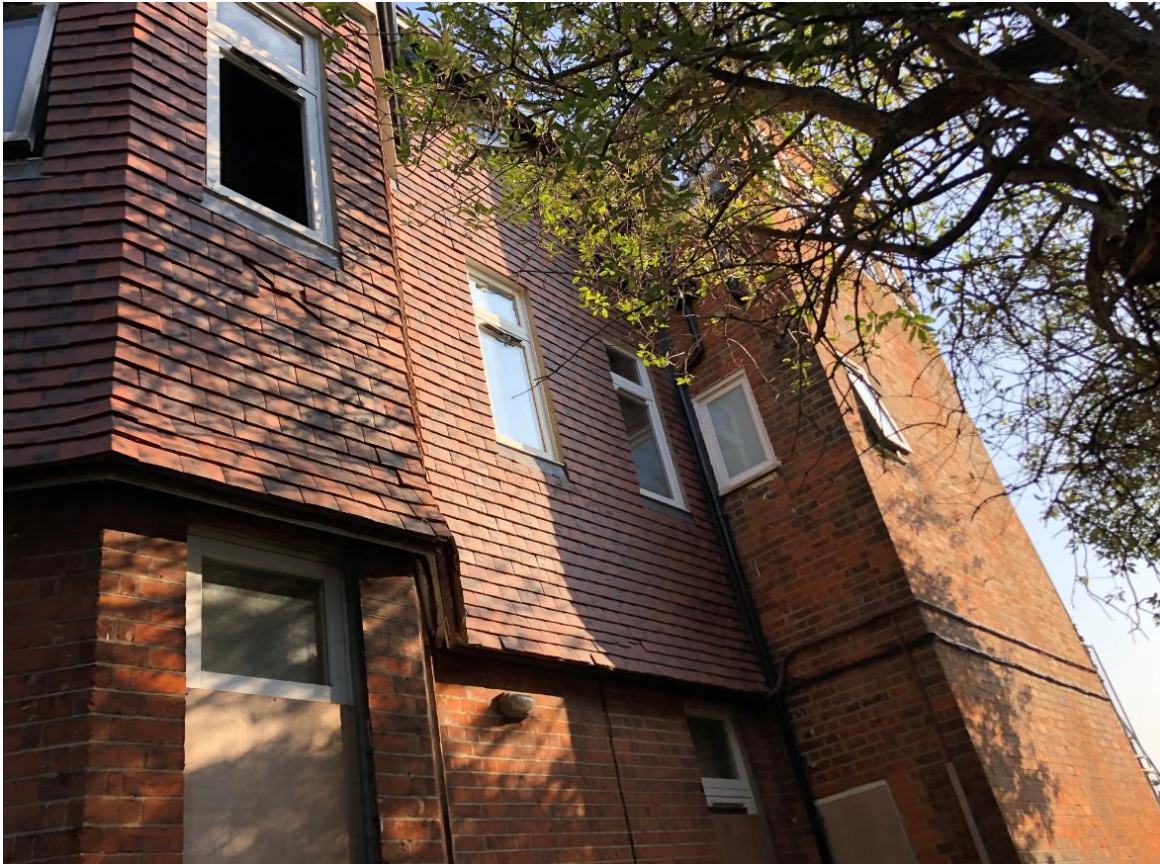
Due to the loss of the main roof and part of the second floor, the external walls and two remaining chimneys are considered to be unstable above first/second floor as they have lost the lateral restraint afforded by the roof and second floor. The rear gable wall and chimney have been previously removed as described earlier. The front façade gable wall is restrained by a scaffold as described earlier. Photographs 20 to 25 show views of the external walls and chimneys.

We recommended that all unrestrained chimneys, walls and severely fire damaged areas be demolished as a matter of urgency as they are considered to be unstable and at risk of collapse in high winds or if subject to additional imposed loads. The remaining parts of the building should be soft stripped and have any ACM's removed prior to demolition. All of the timber floors of the building should be demolished as these are likely to be suffering from wet rot due being exposed to the elements for three years. The possible exception to this would be the rear extension as this appears to have remained watertight. However, this is not considered to be worthy of retention as it is not part of the original construction of the building.

The unrestrained areas requiring demolition are shown on our sketches contained at Appendix A. These should be demolished by hand using a cherry picker located outside the building for access. Bricks should be removed by hand, loaded into the cherry picker and removed from site. Rubble should not be allowed to fall into the building. The walls should be removed first followed by the two chimneys.
