Birkbeck University of London Gordon Square, London

Planning - Roof Level - Scope of Work

computer file
C:\Revit Projects\BRK-AHR-GS-XX-M3-A-Central_amie.mccabe.rvt 2019.00916.000 As indicated@A BRK-AHR-GS-RF-DR-A-27-051

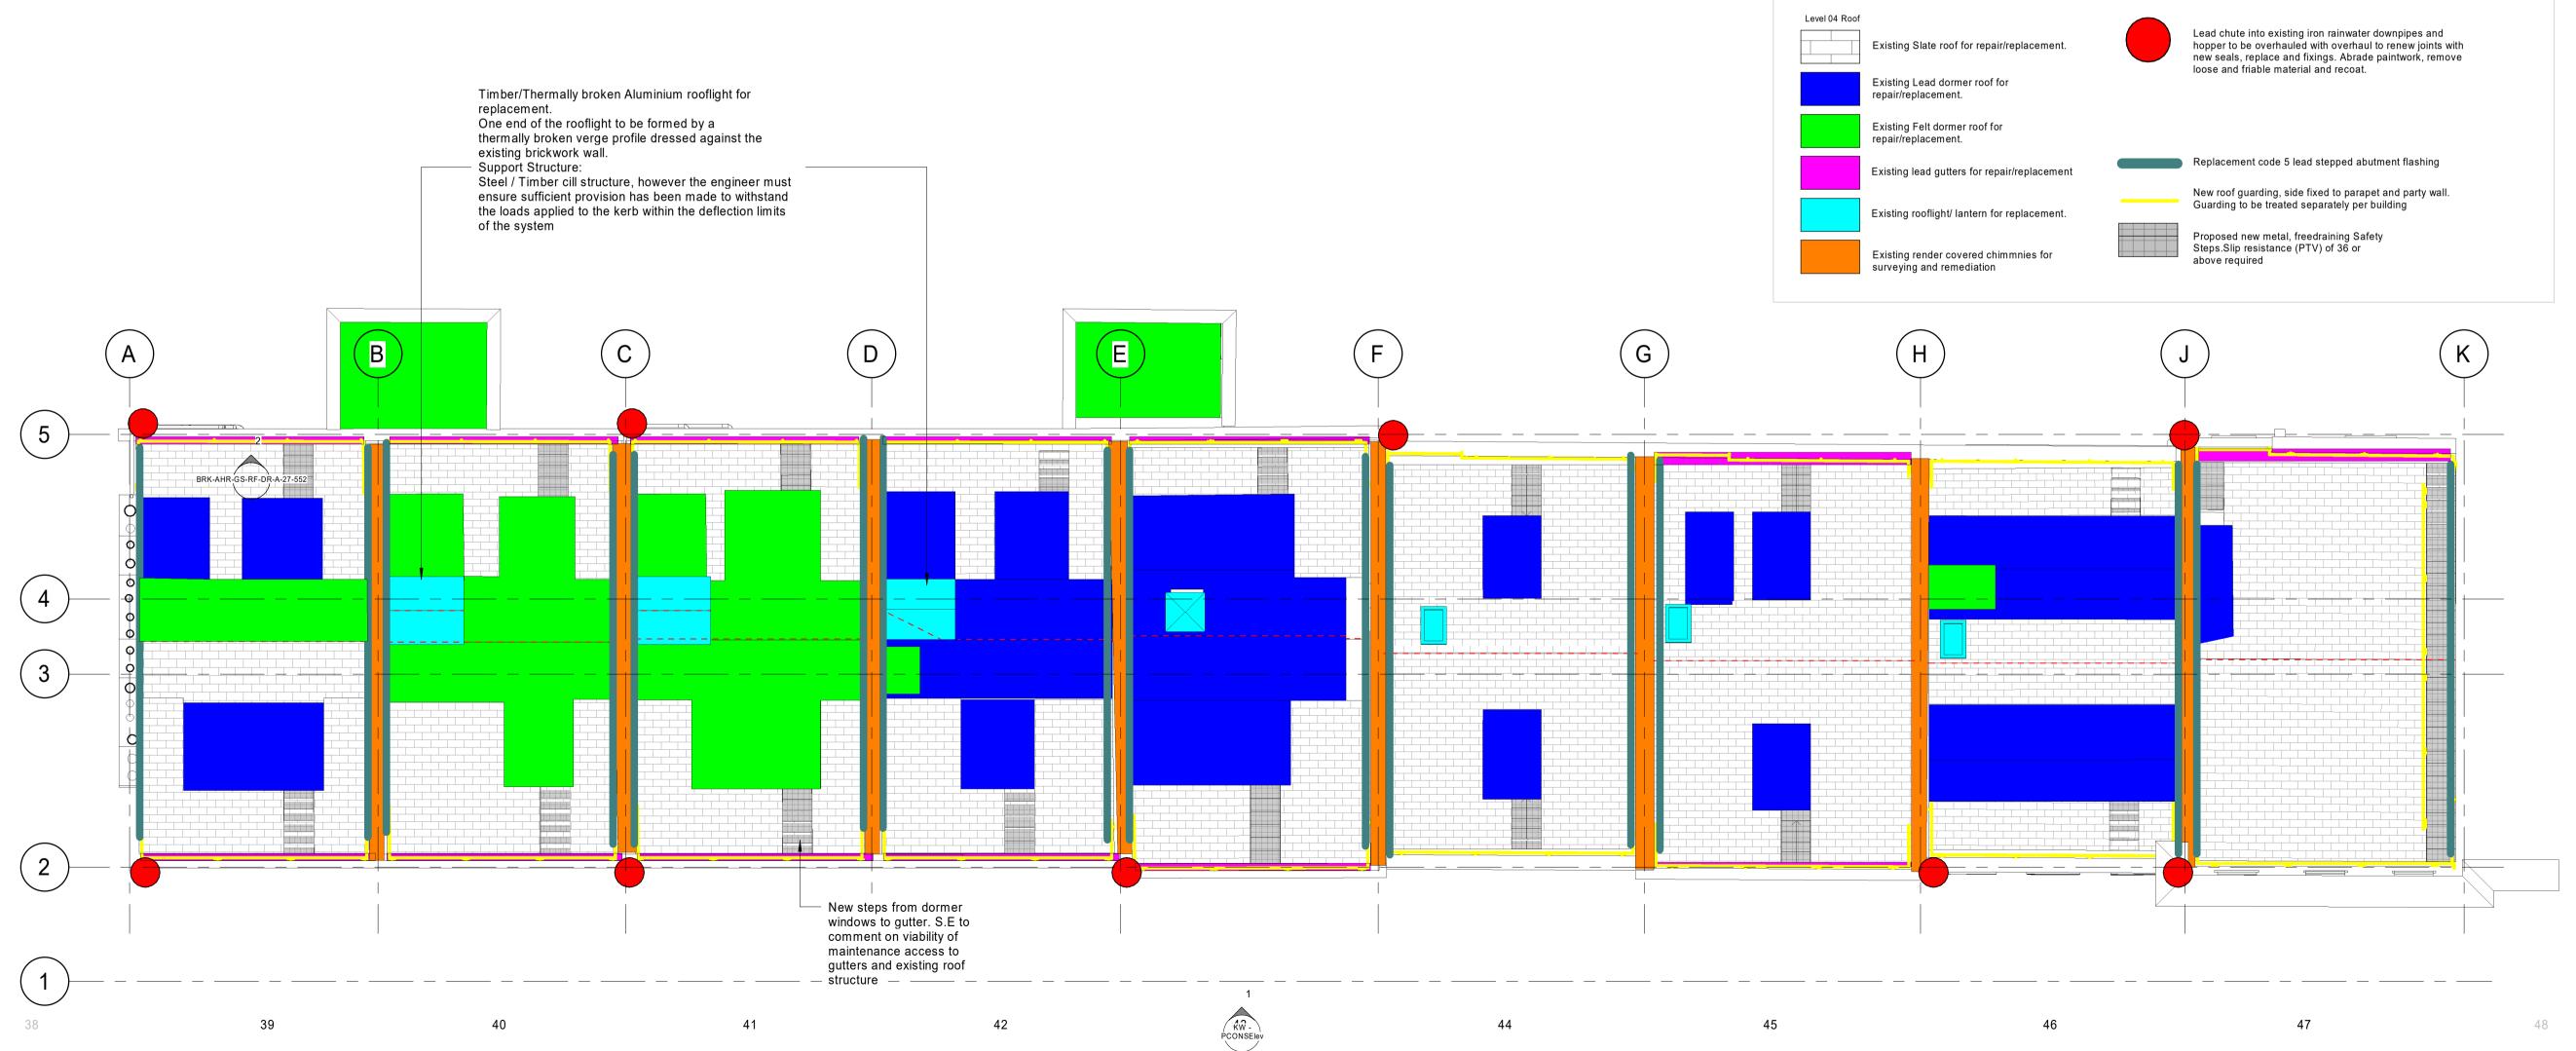
1. Planning - Upper roof scope of works

Coping Stones (Coping details / Party walls):
The coping stones are generally in poor condition and are attributing to the moisture ingress into the building. All coping stones to be removed, cleaned down and rebedded, with the appropriate lead strapping and cloaking. An allowance should be made for the replacement of any demand coping stones. made for the replacement of any damaged coping stones.

Areas of pointing is in poor condition. Patch repoint areas of poor and failing pointing. A full inspection will be required to ascertain the quantity but Condition survey has allowed for a provisional quantity of 1m² per wall.

3no. dormer roofs are of a mineral felt finish. Visually this appears to be in poor condition, with some evidence of ingress internally. Reommended that intrusive survey carried out to ascertain whether moisture has penetrated the cap sheet. If whole scale repairs are required, it is envisaged that the felt system will need to be replaced with a lead system to match the remaining units and to a line with heritage

Leadwork appears to generally be in satisfactory order however there are failed and damaged flashing details prevalent through out. Renew leadwork to damaged sections. This should be subject to a further more detailed investigation and condition survey has allowed a provisional quantity of 0.5m² per unit. It may be considered beneficial to renewal all lead flashing and soaker details, whilst access to the roof is available. An extra over cost should be sought for this.

Lead gutters and flashings
The gutters appear to be a source of moisture penetration and should be overhauled. It was noted that some remedial works have been undertaken with a liquid system. Strip out all gutters and reline with suitably dressed coded lead in accordance with the

Many rainwater outlets were missing leaf guards and exhibited a build up of detritus.

Survey revealed that rooflights are beyond refurbishment and should be replaced like for like. New kerbs installed to punched opening to lift the level of existing rooflights ready for new roof level of proposed green roof. Replace all waterproof junctions as part of roof recovering.

General degradation of flaunching and pots. Allow for stripping off and resetting chimney pots on suitable flaunching.

Full survey required to roof - strip off existing tiles, put to one side those in good condition for re use, Structural Engineer to determine soundness of existing rafters and allow for replacement of 50% off existing rafters and all new battens and

Slate replacement roof tiles with, replacement roof underlay felt and battens/counterbattens to exisiting timber roof construction.

Slates to be from one quarry to match exisiting roof as closely as possible - matching samples to be utilised. Where possible, slates from existing roof to be removed and retained for use in patching existing roofs not due for entire replacement or used in concentrated areas on replacement tile roofs.

Sheet Association guidance. Inspection by qualified contractor to verify state of existing and how much material and underlay can be retained, re used and patched. Existing code 5 lead gutters and

flashings to brought back to acceptable standards to Lead Association typical details. Tiled and pitched roof coverings should be in accordance with the relevant Building

Rainwater goods should be cleared, replaced where necessary (with cast iron to match existing) and leaf guards installed to all outlets.
