## Appendix C

### Site reconnaissance photographs

Project title	Haverstock Hill			Job number
				268265
Visit made by	TM	Place visited	5-17 Haverstock Hill	File reference
Copy to		Person visited		Date of visit
				07/08/20
Purpose of visit	Geo-Environmental Site Walkover

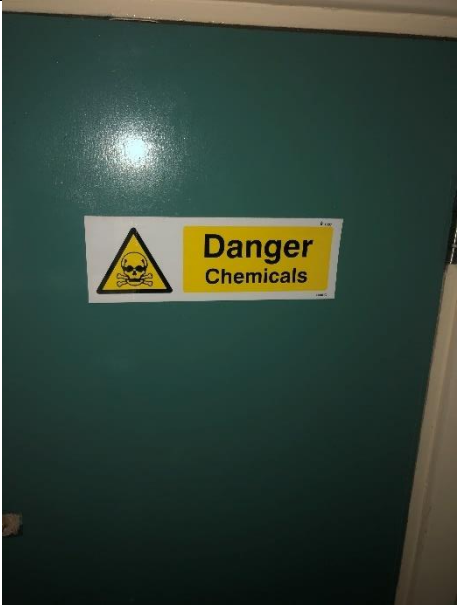
<p>Possible chemical store</p> <p>A store room with a chemicals sign on the door is present in the east of the building. The door was locked and access was not possible during the site visit.</p>

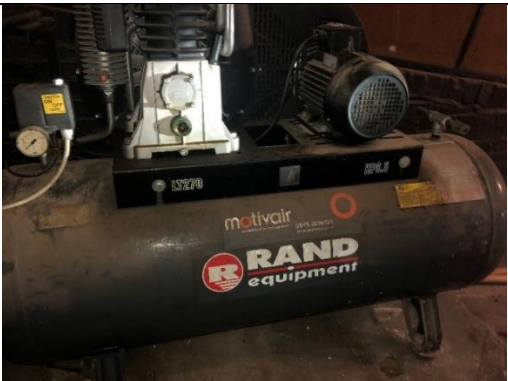
<p>Air compressor</p> <p>An air compressor is present on the lower car park level.</p>

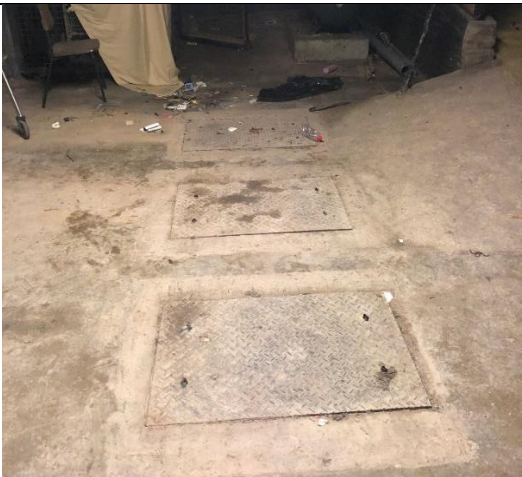
<p>Manhole covers – car park lower level</p> <p>Plans from a previous ground investigation suggest these are related to an interceptor tank.</p>

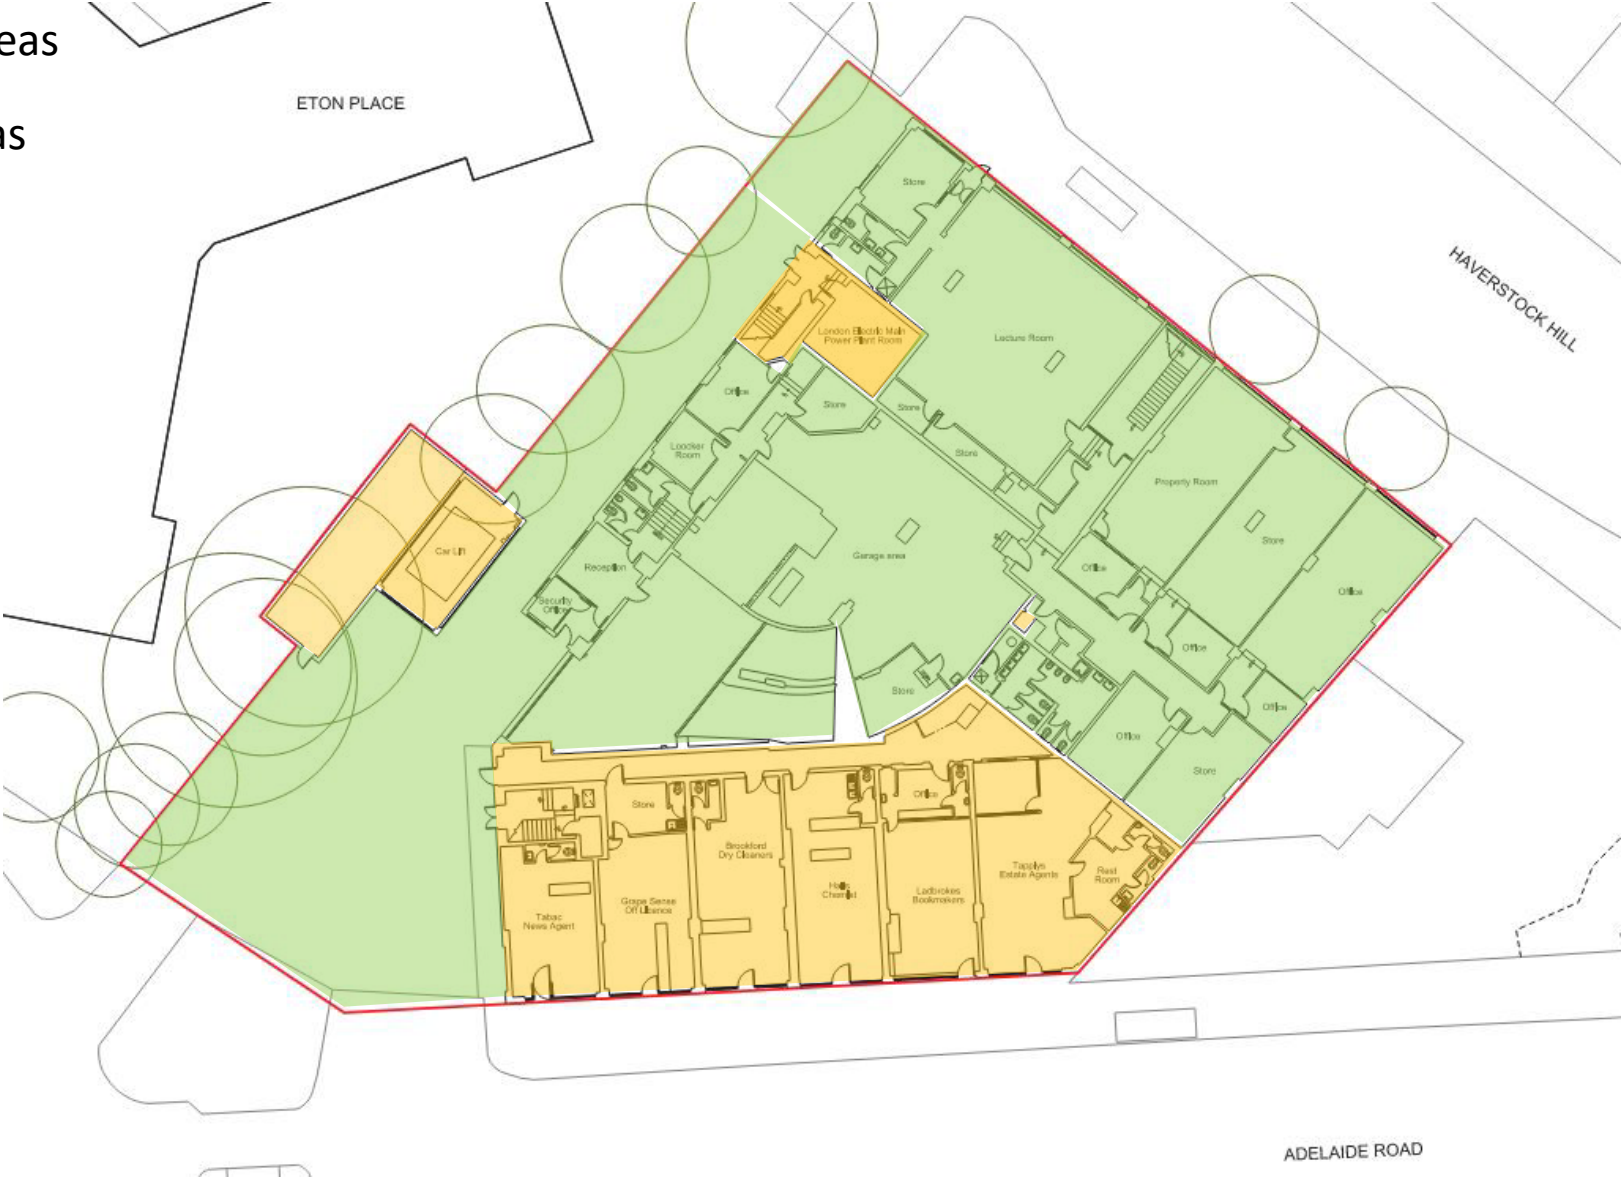
# Access plan

An electric plant room is present in the north of the site, but access is via an external door which had been sealed. A room labelled 'chemical store' in the toilet area in the east of the site was also locked and not accessible. A sprinkler valve room is present on the north western boundary but had a sign on the door warning of asbestos materials inside and was locked and not accessible. Access was also not possible to the retail units on Adelaide Road. Four units were boarded up while two had metal security shutters which were padlocked and not accessible. Access to an external corridor to the side of the units was possible but site security advised they didn't have a key to the door to the rear access corridor. Inaccessible areas are shown in yellow on the attached access plan.

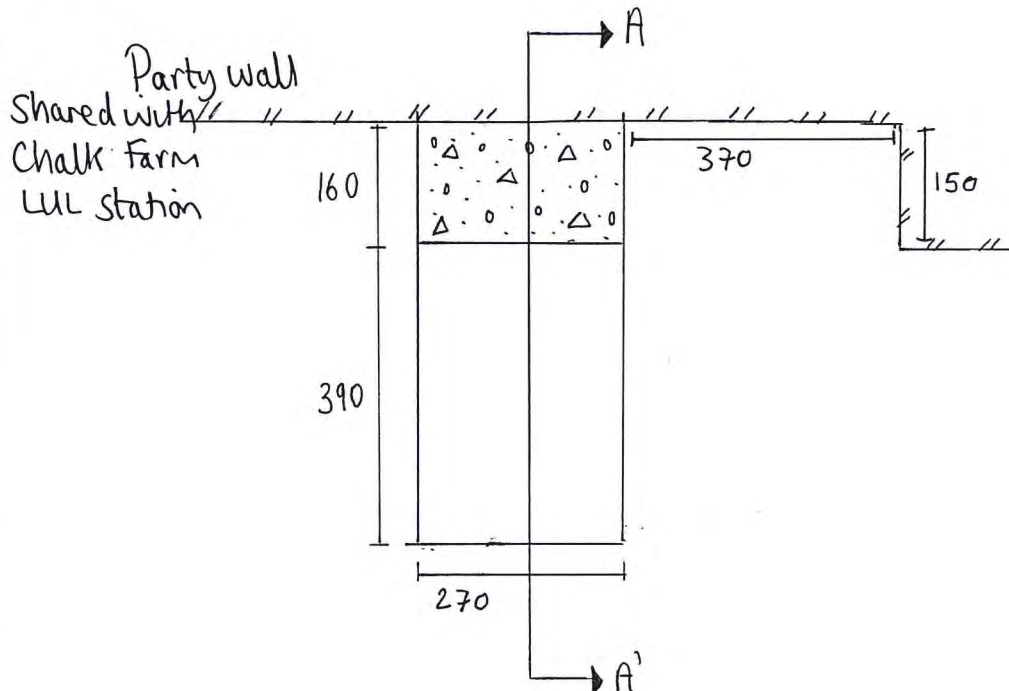
**PLAN**

Sides of trial pit remained stable during excavation

Groundwater: Perched water encountered at the base of the pit, standing at a depth of 0.98 m on completion

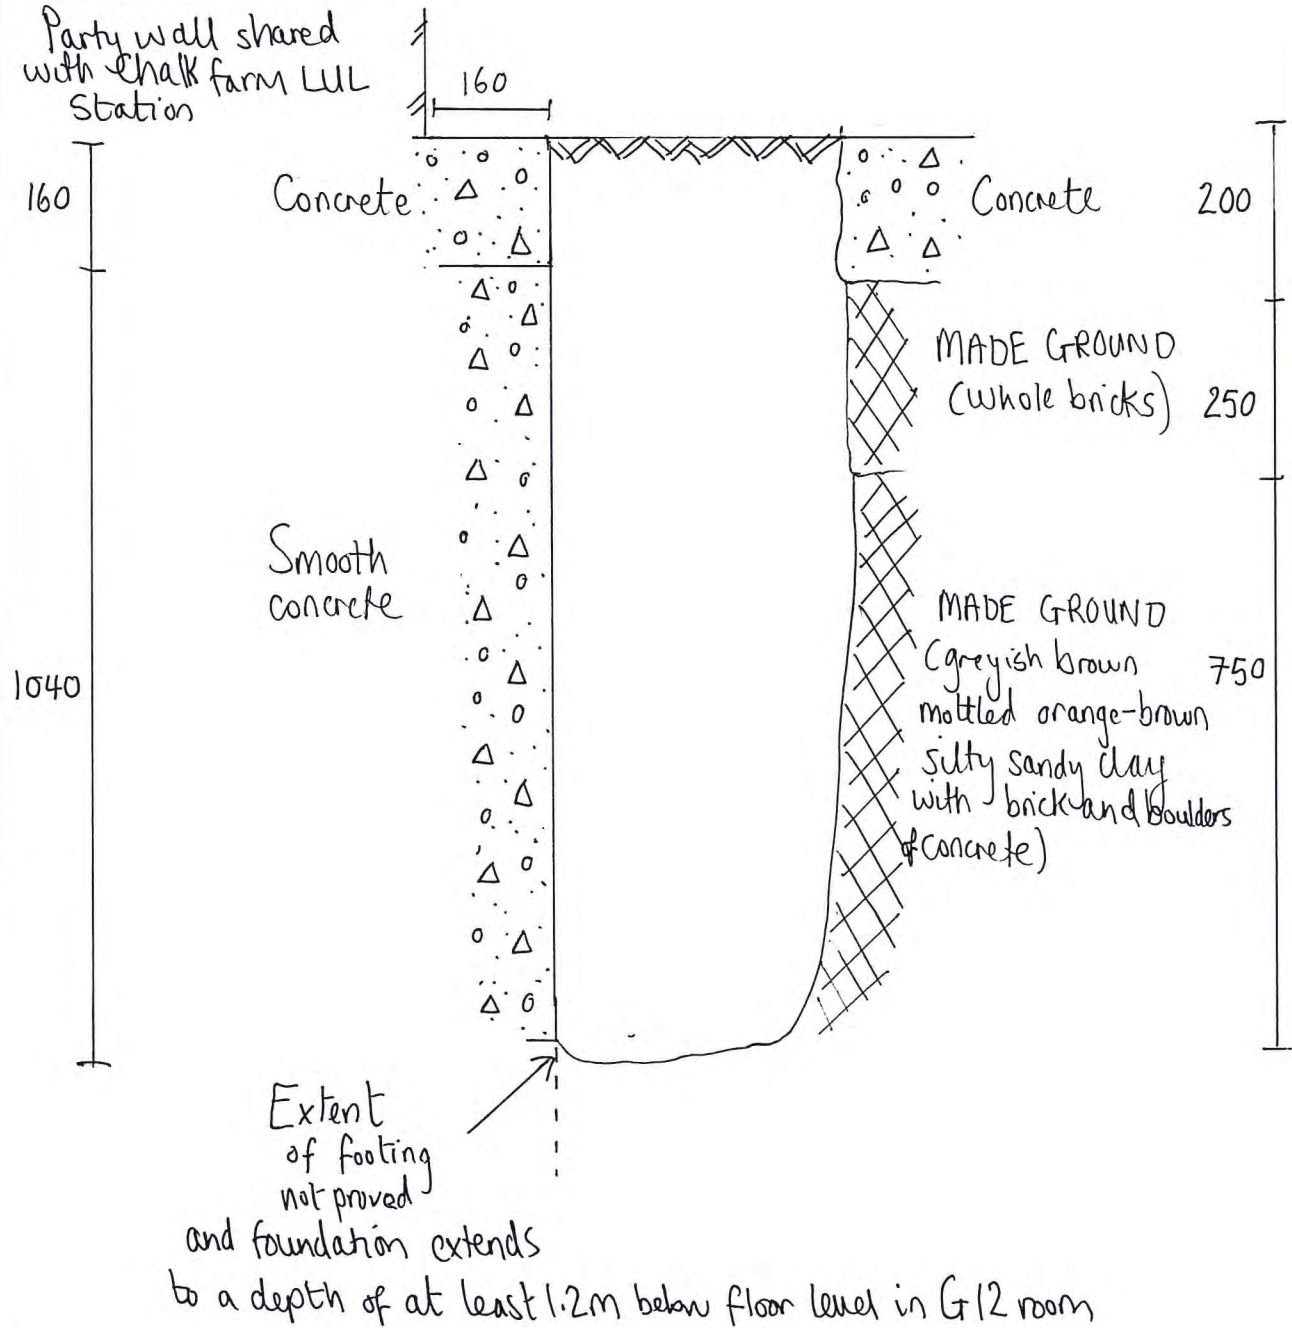
### SECTION A - A'

<b>Remarks:</b> All dimensions in millimetres Sides of trial pit remained stable during excavation Groundwater: Perched water encountered at the base of the pit, standing at a depth of 0.98 m on completion	<b>Scale:</b> 1:10
	<b>Logged by:</b> HD
