OD Camden Hotel Ltd, c/o Best Star
Real Estate 2 Ltd

5 - 17 Haverstock Hill, London

Contamination Risk Assessment and Remediation Strategy

HH-ARP-REP-451

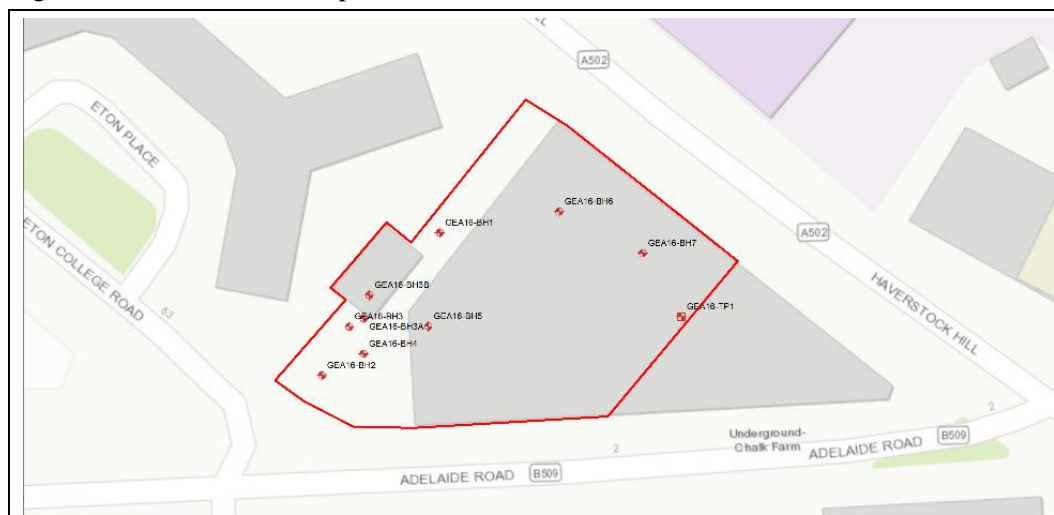
Figure 2 Borehole location plan

No ground gas monitoring or groundwater sampling was undertaken as part of the investigation. Most of the boreholes were located within the south western extent of site due to access restrictions that prevented additional boreholes within the main building. A plan showing the borehole locations is shown in Figure 2.

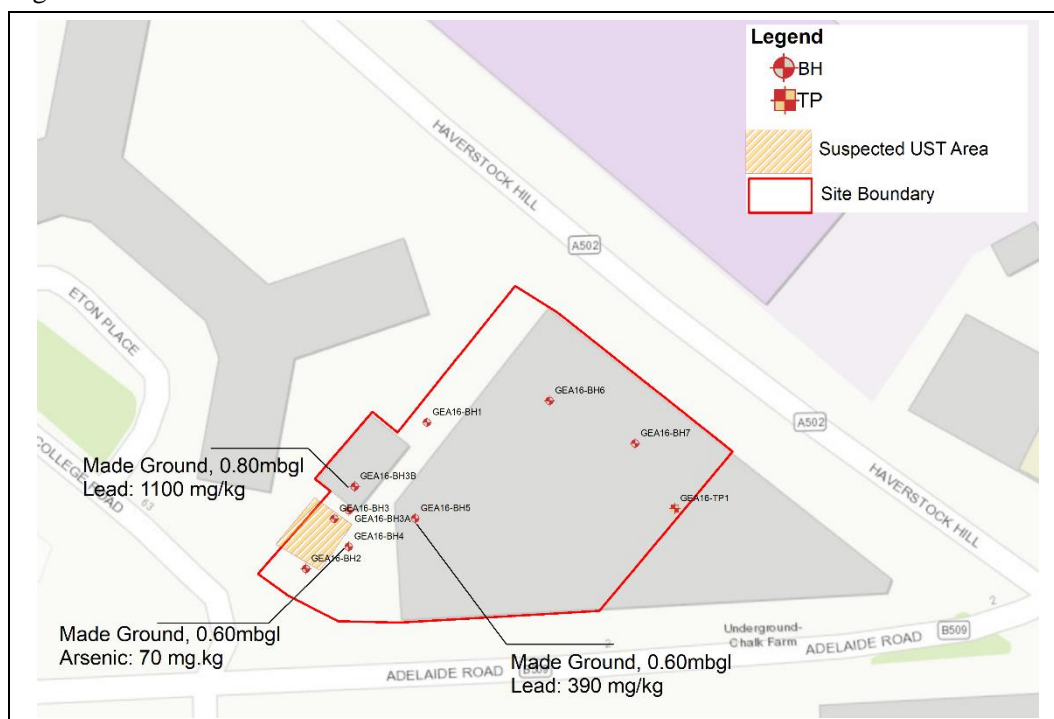
Figure 3 Location of results above GAC

Locations of the results above GAC and the area of the potential underground storage tank (UST) and interceptors are shown in Figure 3.

TPH bands EC16 to EC25 and PAHs (chrysene, benzo(b)fluoranthene, benzo(k)fluoranthene, benzo(a)pyrene, indeno(1,2,3-c,d)pyrene, dibenzo(a,h)anthracene and benzo(g,h,i)perylene) were above saturation limits ranging between 9.6mg/kg to 28mg/kg for TPH and between 0.13mg/kg to 1.8mg/kg for PAHs. The concentrations are in Made Ground within BH3, BH3B and BH4 within the vicinity of the metal obstruction encountered during the investigation and the interceptors observed during the Arup site walkover

These concentrations are low and are not characteristic of significant contamination and there was no indication of free product being present. The volatile TPH fractions (i.e. >EC5 to EC16) were not identified above the laboratory detection limit and are unlikely to present a vapour risk. Furthermore, the soil vapour survey did not identify any significant vapours within the existing basement structure. Whilst ground conditions are unknown within the central and southern areas, given the existing development and basement, likely over London
