Tree Survey & Management Report

45 Highgate West Hill
London
N6 6DB

6th October 2020

AR/MF/0143/20

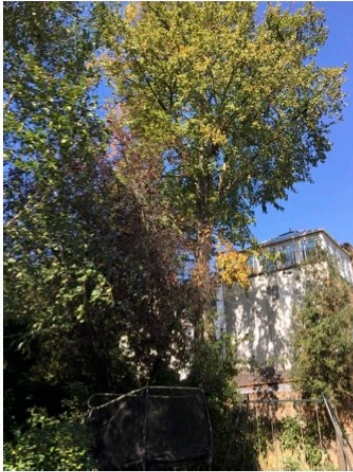
4.9 Tree T2 a mature Lime tree is proposed for crown reduction works in line with good arboricultural practice for the following reasons:

- very close proximity to boundary wall (0.4m distance)
- close proximity to neighbouring southern elevation of Fitzroy Lodge to the north
- crown growing against southern elevation of Fitzroy Lodge and also over building line by up to 4.0m
- lapsed crown reduction works last carried out 3-5 years ago

Lime tree, T2 as viewed in a north westerly direction showing close proximity to southern elevation of neighbouring property

4.8 The proposed works shall provide management of this tree as previously cyclically managed. Remedial works as recommended shall provide a compact crown which shall with regenerative growth retain an even and flowing canopy outline.

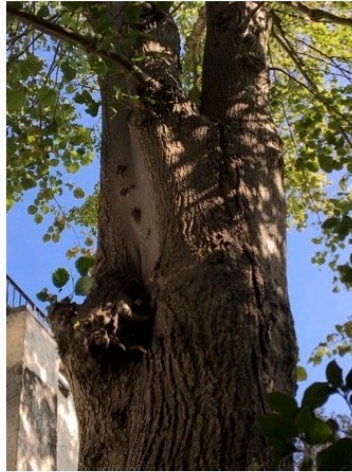
T2	Lime	18	740	10	M	F	G	Even sounding with sound mallet at base - tree growing 0.4m from boundary wall to north. Good root flare at base, less accentuated to the north / west. Straight main stem to 3.5m height where previous stem removed to north west - likely cavity with reaction growth. Main union at 4.5m height with some bark distortion and included bark to west. Co-dominant stems develop from 4.5m with nw stem growing 0.4m from boundary wall of infill extension. South east stem is growing over boundary line. Historically reduced with works last carried out 3-5 years ago; lapsed. Selective major deadwood, notably in upper crown to north (15 & 17m height) and west (12m height)	Crown reduce height by branch lengths of up to 4m - 4.5m Crown reduce spread by branch lengths of up to 3m - 3.5m to give even and flowing canopy outline by retaining soft furnishing growth Remove all epicormic growth to 5m height Remove any remaining major deadwood	M	M	M

Included bark to west of main stem at 3.5-4.5m height - also showing area where western secondary leader has been previously removed

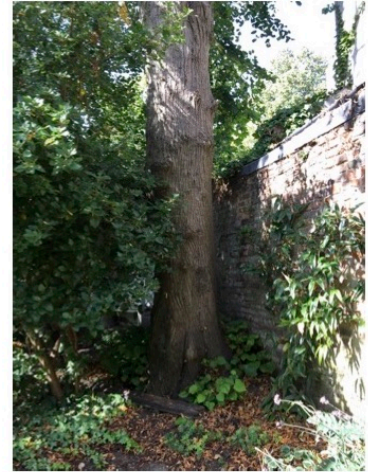
- very close proximity to boundary wall (0.7m distance)
- close proximity to neighbouring Old Wells House to west
- Upper crown growing directly against eastern elevation of Old Wells House and also over building line by up to 3.5m

Base of tree T1 as viewed in a westerly direction showing 0.7m distance from neighbouring property

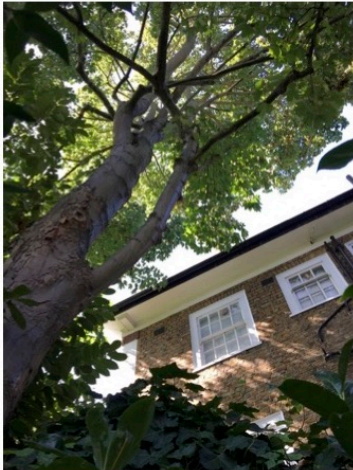
4.8 The limited management of the tree historically (in relation to crown reduction works) has resulted in the development of over-extended growth over Old Wells House and very close proximity of a mature crown to the neighbouring property. Remedial works as recommended shall provide a compact crown without over-extended form as currently exists.

Sycamore tree T1 as viewed vertically in a westerly direction showing over-extended form to west

TREE WORKS SCHEDULE 45 Highgate West Hill, London, N6 6DB			
Tree No.	Common Name	Priority Rating	Tree Works
T1	Sycamore	Moderate	Crown reduce height by 4m branch lengths and spread by branch lengths of 3m - 3.5m to balance and reduce over-extended form over neighbouring property and retain even and lowing canopy outline Prune any remaining growth growing towards neighbouring property to ensure 2.5m clearance
T2	Lime	Moderate	Crown reduce height by branch lengths of up to 4m - 4.5m Crown reduce spread by branch lengths of up to 3m - 3.5m to give even and flowing canopy outline by retaining soft furnishing growth Remove all epicormic growth to 5m height Remove any remaining major deadwood
T3	Hawthorn	Moderate	Fell to ground level Provide replacement planting: 1 x Pyrus calleryana 'Chanticleer' (14-16cm girth heavy standard)
T4	Purple plum	Moderate	Fell to ground level Provide replacement planting: 1 x Pyrus calleryana 'Chanticleer' (14-16cm girth heavy standard)

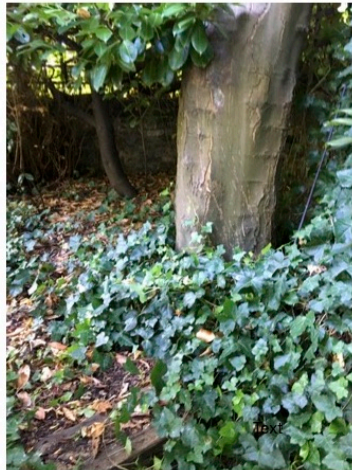
Base of Sycamore tree, T1 growing within south west corner of garden

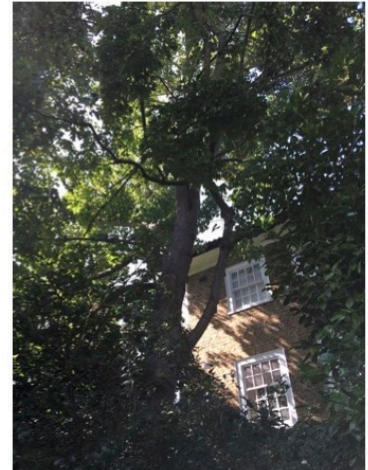
Sycamore tree T1 as viewed in a westerly direction showing over-extended form to west showing dense form

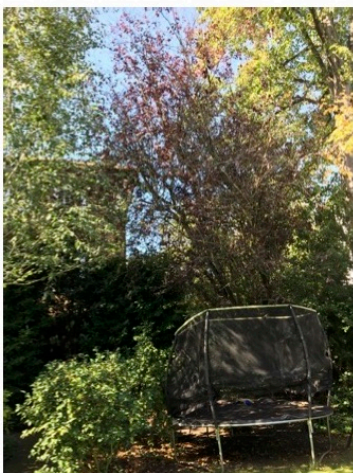
T3	Hawthorn	5	140	4	SM	G	F	Leaning to south west; suppressed. Ornamental form	Fell to ground level Provide replacement planting: 1 x Pyrus calleryana 'Chanticleer' (14-16cm girth heavy standard)	L	M	/
T4	Purple plum	8	280	5	EM	G	G	Leaning to south; suppressed beneath adjacent Lime (T2). Mainly ornamental form	Fell to ground level Provide replacement planting: 1 x Pyrus calleryana 'Chanticleer' (14-16cm girth heavy standard)	L	M	/
T5	Himalayan birch	10	190	4	SM	G	G	1 of 3 x trees planted within past 10-12 years; ornamental form, columnar	Fell to ground level Provide replacement planting: 1 x Amelanchier arboreal 'Robin Hill' (14-16cm girth heavy standard)	L	M	/
T6	Cherry	7	200	4	SM	P	P	Tree is largely dead; overhanging driveway	Fell to ground level Provide replacement planting at rear of property: 1 x Pyrus calleryana 'Chanticleer' (14-16cm girth heavy standard)	L	M	/

Trees T3 & T4 as viewed in a westerly direction showing ornamental form beneath canopy of tree T2

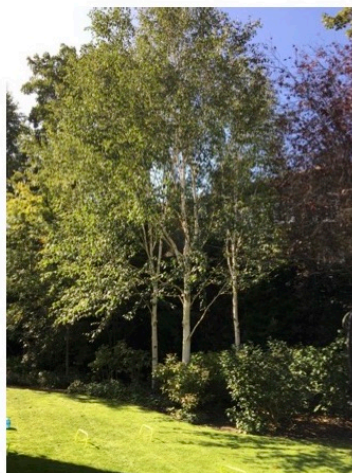
Himalayan birch tree T5 (tree growing furthest to east) to as viewed in a south westerly direction

T5	Himalayan birch	Moderate	Fell to ground level Provide replacement planting: 1 x Amelanchier arboreal 'Robin Hill' (14-16cm girth heavy standard)
T6	Cherry	Moderate	Fell to ground level Provide replacement planting at rear of property: 1 x Pyrus calleryana 'Chanticleer' (14-16cm girth heavy standard)

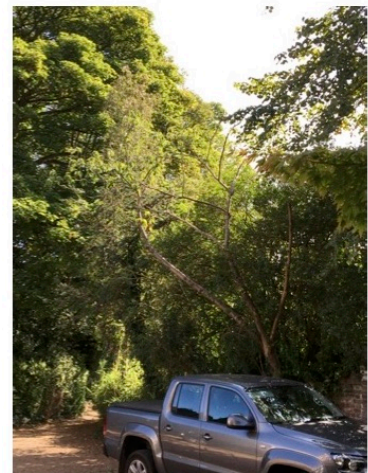
4.9 The tree removal is of ornamental understory trees only. In the case of tree T6, the cherry is largely dead. Where removal is recommended for trees T2-T6 a replacement strategy shall be implemented to include the following tree species

Tree T6 at front of property, largely dead and overhanging driveway
