Antonia Mitchell
41, Arlington Road,
London.
NW1 7ES

Date report produced: 1 November 2019
Type of Survey: Domestic
Survey address: 41 Arlington Road, London NW1 7ES
Page 1 of 18

Surveyed by:	Lee Hunter
Survey number:	343062/19/LH
Inspection references:	All references regarding left- and right-hand side are made facing the property from the front elevation

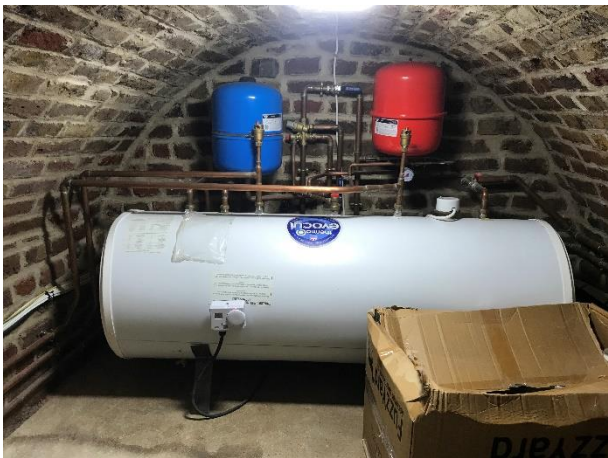
The vault is located at lower ground floor level at the front of the property and is currently being used as storage along with the positioning of the mains electrics, gas boiler and a large water tank with associated pipework.

<p>The vault area is currently used for storage and location of water heater and associated pipework.</p> <p>The head height in this area at the highest point is approximately 1.4m.</p> <p>To install a successful Type C structural waterproofing system keeping the current floor level then the existing floor level will need to be reduced and a new slab installed.</p>
03

- Remove existing floor screed and dispose of all waste.
- Excavate ground ready for installation of the Delta V3 single sump pump station. As the client has requested that the head height of the vault is not to be reduced then the floor level will need to be lowered to allow for reinstatement work to be carried out.

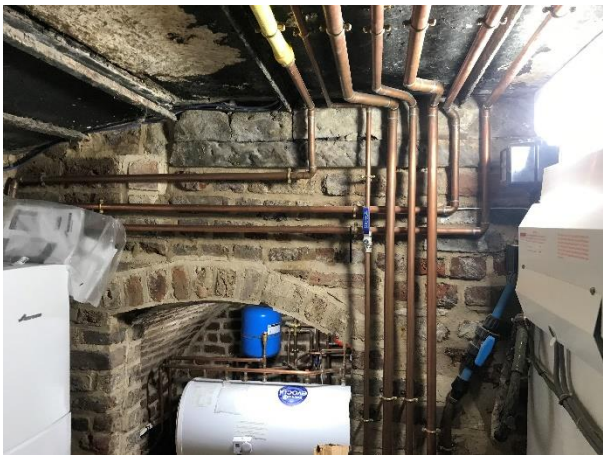
<p>We have been requested to terminate the type C cavity drained waterproofing system at the entrance of the vault.</p> <p>No waterproofing system is required in the adjacent lobby at client's request.</p>

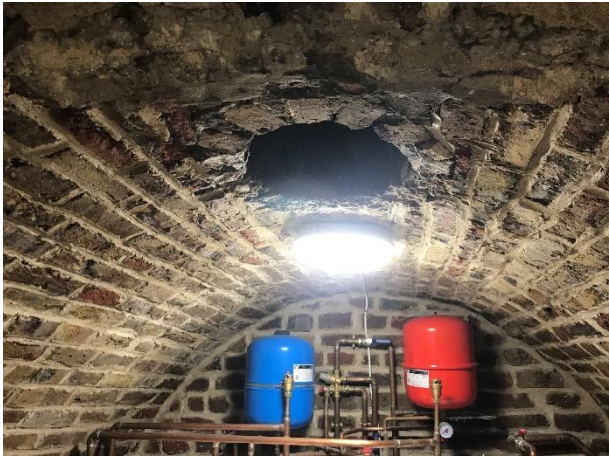
<p>Original coal chute in the vaulted soffit.</p> <p>The Delta internal cavity drained membrane system can be installed over this section and held in place using pressure treated timbers.</p> <p>This way there is no need to fill in with concrete and ensuring compliance with the properties grade 2 listing.</p>
05

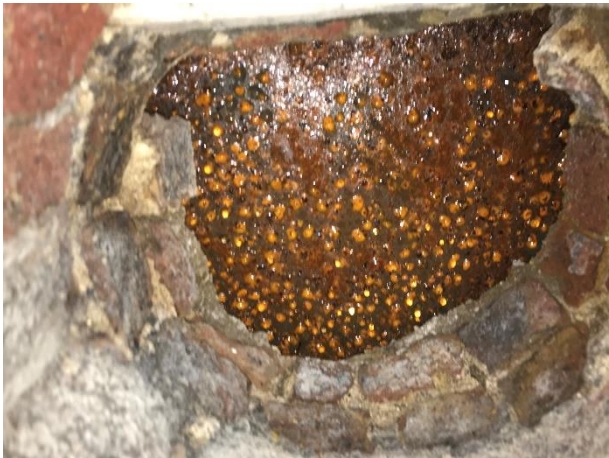
The original coal chute is located at the front entrance of the vault which at the time of survey had water droplets coming from the steel plate covering due to humidity levels and cold bridging. This has been ongoing for some time as evidence of rust staining was noted on the floor beneath. At the time of survey, condensation was present, however it is understood that during times of rainfall the vault is subject to an extreme influx of water, the effects of which are causing damage to the brickwork and mortar.

<p>Condensation noted to the underside of the coal chute due to humidity levels and cold bridging.</p>
06

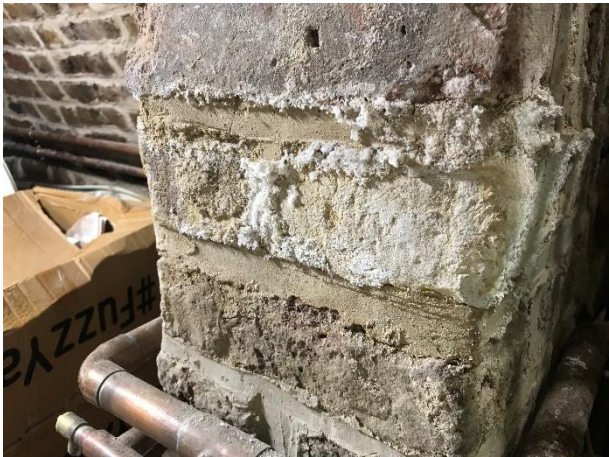
Damp/Salt efflorescence was evident on areas of the brickwork where Calcium hydroxide has been brought to the surface by moisture, this combined with carbon dioxide in the air then forms calcium carbonate. This then appears as the whitish deposit we can now see on the face of the brickwork.

<p>High salt content noted to areas of the brick work at the entrance to the vault.</p>
08

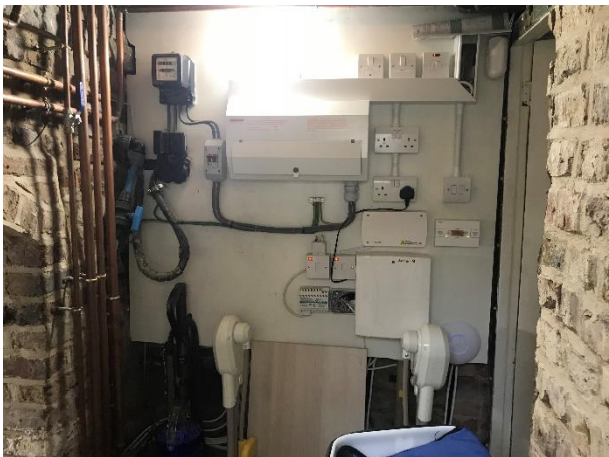
The electrical RCD board and other electrical components are all positioned on the left side external wall next to the vault entrance. These items restricted access to the wall area here.

<p>We have been requested not to specify any system to the lobby area where the electrical board is positioned at client's request.</p>

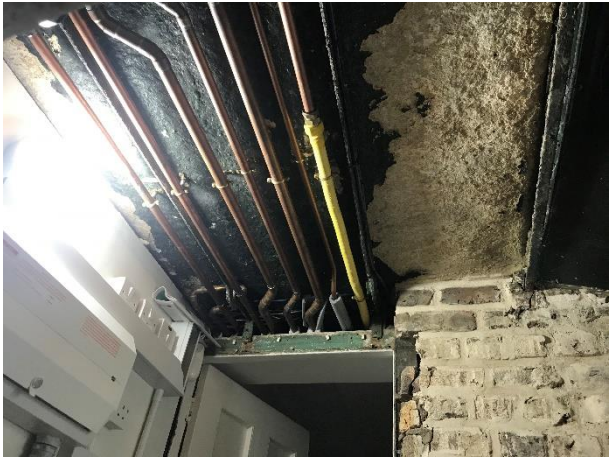
The natural stone soffit at the vault entrance had previously been painted black but over time has begun to deteriorate and is frail in places. The central heating pipework has been drilled and fixed through this area so carrying out waterproofing here would mean the removal of all pipework completely.

<p>The natural stone soffit is showing signs of deterioration, but we have been requested not to specify any waterproofing systems to this area at client's request.</p>
11

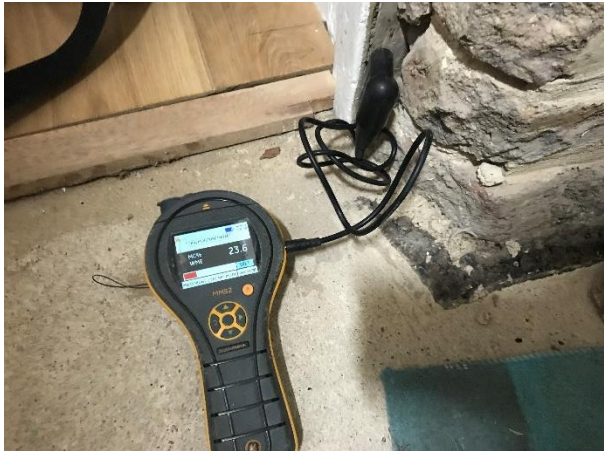
Wood moisture content readings were taken at the base of the rear door liner using the protimeter MMS2 conductivity meter and readings recorded were in excess of 20% moisture content. High moisture content of these timbers are due to the timber being in direct contact with the damp masonry.

<p>The rear door liner of the property at basement level was tested for moisture content.</p> <p>Readings recorded were in excess of 23% wood moisture content.</p> <p>Fungal decay always arises because the wood has become wet, usually timbers will be in excess of 20 per cent moisture content.</p>
12

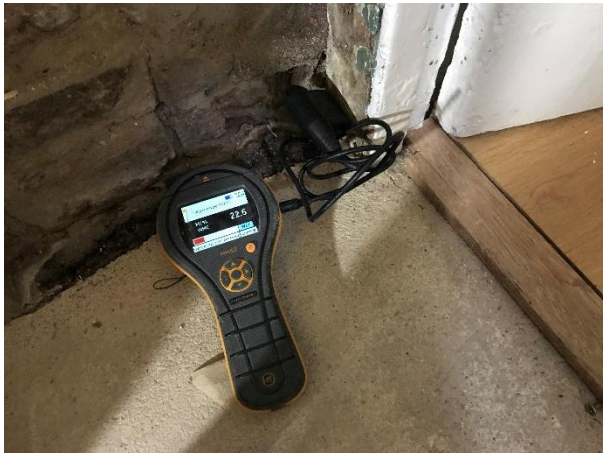
<p>Photograph highlighting the high wood moisture content levels recorded to the other side of the door liner at basement level.</p>
