## SITE INVESTIGATION FACTUAL REPORT

Report No: [REDACTED]  
Client: Sedgwick International UK - Maidstone  
Site: 2 Cleve Road, London  
Client Ref: [REDACTED]  
Date of Visit: 20/03/2020

Home Emergency Response - Subsidence Investigation - Drainage Services – Crack & Level Monitoring – Property Video Surveys

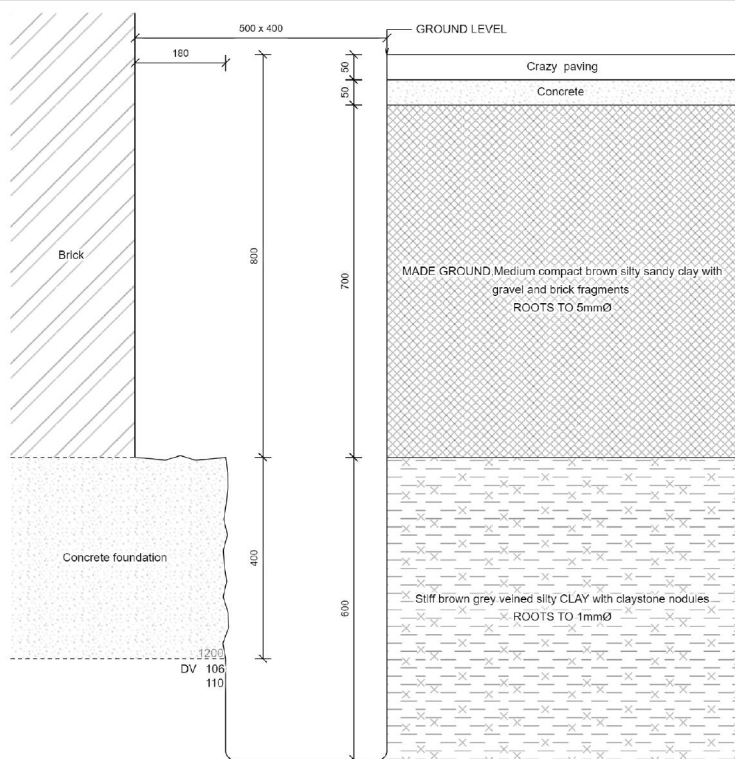
TP1

For Strata below 1400mm see Bore Hole log
