METHOD STATEMENT FOR THE REPAIR OF THE MOULDED TREADS TO THE MAIN STAIRCASE.

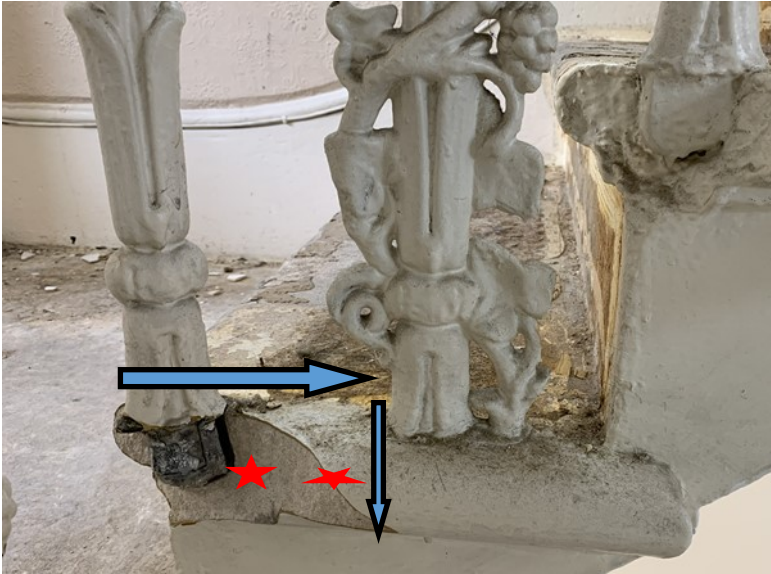
This photograph shows the typical damage to the Portland stone tread of the cantilevered staircase. The damage has been caused by the base of the iron balustrade spalling and bursting the stone at its weakest point.

The proposed method repair would be for our skilled masons to carefully square cut the damaged areas along the lines shown by the blue arrows.

A new piece of Portland stone pre-cut off site to match the moulded leading edge and return of the tread will be fixed into position on stainless steel dowels. These dowels will be 6mm 304 grade stainless steel resin fixed into the existing tread as indicated on the photograph with a red star.

The new piece of stone will be fitted around the balustrade base and glued in position and pointed with fine lime putty mortar.

The balustrade will be resin fixed into the new stone indent and left ready for redecorations by others.

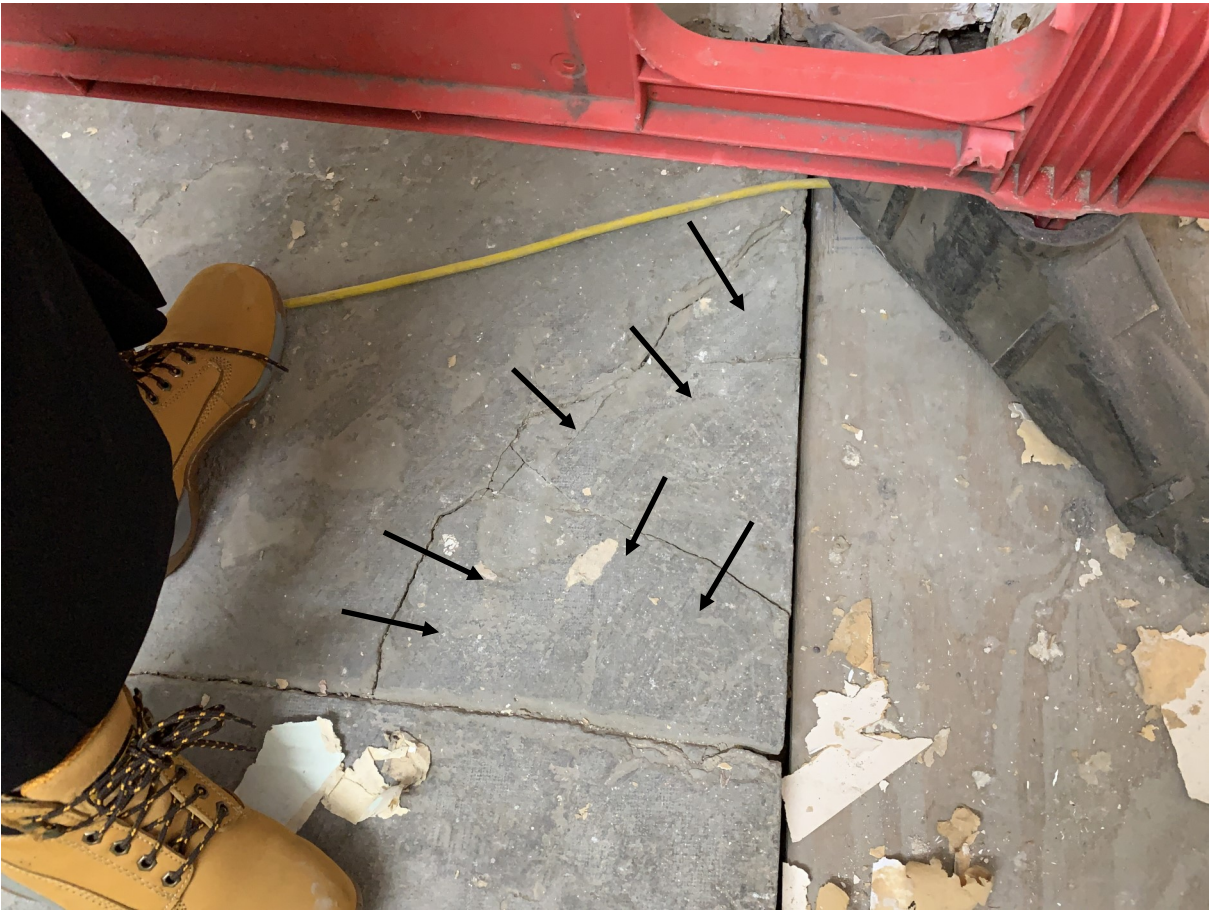
To the second floor landing the broken slab of York stone will be re-bedded as previously and have multiple pins inserted across the various cracks. The surface joints will be grouted with lime mortar.
