CONDITION REPORT

**ODEON COVENT GARDEN
135-149 SHAFTSBURY AVENUE
LONDON
WC2 8AH**

PREPARED FOR:	Rosemoorgate Ltd
PROJECT LOCATION:	The Odeon
PURPOSE OF THIS REPORT:	Prepare a condition report for the scheme
DATE:	7 th August 2017
PREPARED BY:	Andrew Hentschel Senior Building Surveyor
OUR REFERENCE:	HA1901

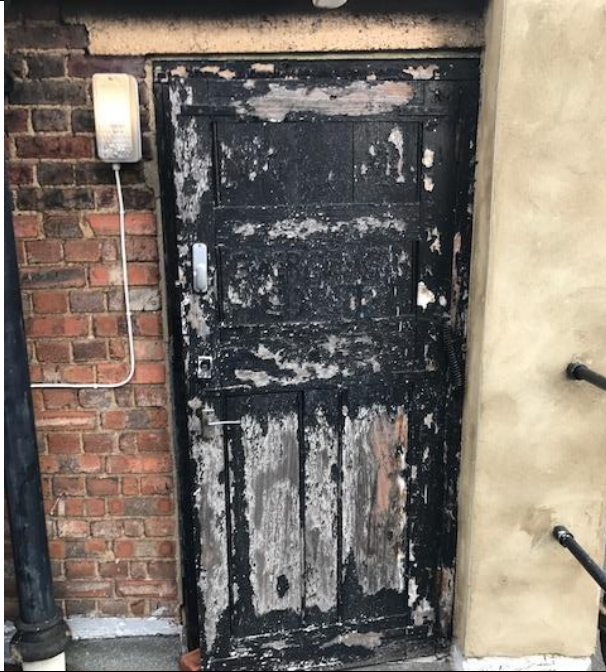
3.

The timber doors and paintwork to the tank housing rooms are beyond economical repair.

Door leading from staircase A onto roof

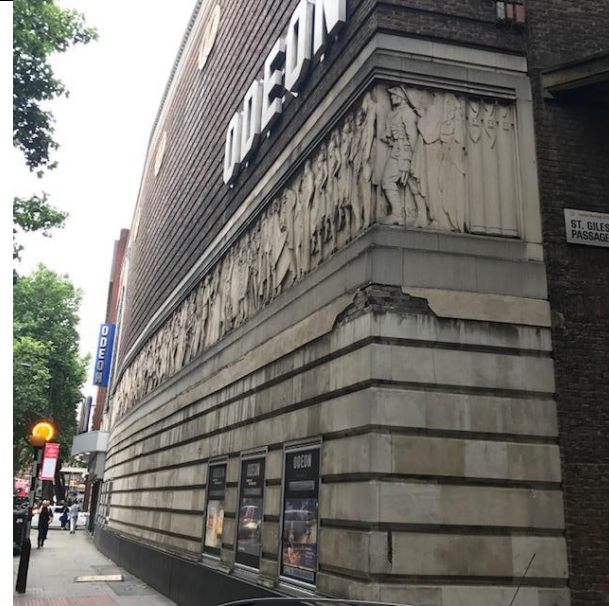
There is also damage to the front right hand corner of the frieze. There is also evidence of piecemeal repairs to the front lower masonry sections.

Damage to stonework of frieze

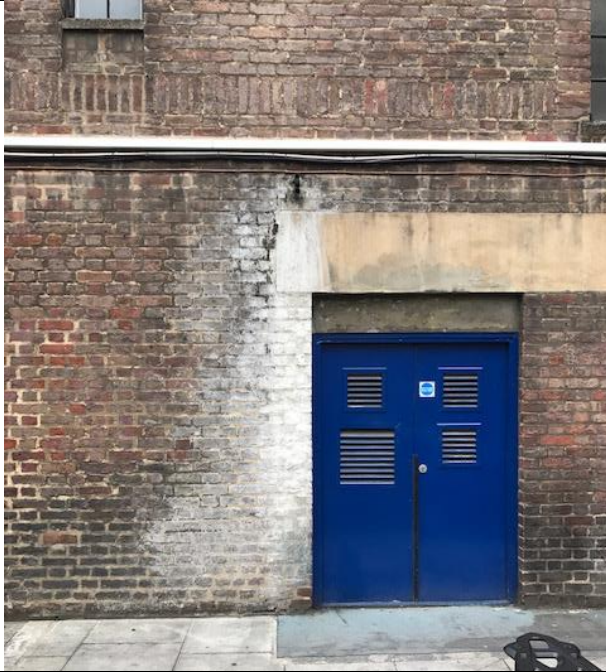
4.

The brickwork is in generally fair condition. However, overflows have caused damage to the brickwork to the rear elevation at lower level.

Damage caused to brickwork of rear elevation by defective overflow.

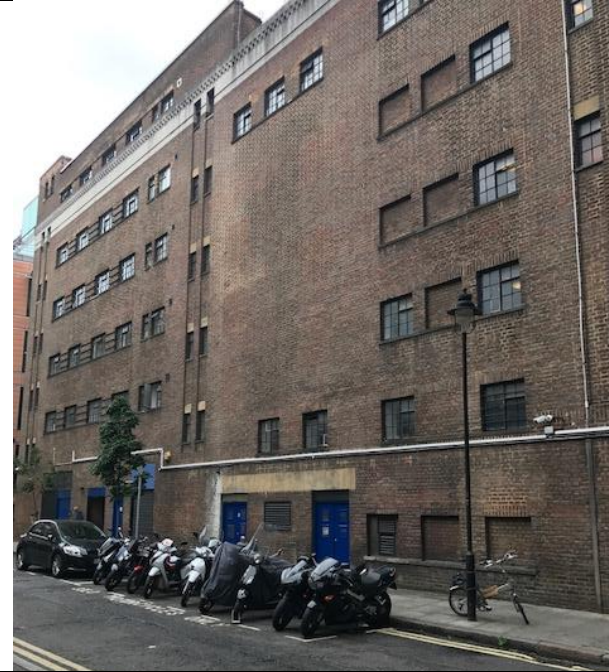
The windows are single glazed metal with side hung casements. These windows are in generally poor condition throughout with cracked glazing and poorly fitting openers.

General view of rear elevation showing metal windows.

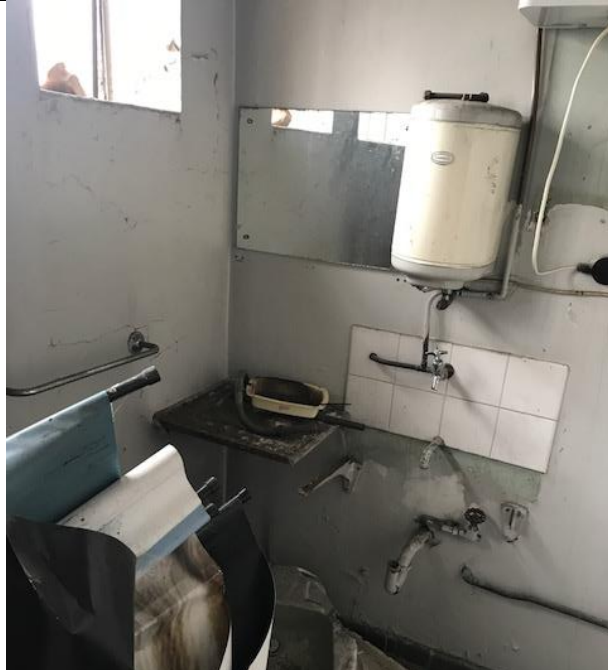
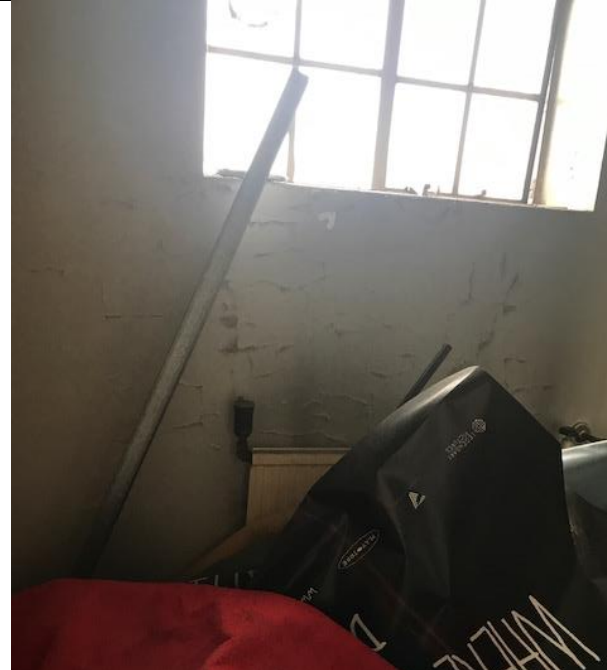
5.

Typical condition of level 9 washroom

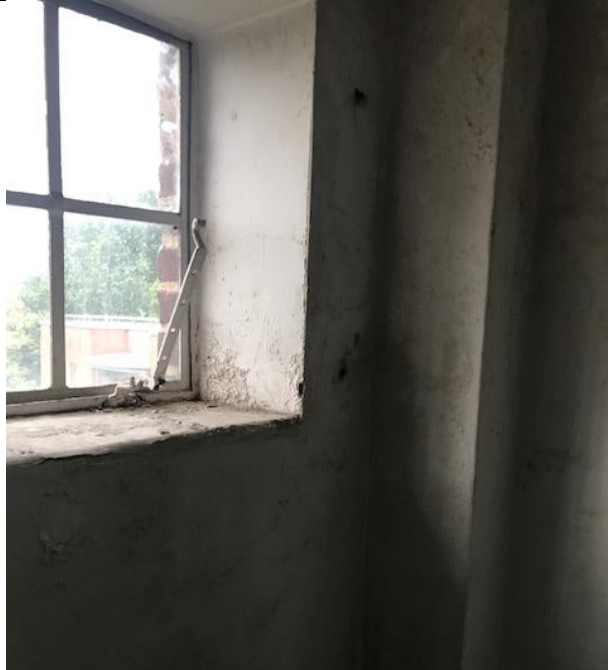
6.

The staircases (A-C) require new floor coverings as these have generally fallen into disrepair.

Walls to staircase A

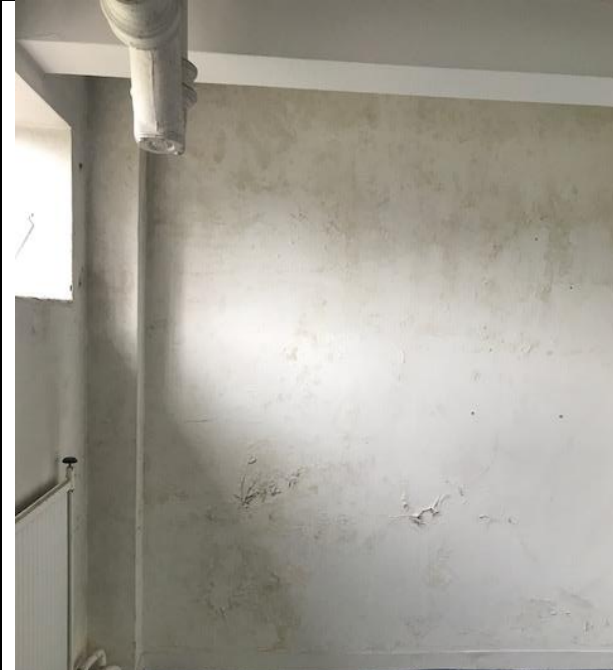
Wall to unused office affected by penetrating dampness

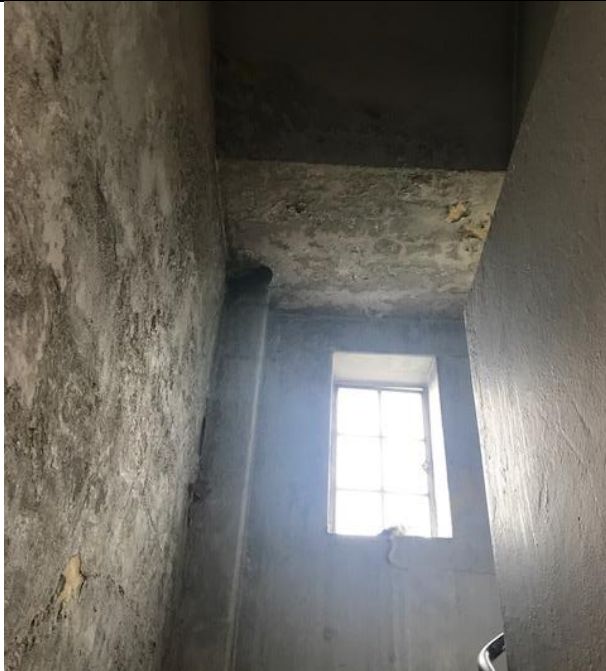
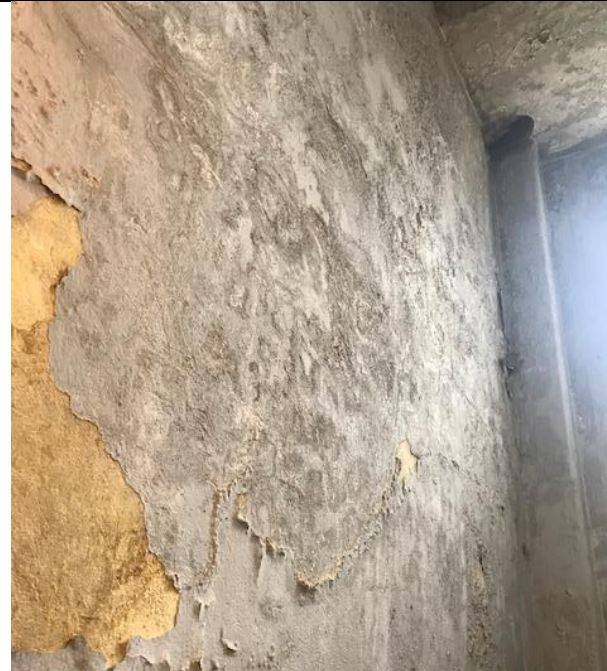
7.

We found evidence of a major roof leak that has caused damage to the upper stories of staircase C which is situated to the right hand side of the building.

Staircase C damage caused by penetrating dampness

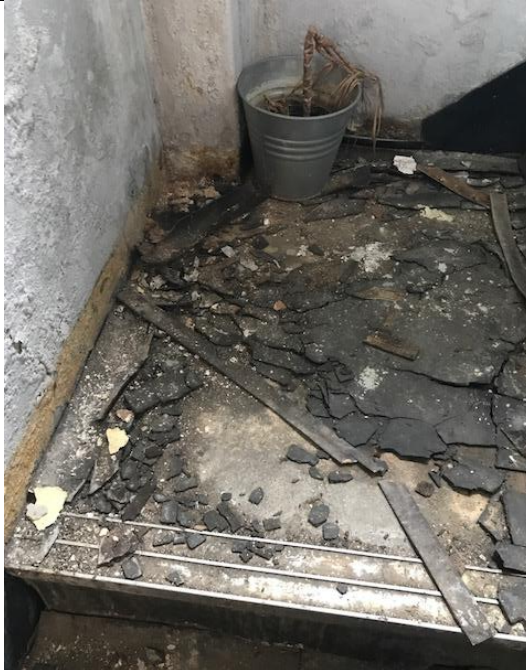
8.

Flooring to staircase C

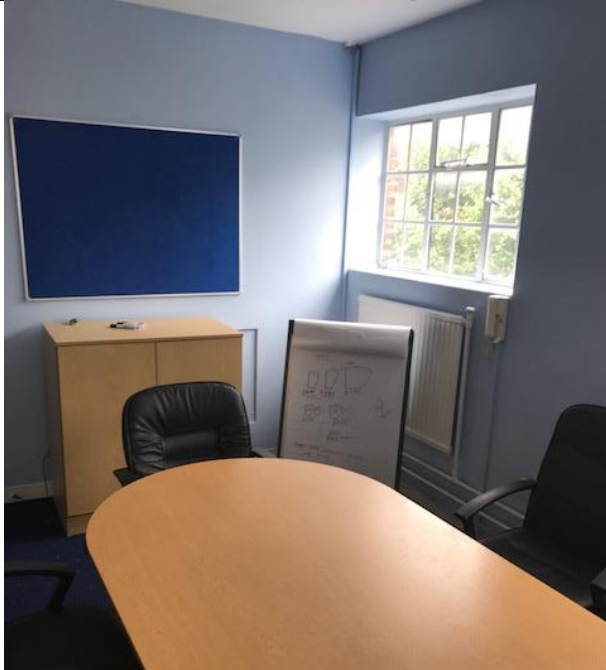
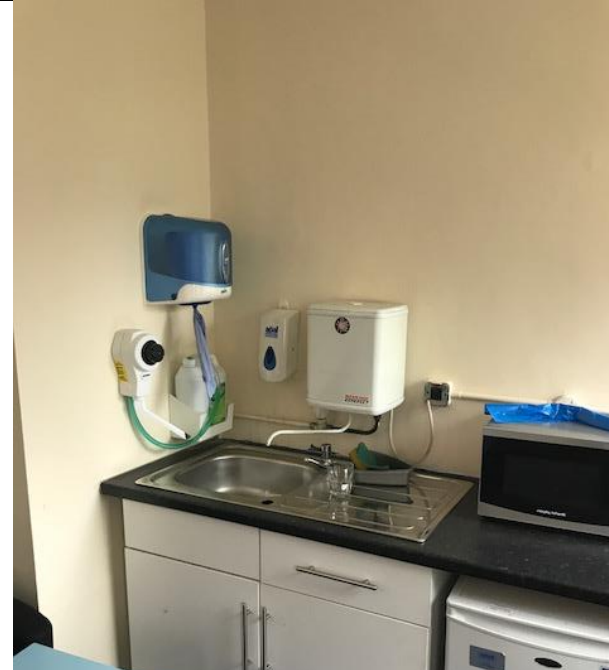
There are numerous offices that have fallen into disrepair which are situated to levels 9. The offices currently being occupied (levels 7-8) are in fair condition having been decorated.

Office and kitchen areas currently being used

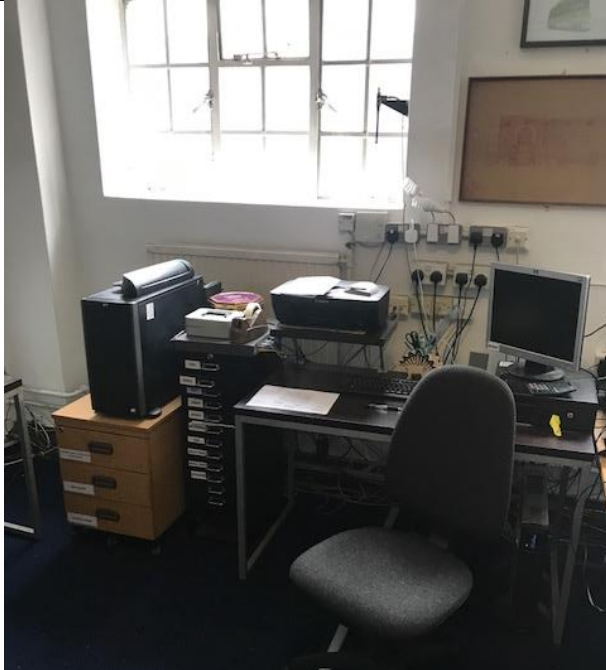
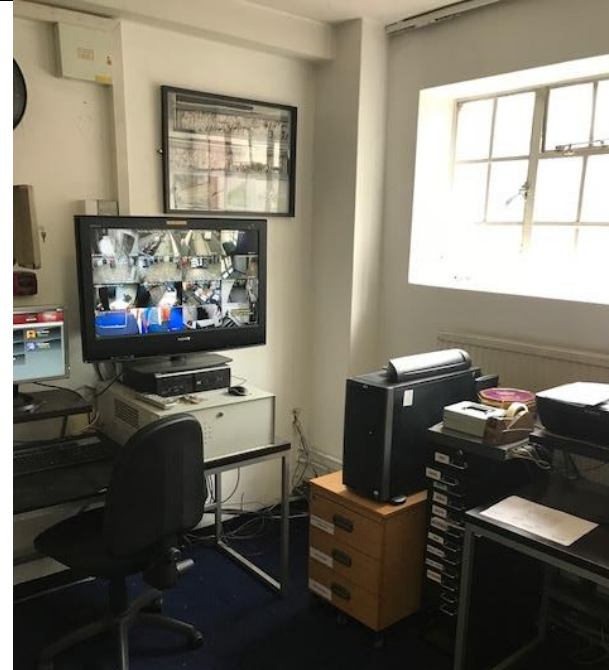
10.

However, it was noted that there are a limited amount of electrical sockets and lighting which would be required to bring these areas up to an acceptable standard for future use.

Offices showing additional electrical sockets

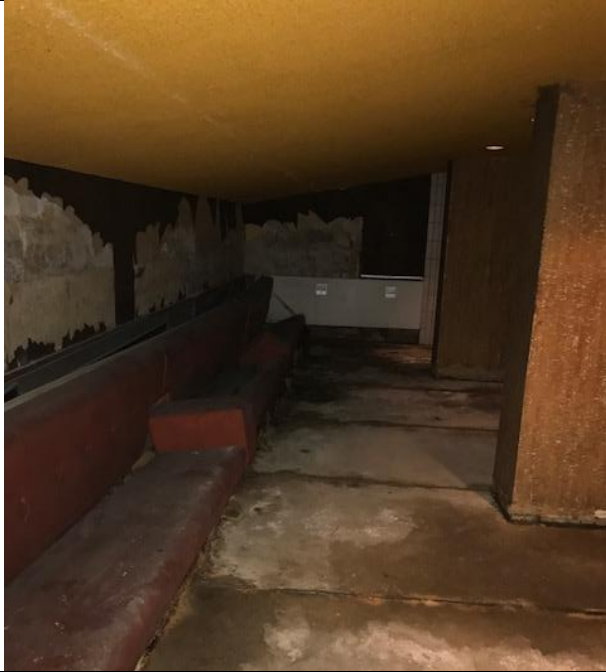
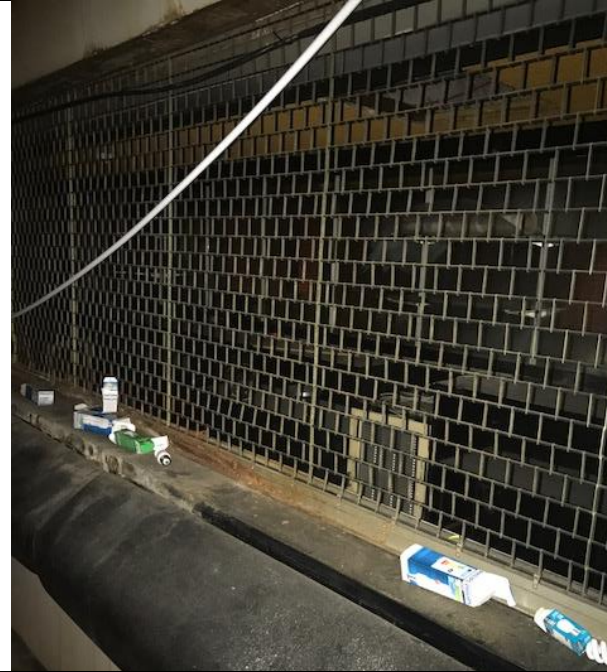
11.

Disused bar area to lower level

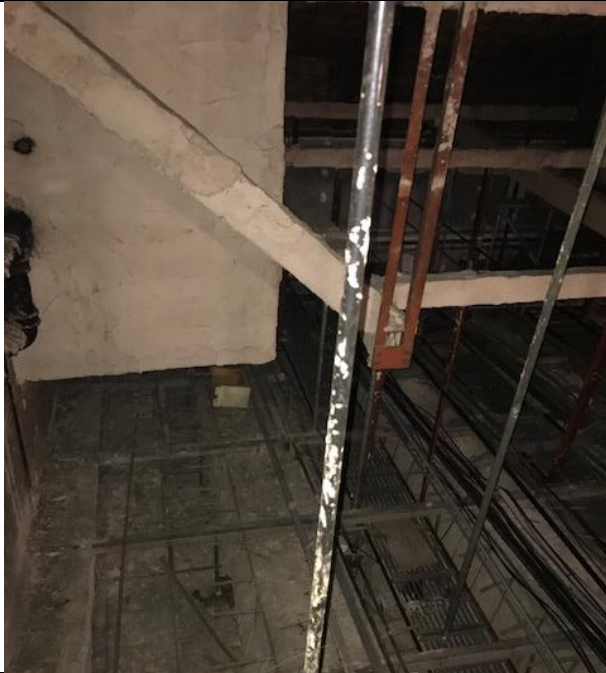
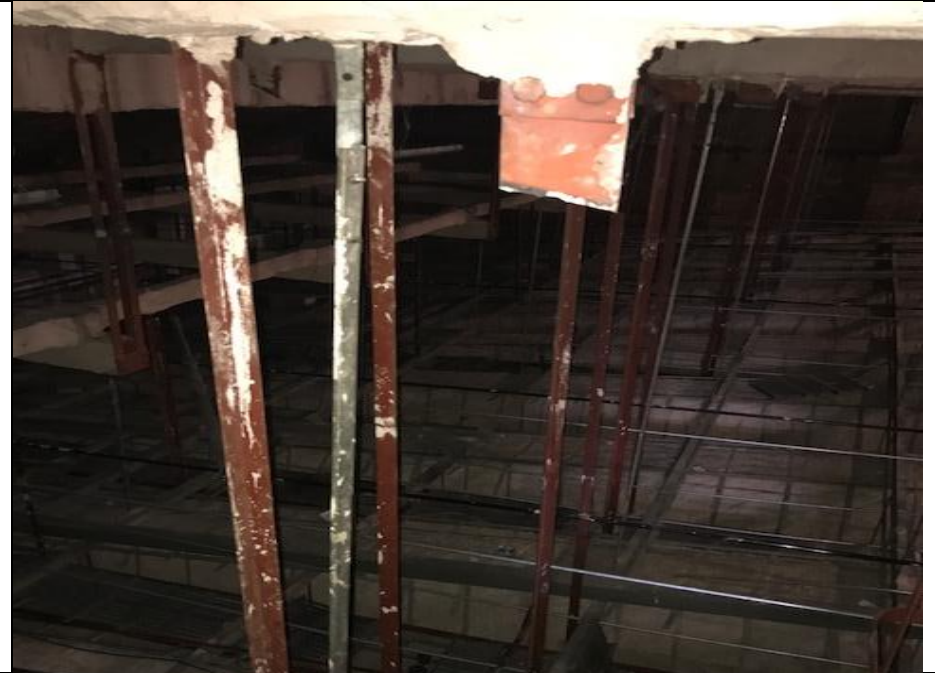
12.

Roof void

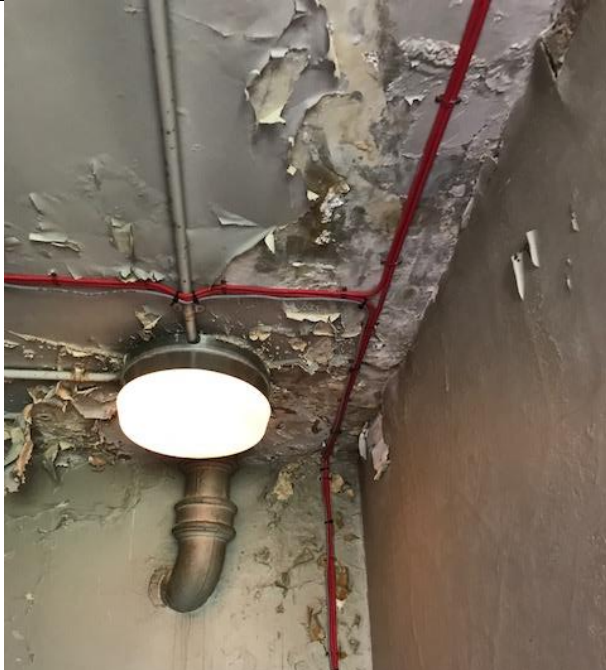
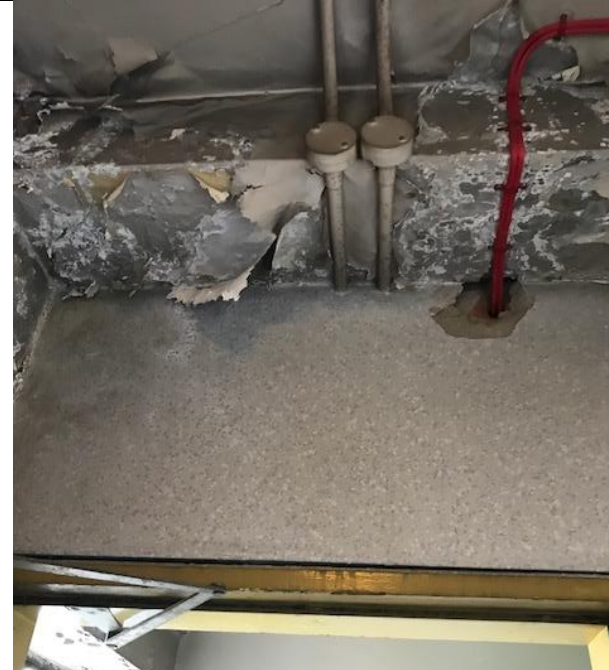
13.

General condition of upper and lower levels

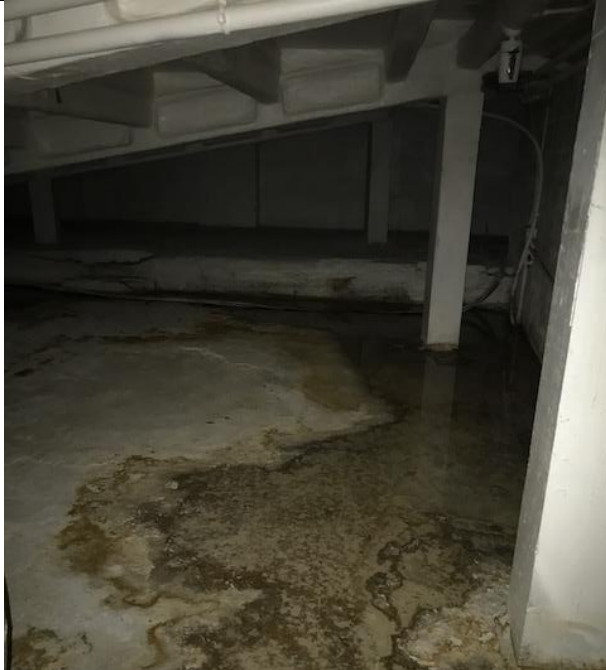
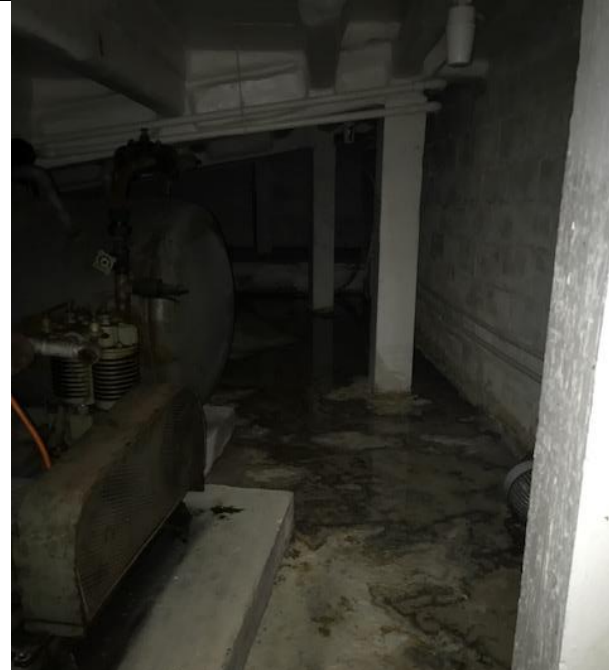
14.

We inspected the basement levels and noted flooding has occurred to the plant room.

Flooding to plant room at basement level
