31 Daleham Gardens, London, NW3 5BU
Initial Structural Survey of
Fire Damaged Building
for Pristine London Limited
40420–R01

Revision	Date	Prepared by	Checked by	Reason for issue
P4	09/11/2020	Mark Duncombe	Sven Griesemann	For information

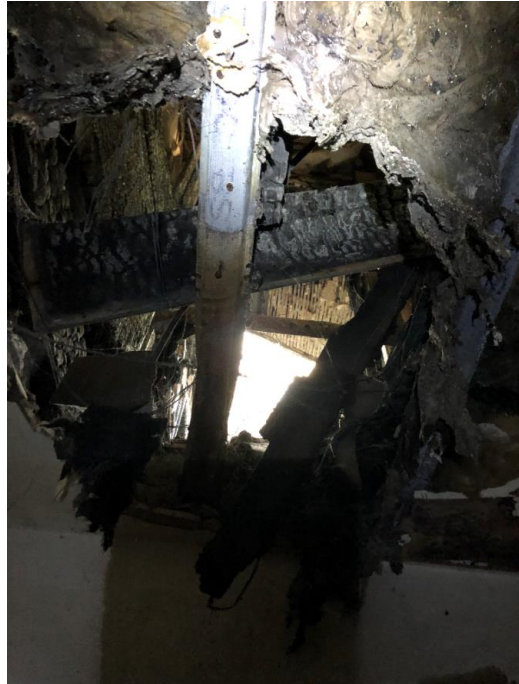
Photo 1 - Apartment 1 fire damage to stair above kitchen

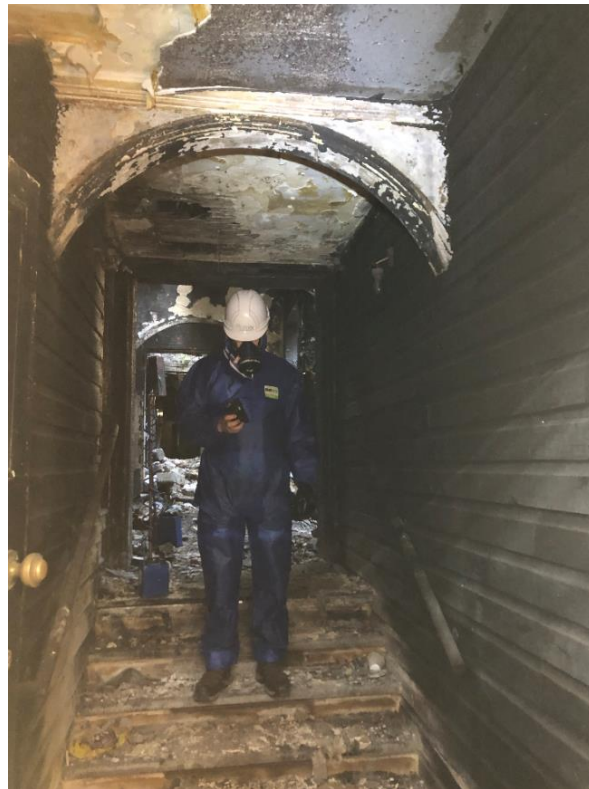
At ground floor there is smoke damage but little evidence of structural fire damage in most areas. However, there is significant charring of a load bearing door frame around the main entrance door that supports the first floor joists above. It was not possible to access apartment 3 due to fire damage of the ground floor in the entrance to the apartment. Apartments 4 and 5 were accessible and had no evidence of structural fire damage. There is rubble present on in the entrance hall to apartments 6 and 7 that has fallen from above. There was no access to apartment 7 due to the entrance door being blocked by the belonging of the previous occupier. Our findings at ground floor level are summarised in the table below and photographs are included at Appendix B.

Photo 8 - Main entrance hall

The load bearing door frame that supports the first floor joists should be propped using Acrow props with double scaffold head and sole boards at basement and ground floor levels. Refer to sketch number 40420/SK/TW/01 for details of propping required.

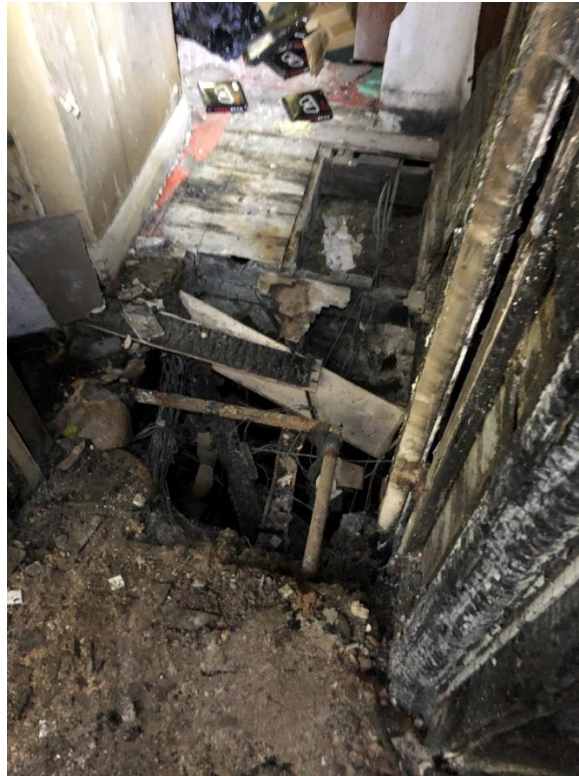
Photo 9 - Apartment 3 fire damaged in entrance

The fire damaged area of the ground floor in the entrance to apartment 3 should be locally removed and replaced to enable access to the apartment. Refer to sketch number 40420/SK/TW/01 for details.

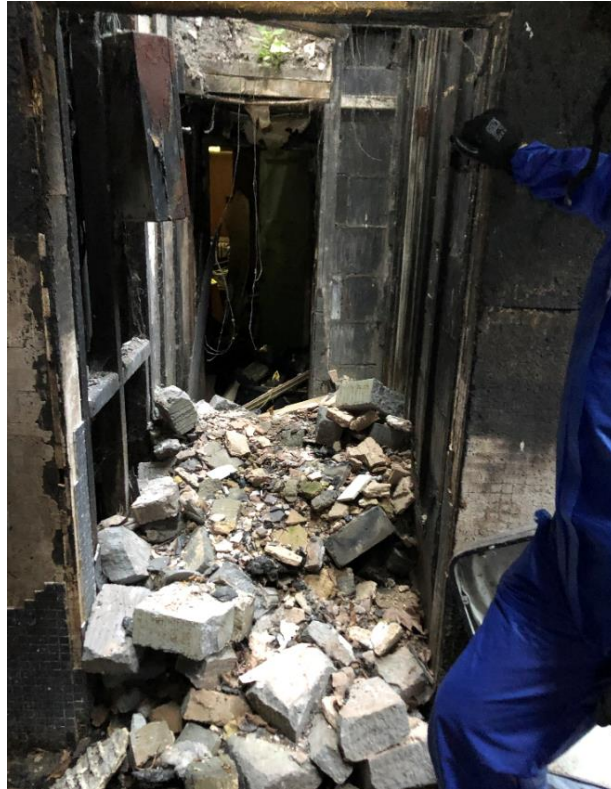
Photo 13 - Apartment 6 rubble build up in entrance

An asbestos management contractor should carry out soft strip and ACM removal to apartments 1 to 10. It will also be necessary to remove the rubble build up in the entrance to apartment 6 in order to gain access. Access will not be possible to apartment 11 and 12 due to the dangerous condition of the roof and second floor structure above.

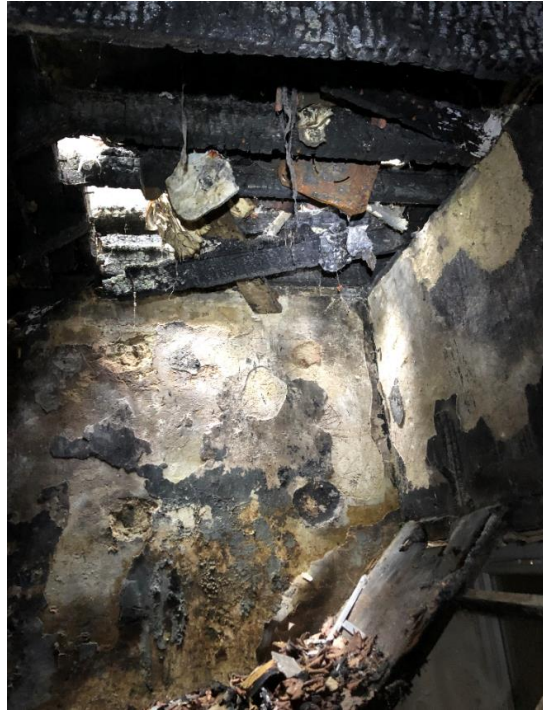
The stair from ground to first floor has severe fire damage and is supporting fallen debris most of the way up. We would not recommend using this stair as it is likely to collapse if it subject to additional loads. The first floor landing is also severely fire damaged and has very little remaining integrity, as shown in photograph 18.

Photo 15 - Stair from ground to first floor underside of half landing

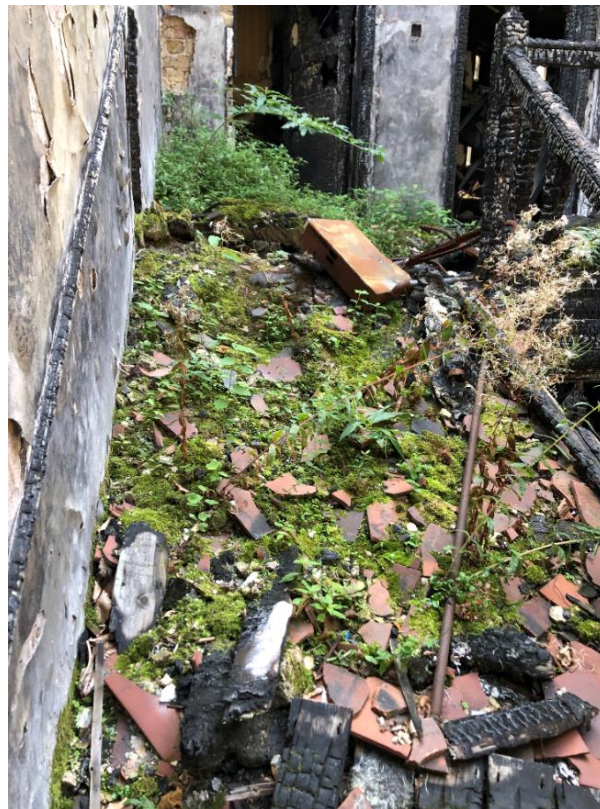
Photo 16 - Stair from ground floor to first floor

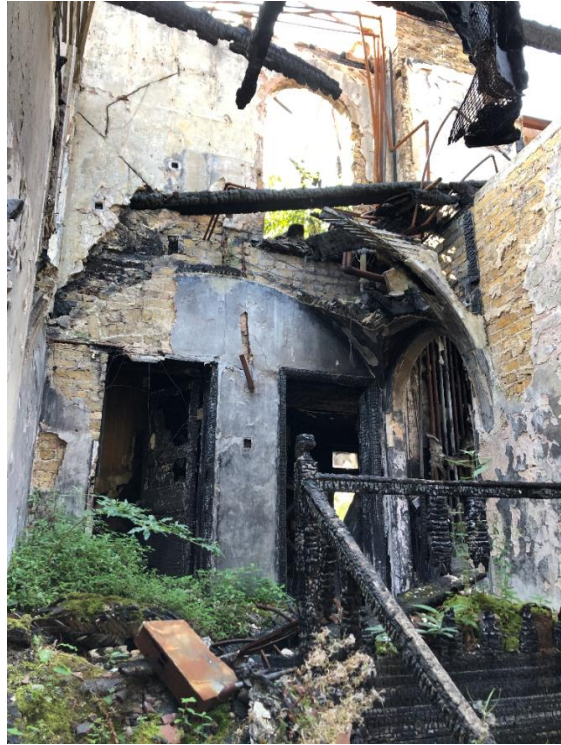
Photo 17 - Stair from ground to first floor

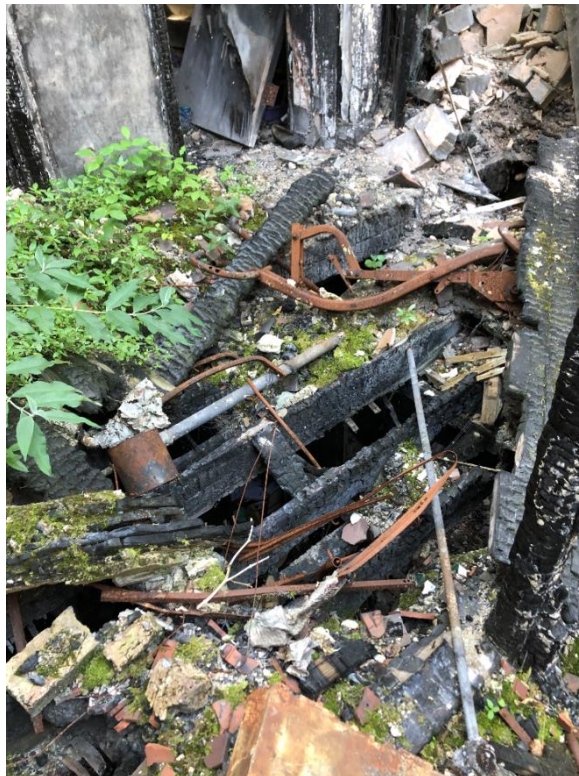
Photo 18 - First floor landing

The existing first floor landing and stair from first to ground floor should be demolished as they are unsafe for use. Edge protection should be provided at first floor and ground floor prior to demolition. A temporary Haki access stair may be installed if required by the contractor.

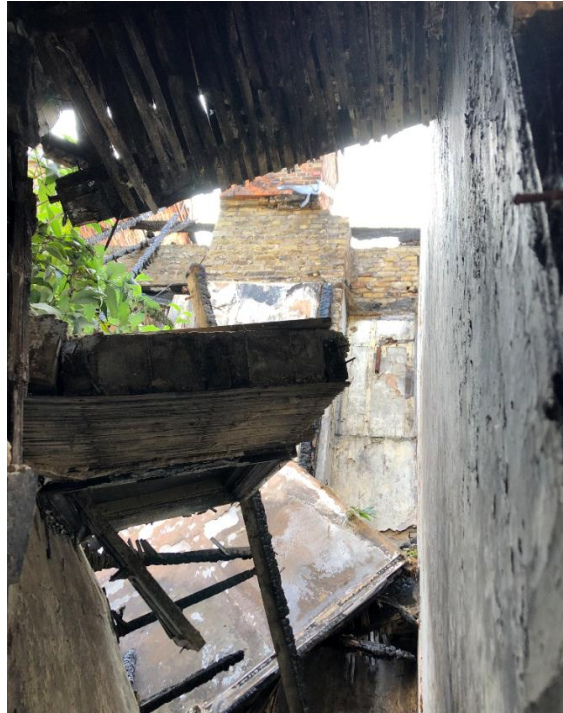
During our first site visit it was not possible to access any of the rooms at first or second floor due to the condition of the stair and landing area. From part way up the stair we could see that the second floor and roof above apartment 12 have collapsed as shown in photograph 19. We could also see that the floor above apartments 8 and 9 appeared to be present. It can be seen from Google maps that the second floor roof to the rear extension is present and may be relatively undamaged by the fire. However, it would be necessary to access apartment 10 through the rear elevation window in order to confirm its condition.

Photo 19 - Apartment 12 view of second floor and roof

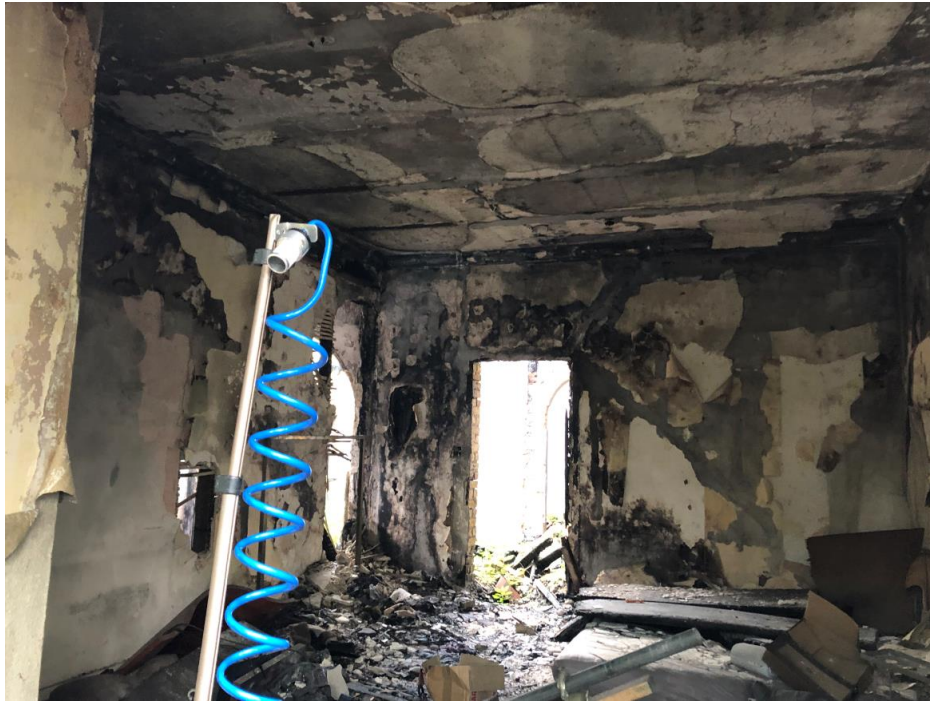
floor level. The timber stud wall between apartment 10 and 11 has fire damage as shown in photograph 26. Any person entering this apartment should avoid leaning against this wall.

The roof above apartment 10 is of filler joist concrete slab construction. This has not been structurally damaged by the fire but is suffering from water penetration as shown in photograph 26. There is a steel beam located above the stud wall between apartment 10 and 11 that supports the filler joist roof slab. Photograph 27 shows the roof slab, steel beam and stud wall.

Photo 26 - Fire damage wall and water penetration through roof of Apartment 10

An exclusion zone should be provided near the entrance door or apartment 10 and the first floor joists should be propped down to ground floor level. Refer to sketch number 40420/SK/TW/02 for details.

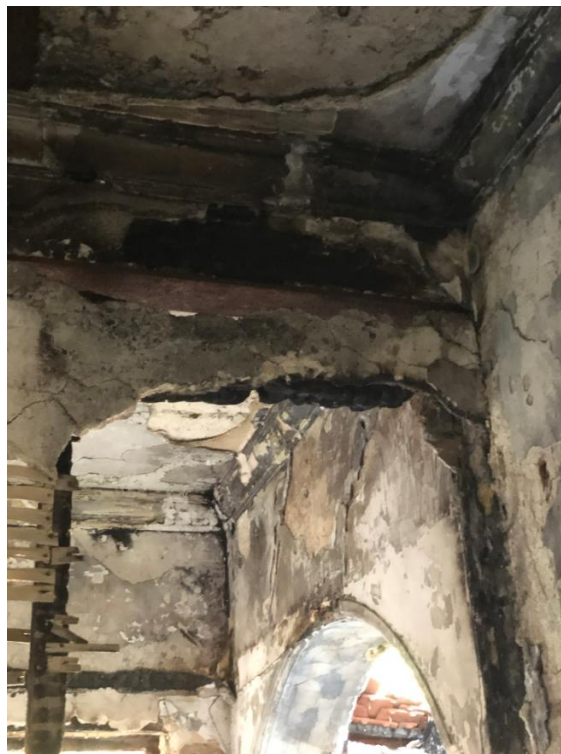
Photo 27 - Steel beam above fire damaged wall of Apartment 10

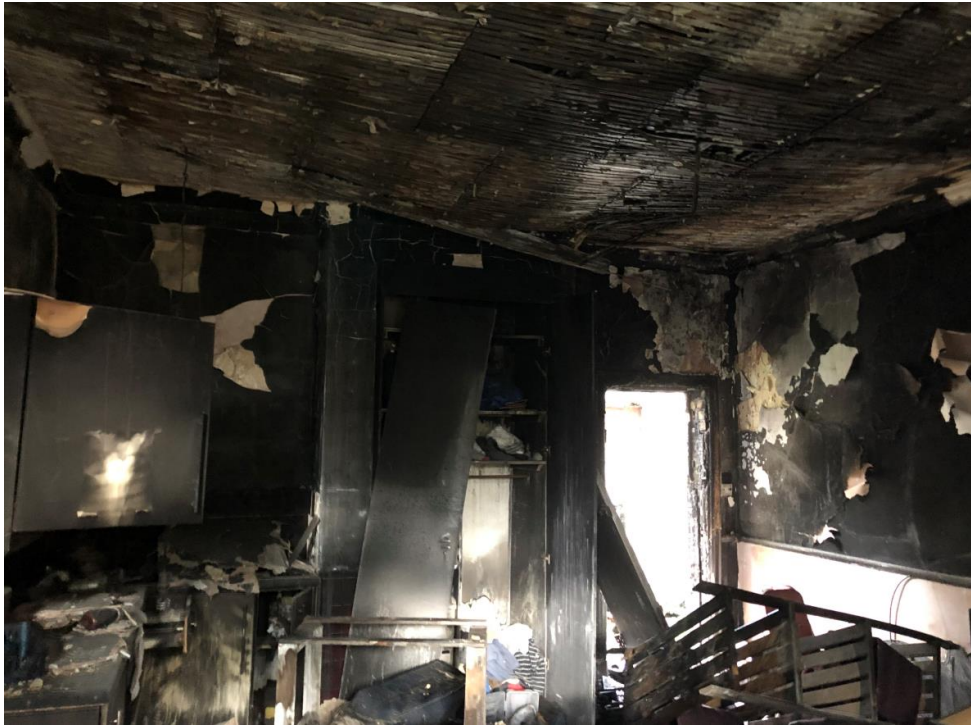
The second floor above apartment 9 is of timber joist construction. The second floor is sagging due to a trimmer joist around the chimney breast becoming disconnected at one end as shown in photographs 28 and 29. This trimmer joist should be propped down to the top of the basement retaining wall using a single Acrow prop at each level with double scaffold board spreader plates above and below the first floor joists.

Photo 28 - sagging trimmer joist at second floor level above Apartment 9

The second floor trimmer joist in apartment 9 should be propped down to the top of the basement retaining wall using a single Acrow prop at each level with double scaffold board spreader plates above and below the first floor joists. Refer to sketch numbers 40420/SK/TW/01 & 02 for details.

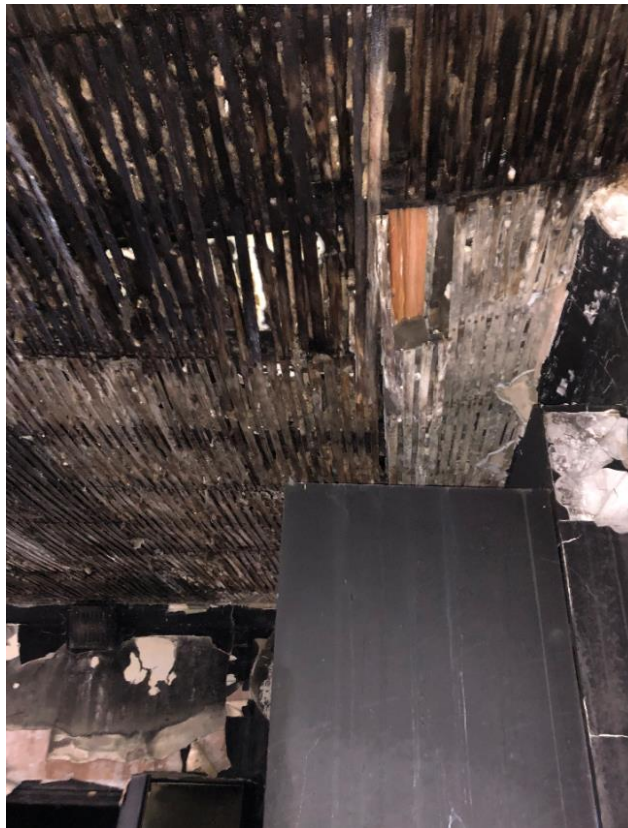
Photo 29 - sagging trimmer joist at second floor level above Apartment 9
