THREATS Tree Report

Vesta Management Ltd.

14 Hampstead Hill Gardens,
Hampstead,
London
NW3 2PL.

08 September 2020

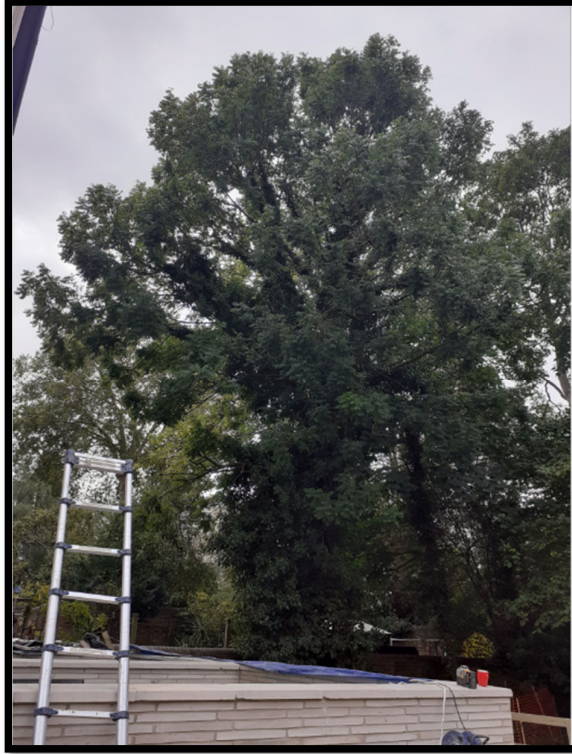
Tree T01, an early mature common ash, has an asymmetrical crown distribution due to proximity of companion trees. Ivy wholly obscures inspection of base, stem and primary branch unions from ground level to apex. The basement construction works are within the notional circular RPA. The basement is being 'renovated' with its the closest edge of the back face (outside) of the retaining wall at 1.98m from the stem, I am told that a staircase out of the old basement climbed to the south boundary wall which has been removed, this included soil; Root morphology in the exposed face suggests this is an accurate description, as exposed root are vertical suggesting the absence of a previous structure/barrier to root development.

Secondary branches have been broken at 5m, 3m from the stem. There is a mechanical bark wound measuring 100x100mm at 0.5m on the west side suggesting vegetation around the base of the tree has been cleared using a machine.

The tree appears to be in good health showing no signs in the crown of significant root damage at this stage, however, it is conceded that any such symptoms may not have manifested yet as the basement construction has been within the current growing season.

Photo1: Tree T01, common ash

It is recommended that the ivy is severed at base of removing a band of 300mm around the circumference of the tree without damaging the underlying bark.

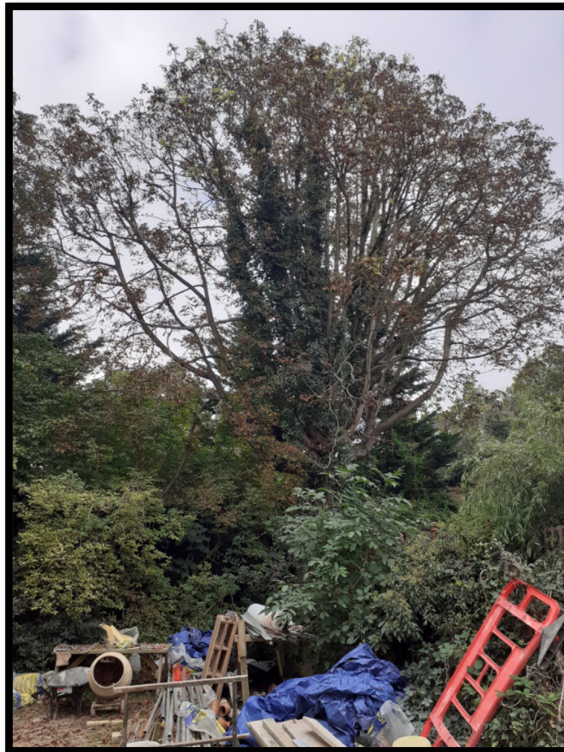
Tree T02, is a mature horse chestnut. Ivy obscures detailed inspection of stem and primary unions. There has been no excavation within the RPA assuming that the basement has not been extended. Materials are, however, stored within the RPA. Leaf minor moth infestation throughout the crown has denuded the tree of 90% of green foliage with most leaves brown and curling or fallen leaving petioles attached to twigs. *Ganoderma applanatum* fruiting bodies are found at the base on south side. Investigation with a nylon sounding hammer returns a thin residual wall of wood to 25% of circumference with a 200mm blunt probe easily pushed into the stem to its full extents 400mm above the lowest bracket and 200mm either side of it; the decay extends below ground.

Photo 2: Tree T02, common horse chestnut

It is recommended that this tree is removed and replaced due to root and stem decay. The planning authority may require further information regarding the extent of the decay using internal decay detection equipment prior to allowing a removal. However, given that the tree has, no doubt, been subjected to years of early defoliation it is safe to assume that its energy reserves have been depleted to such an extent that sever tree surgery to reduce the size of the tree would result in multiple large wounds. This would be likely to allow the decay fungi present to further colonise newly dysfunctional structural elements of the tree perpetuating the issues until such time as it would be ultimately removed. i.e. this would allow for a slight prolonging of the inevitable to such time that the replacement tree, if planted now, would have established.

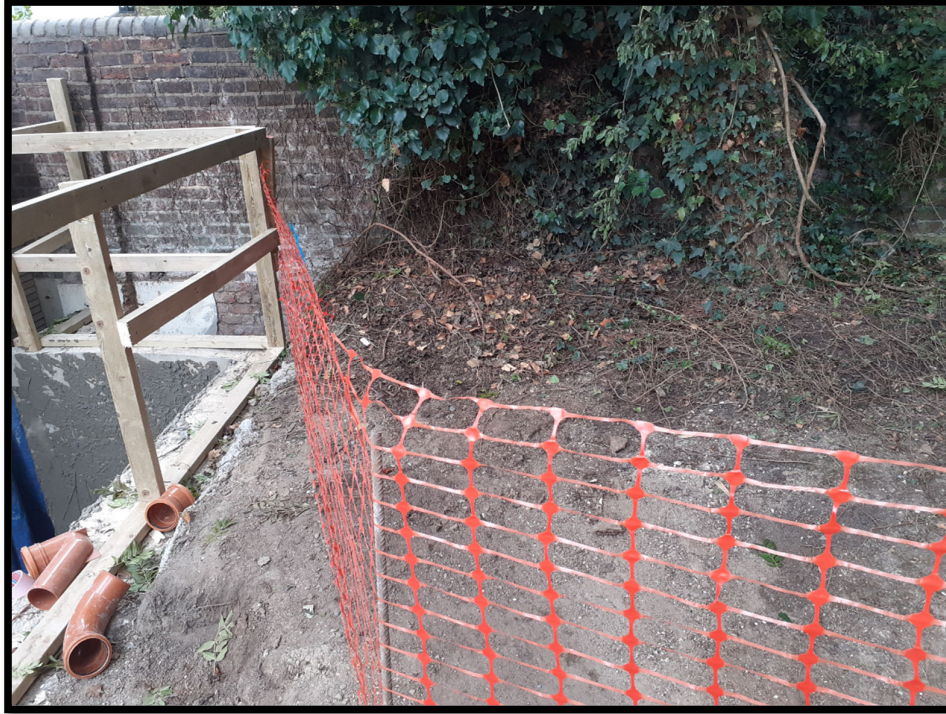
Photo 3: Proximity of basement to tree T01

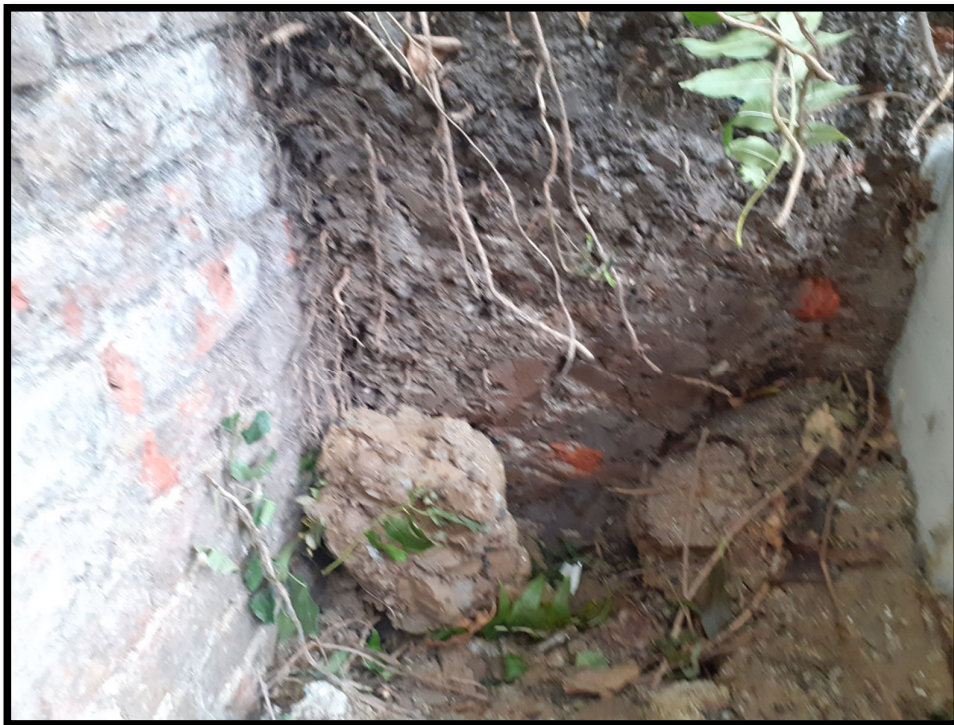
Photo 4: Vertical roots demonstrating removal of previous structure

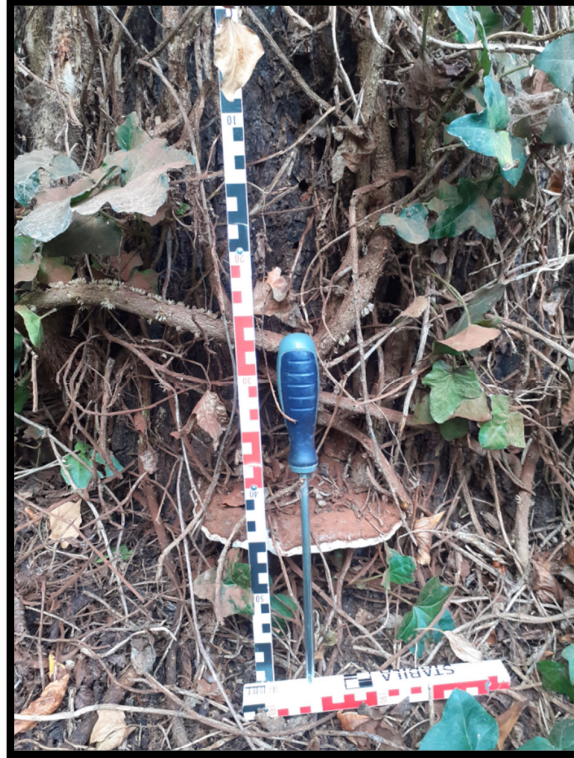
Photo 5: Fungal fruiting body on southern base of tree T02 with probe

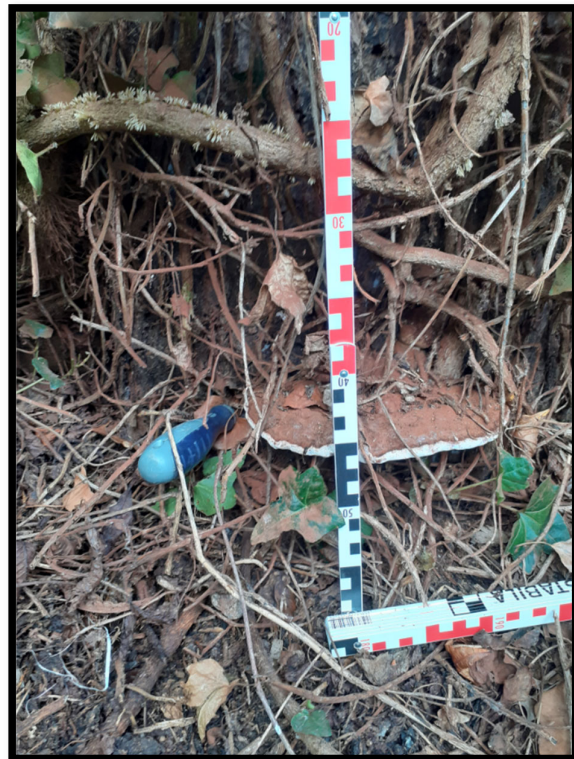
Photo 6: Fungal fruiting body on southern base of tree T02 with probe fully inserted to left.

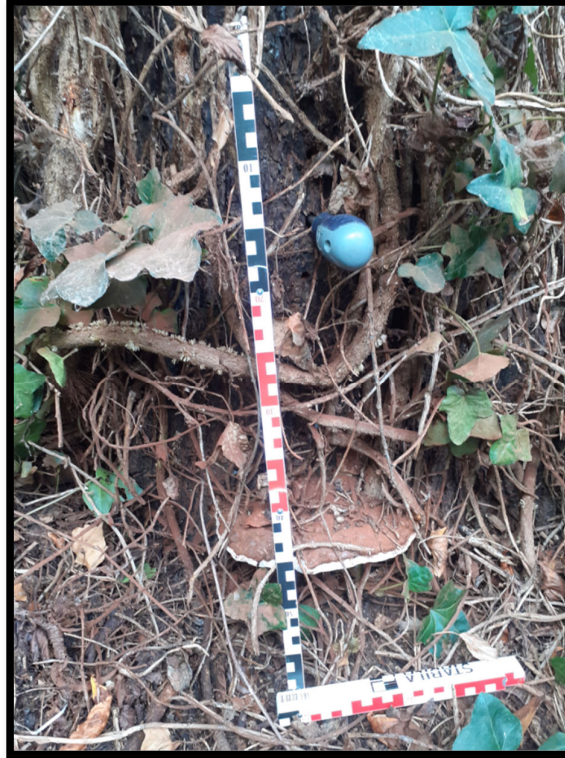
Photo 7 Fungal fruiting body on southern base of tree T02 with probe fully inserted above

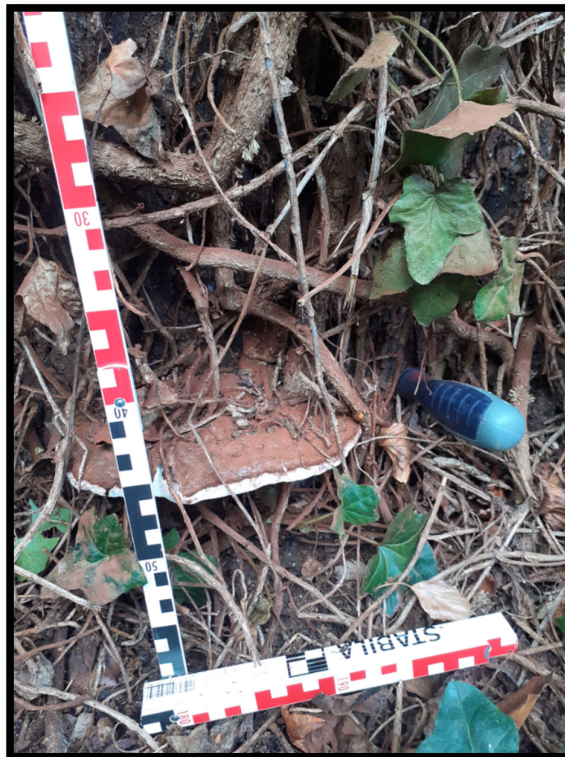
Photo 8: Fungal fruiting body on southern base of tree T02 with probe fully inserted to right.
