COLLETT ~ ZARZYCKI

Investigation works

Job: 55 Cumberland Terrace
Ref: 2001 - D17 - 311 (Investigation works)
Date: 19th October 2020
No. of Pages: 26

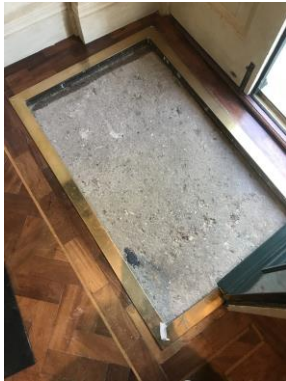
The entrance mat was removed showing a concrete floor construction at the entrance.

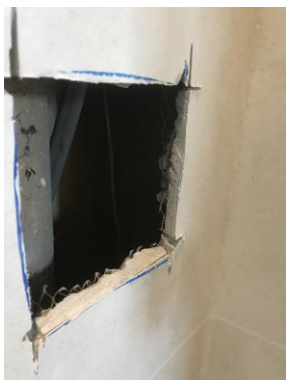
A small opening was made in the duct in the entrance hall. The wall is made of timber battens with EML mesh and plaster. The ducting conceals a rainwater pipe and wiring for the house.

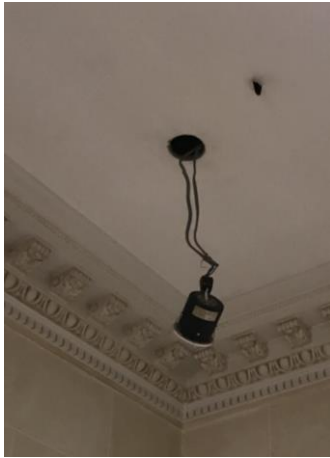
A downlight in the entrance hall was removed to show a non original ceiling construction

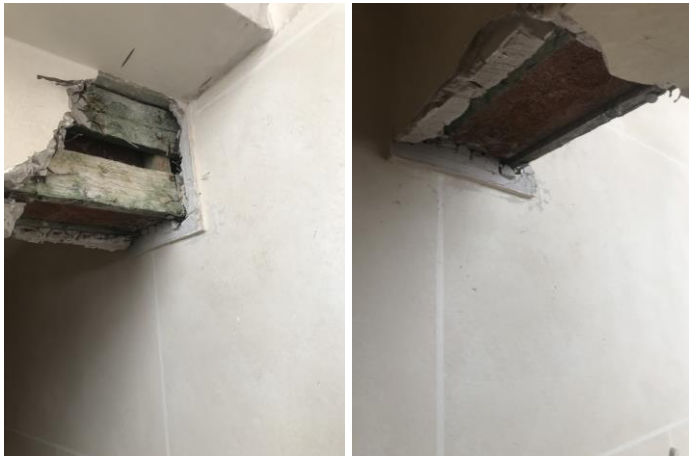
An opening in the staircase landing beam was made for the structural engineer to inspect the structure behind.

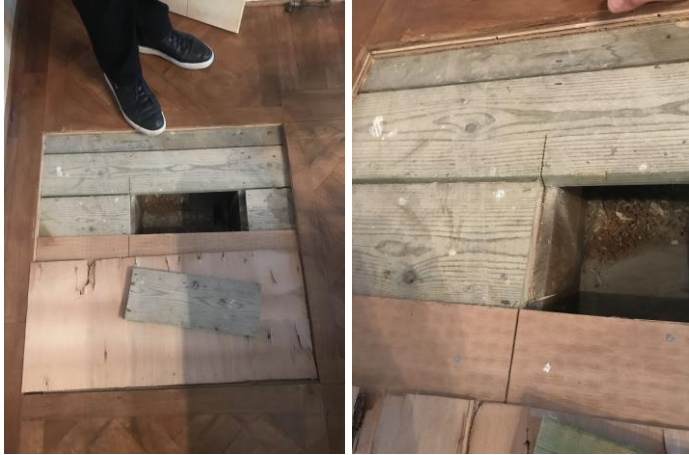
A small portion of floor covering was removed showing 6mm plywood on top of 20mm timber floorboards on existing timber joists. The ceiling underside is a plasterboard ceiling.

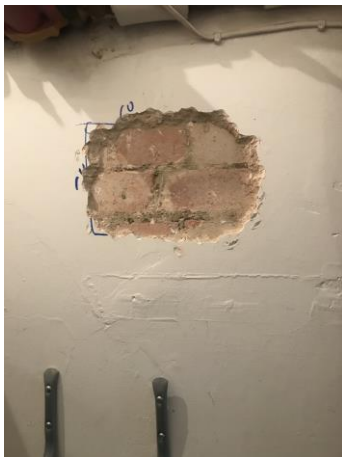
A small opening on the render was made on the spine wall between the dining room and the water storage room exposing a brickwork construction.

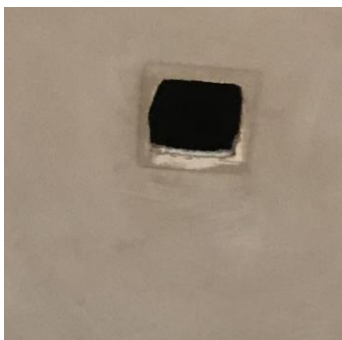
A downlight was removed to reveal that the ceiling is a non original construction.

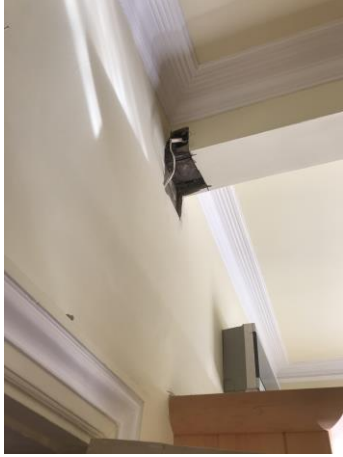
A small portion of the ceiling beam render was removed for the structural engineer to inspect the structure behind.

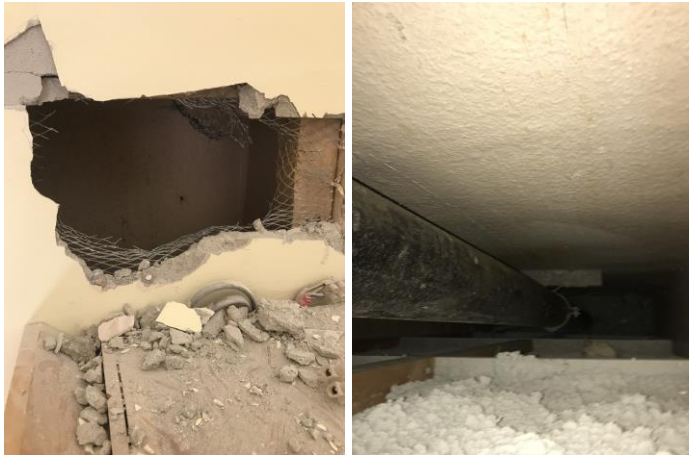
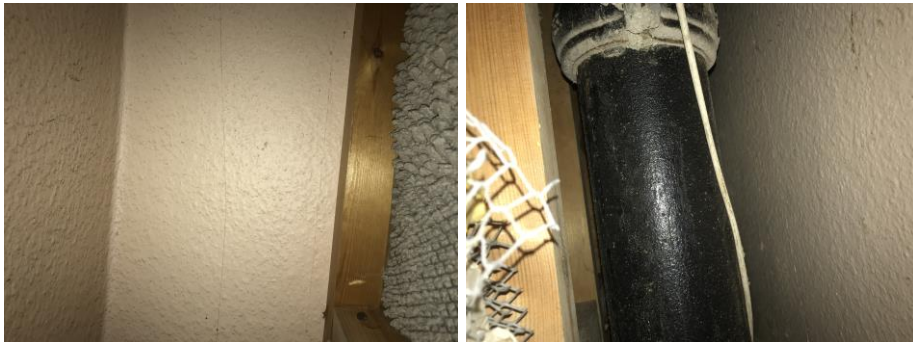
A small opening was made on both sides of the chimney breast party wall. There is a void behind enclosing SVP's and cables for the property. The wall construction is timber studs on EML mesh and plaster.

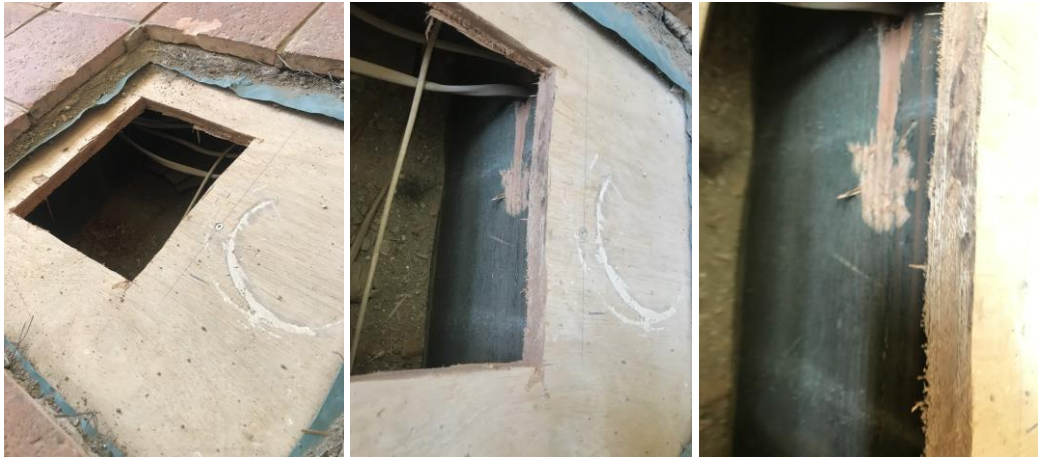
A small portion of the floor covering was removed to show a construction made of plywood on joists and revealing the ceiling on basement as a non original construction.

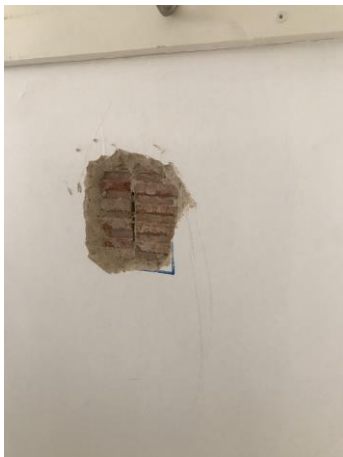
A small portion of the render on the wall between the kitchen and the water storage was removed to show the ceramic blockwork construction behind.

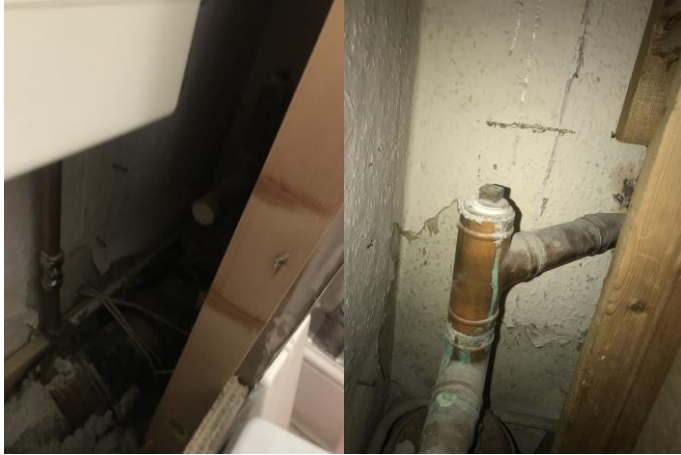
The WC panel was removed to show the void construction made of timber battens and a stub stack connected to the toilet.

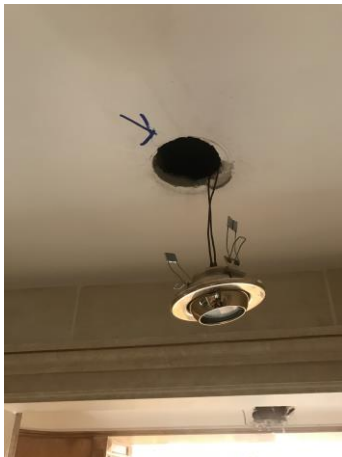
A downlight was removed showing how the ceiling is a non original construction

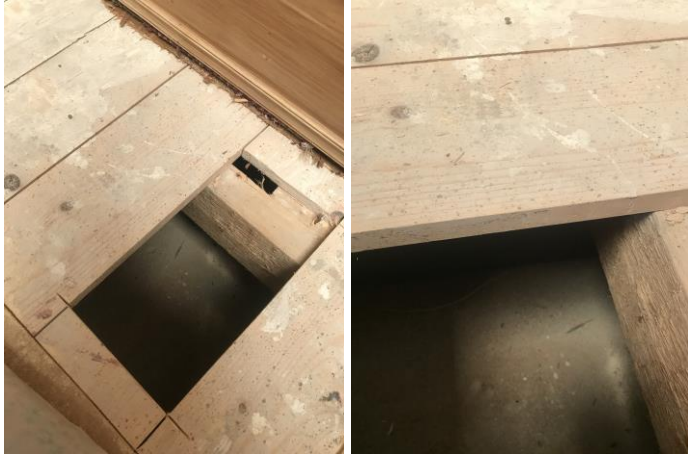
A small portion of the floor covering was removed to show 20mm timber floorboards on timber joists and showing the ceiling of the basement as a non original plasterboard.

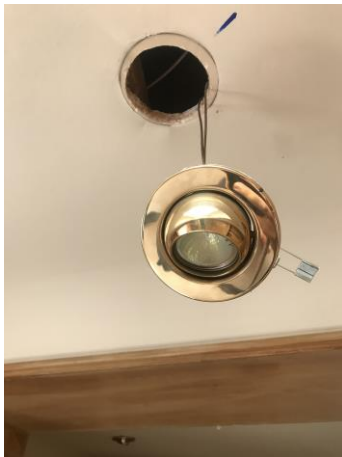
A downlight was removed to show the ceiling in this area as a non original construction.

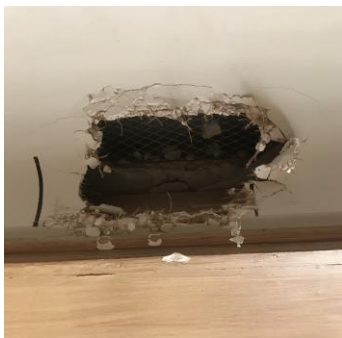
An opening at ceiling level between the Library and the Hallway was made for the structural engineer to inspect the structure behind.

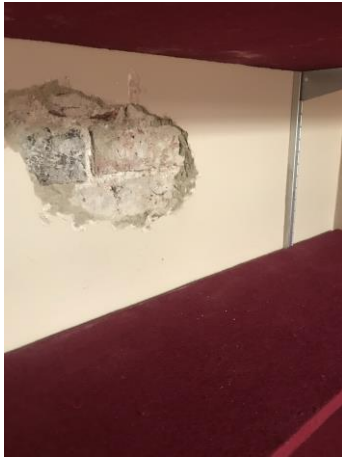
A small portion of the render in the mews wall was removed showing a brickwork construction.

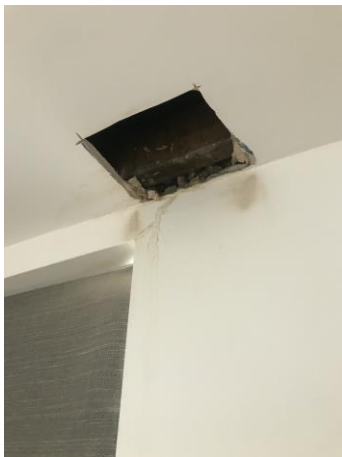
A small portion of the ceiling was removed to show that the ceiling is non original.

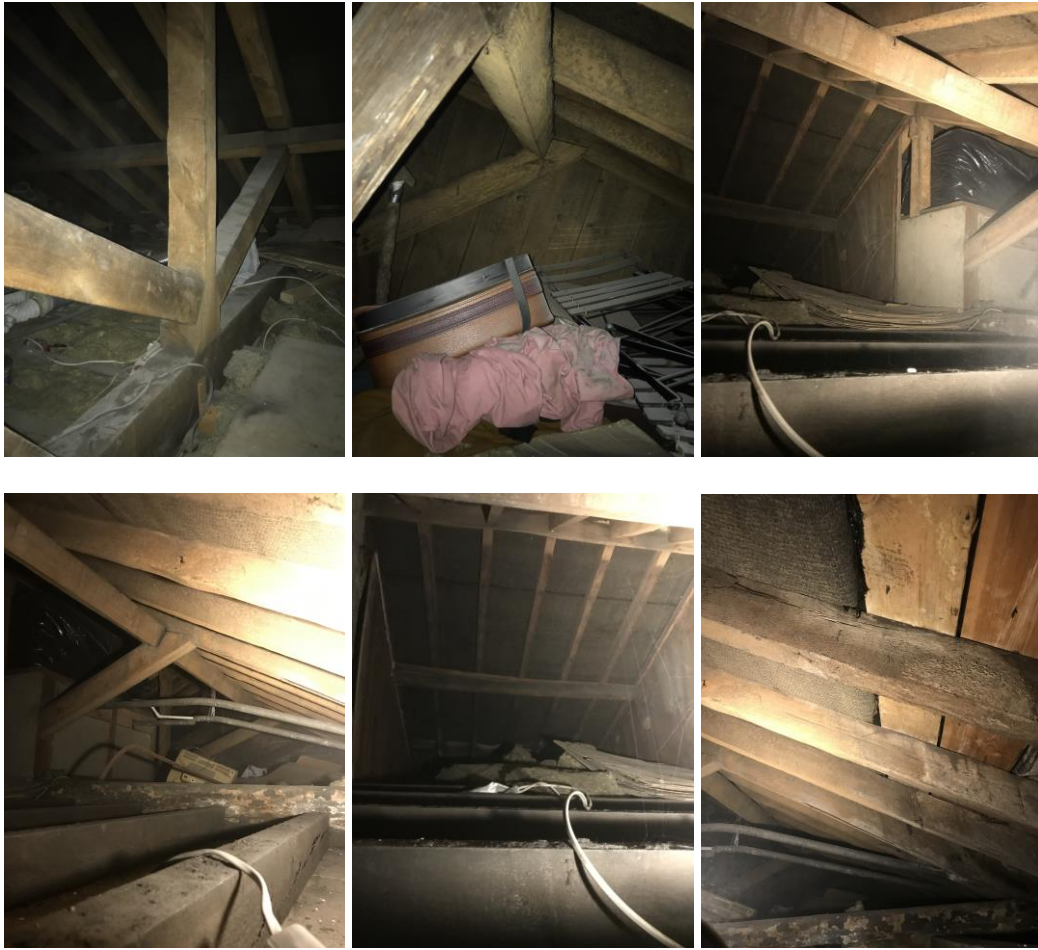
Photos of the loft area were taken showing the timber construction.

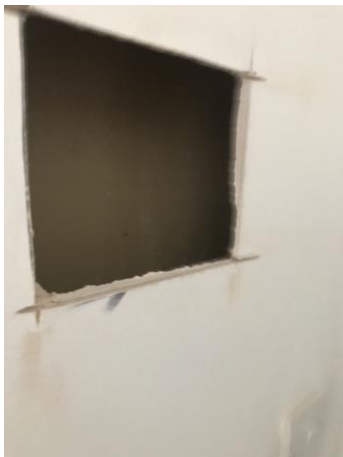
A small opening in the stud partitions walls was made showing a plasterboard construction.

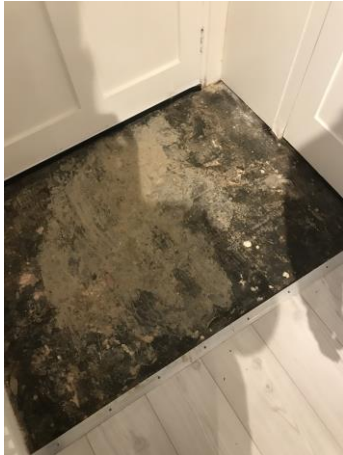
The entrance mat was lifted showing a concrete screed underneath.

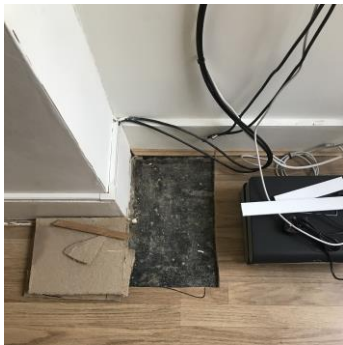
A small portion of the floor covering was removed showing a concrete screed underneath.

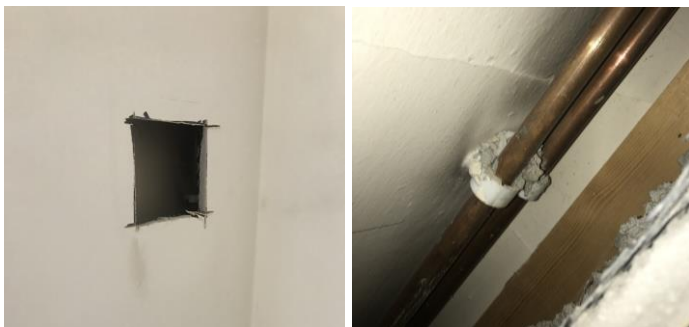
A small portion of the duct in the corner was removed. It conceals water pipes and made of timber battens with an EML mesh and render.

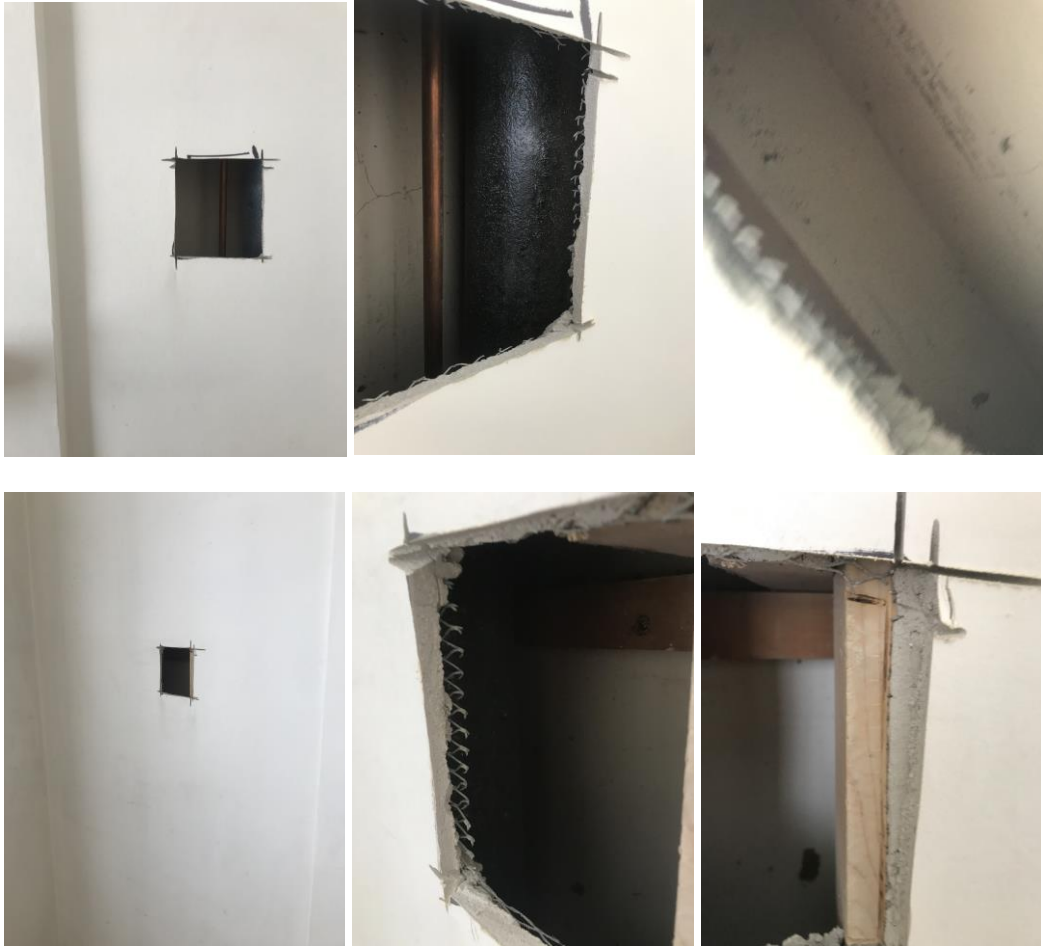
Small opening both sides of the chimney breast were open showing a timber studs with EML mesh and render construction. The void created concealed two SVPs.

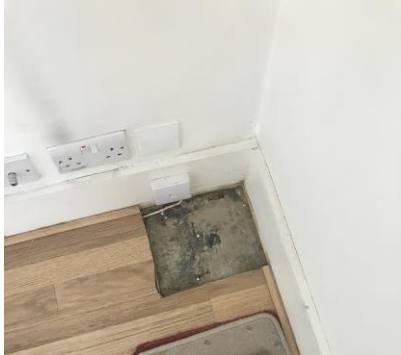
A small portion of the floor has been removed showing a concrete screed below.

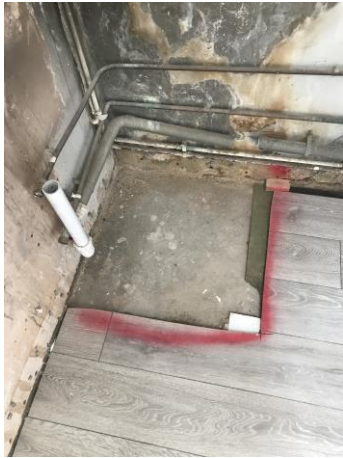
A small portion of the floor has been removed showing a concrete screed below

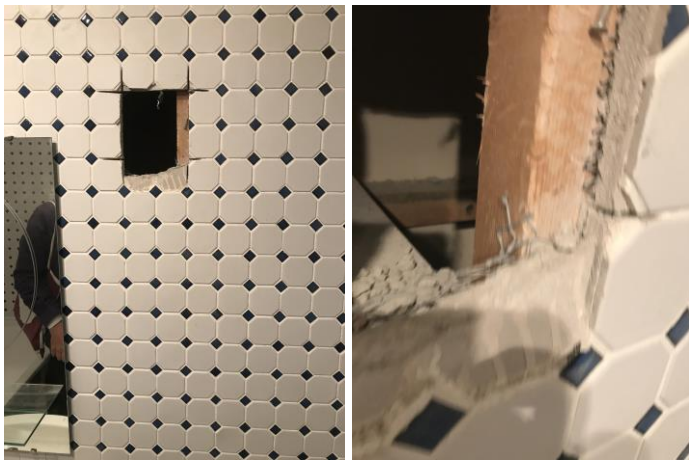
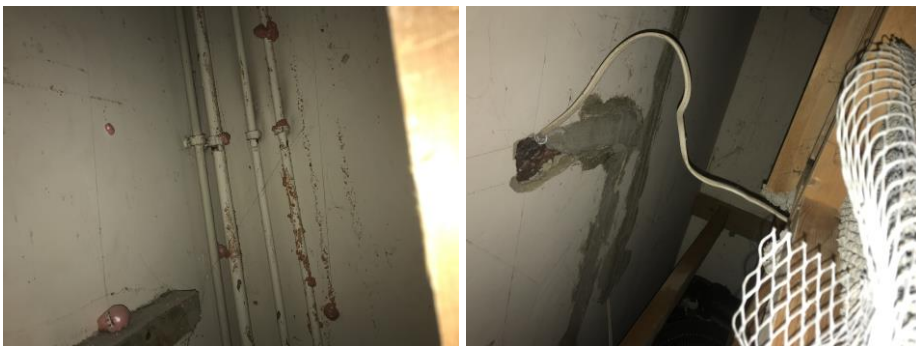
A small portion of the wall coverings was removed showing a timber stud construction with EML mesh and plaster.

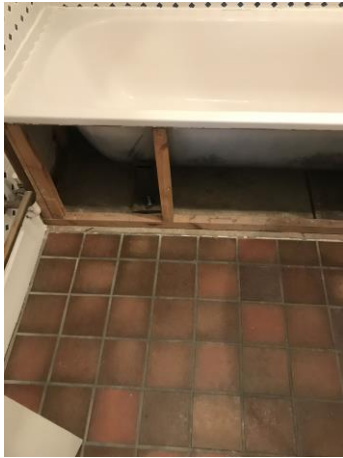
The bath panel was removed to show the concrete screed below

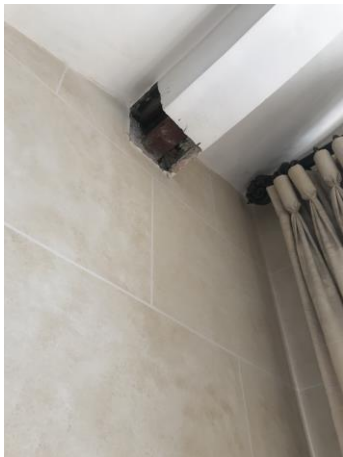
A small portion of the beam supporting the staircase landing was removed for the structural engineer to inspect the structure behind.

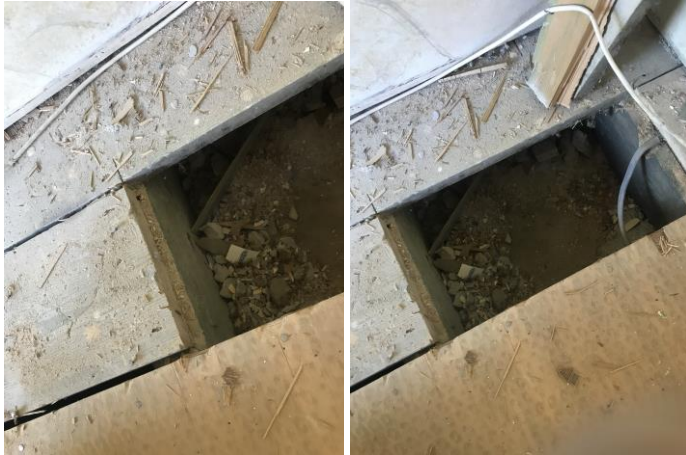
A small portion of the floor coverings were removed showing the floor construction of 6mm plywood over 20mm timber floorboards and timber joists, showing a non original plasterboard ceiling below.

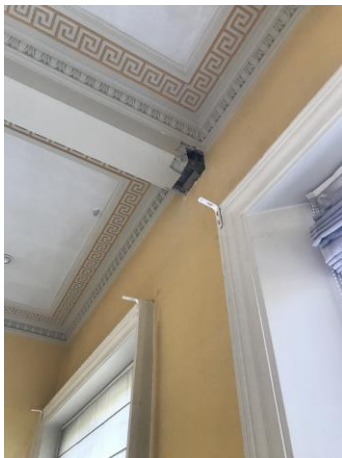
A small portion of the beams casing was removed for the structural engineer to inspect the structure behind.

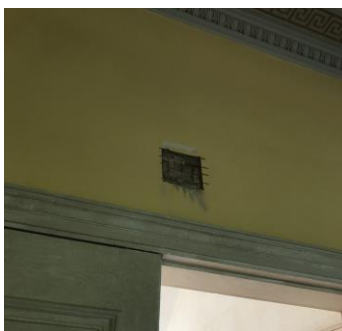
A small portion of the render above the door was removed showing a ceramic blockwork construction.

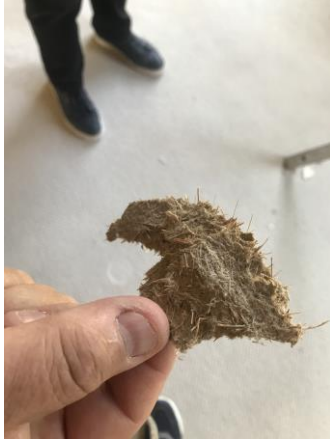
A small portion of the ceiling was removed showing that is not an original sandela board ceiling

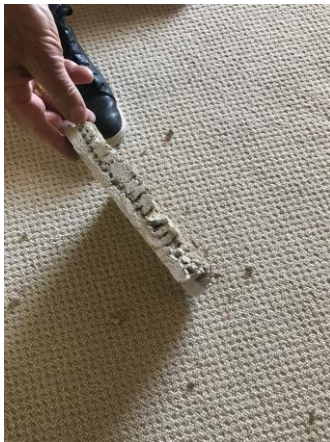
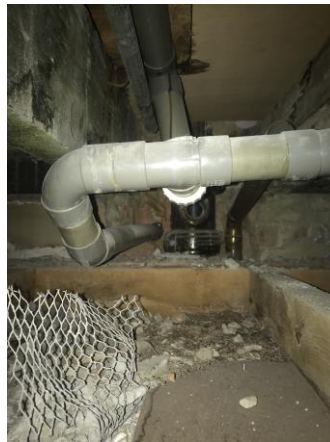
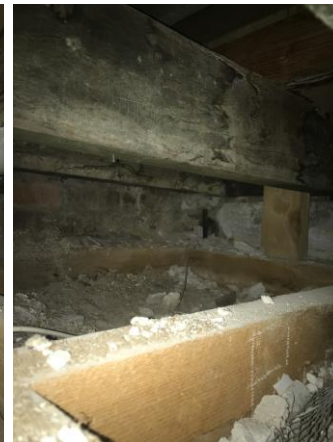
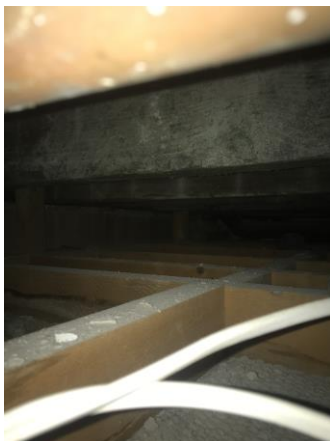
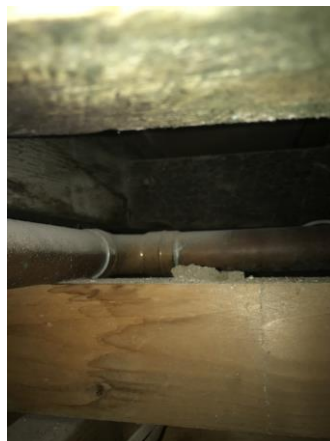
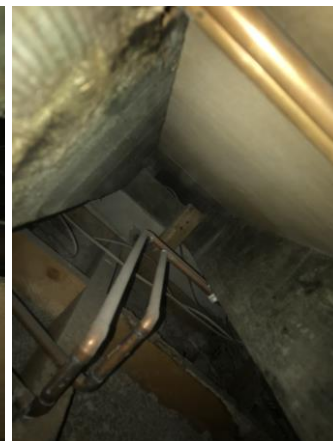
A small portion of the suspended ceiling was removed. The construction of this ceiling of with EML mesh and plaster. Photos of the void between the new ceiling and the joists were taking to show the drainage from the master bathroom above.

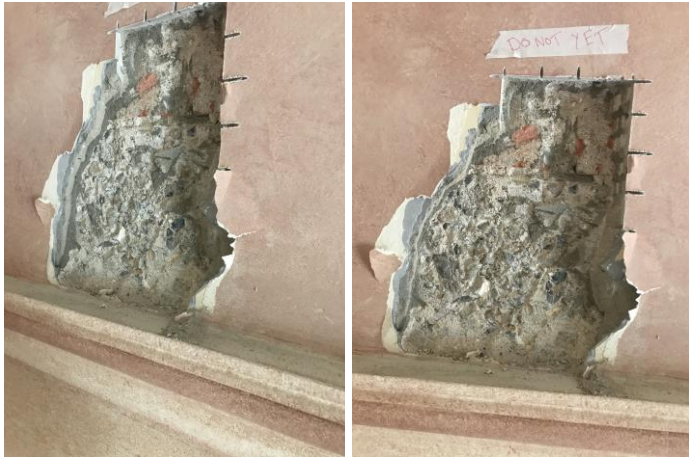
A small portion of the render above the door was removed showing a concrete lintel.

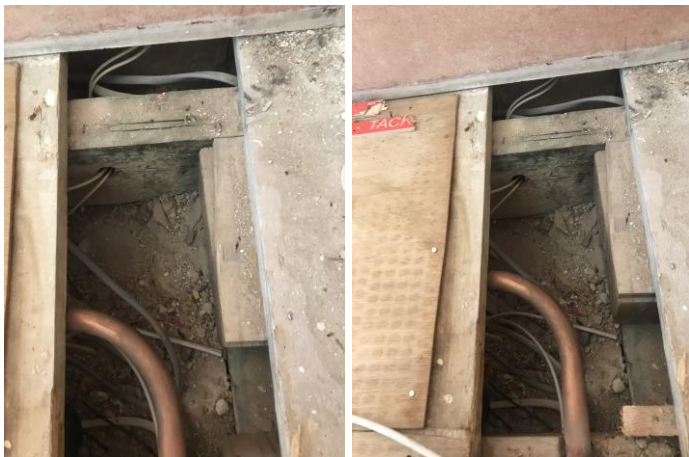
A small portion of the floor covering was removed showing a 6mm plywood over 20mm floorboards on top of timber joists notched for the pipe's runs and a non original plasterboard ceiling below.

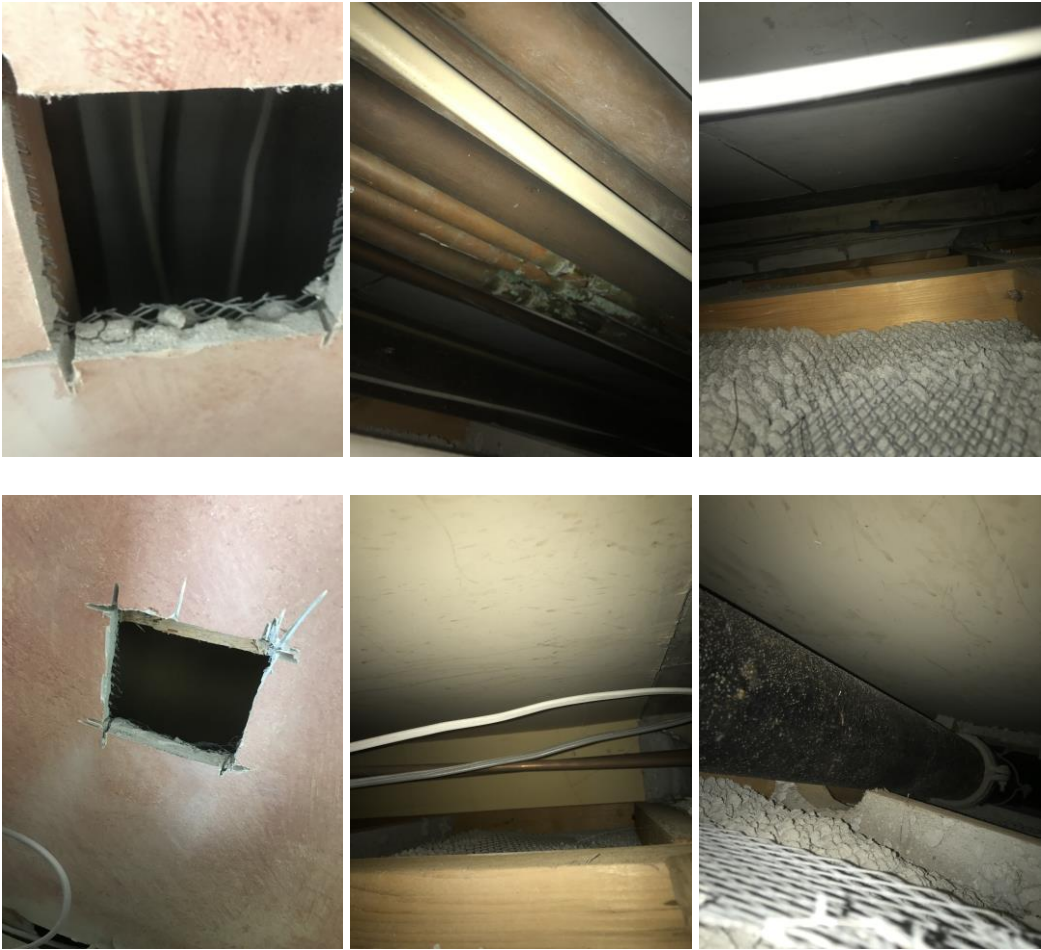
An opening both sides of the chimney breast was made showing a timber stud construction with EML mesh and plaster to concealed service runs for the building.

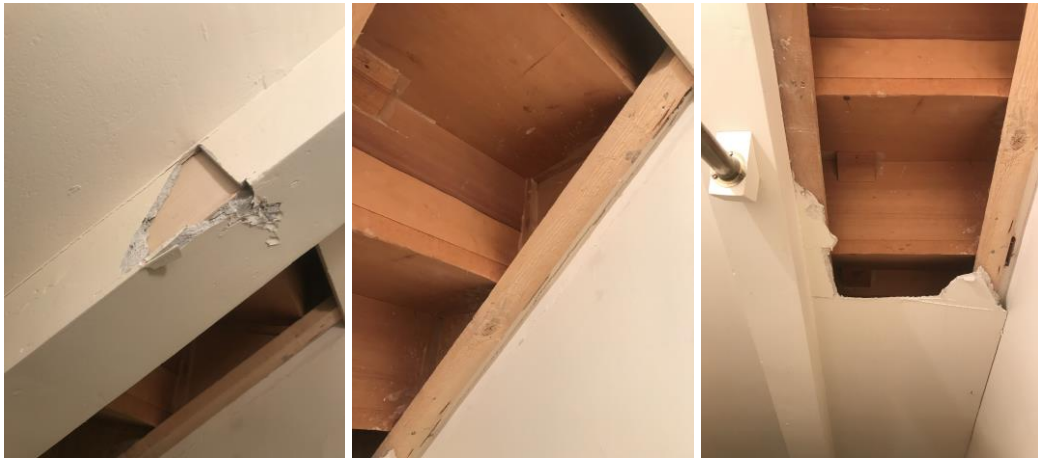
An opening in the soffit of the staircase was made to show the new timber construction of this non historic secondary staircase

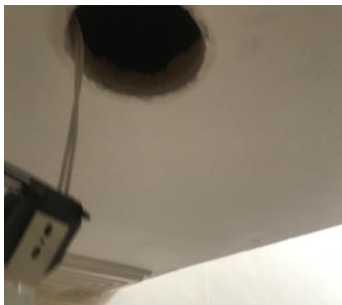
A spotlight was removed showing that the ceiling is non original

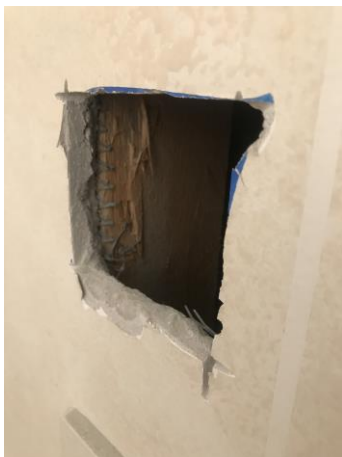
A small opening on the partition with the main staircase was made showing a new construction of timber studs with EML mesh and plaster.

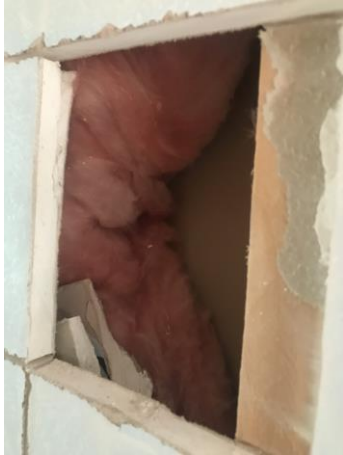
A small opening was made on the internal partitions showing a new timber studs and plasterboard construction.

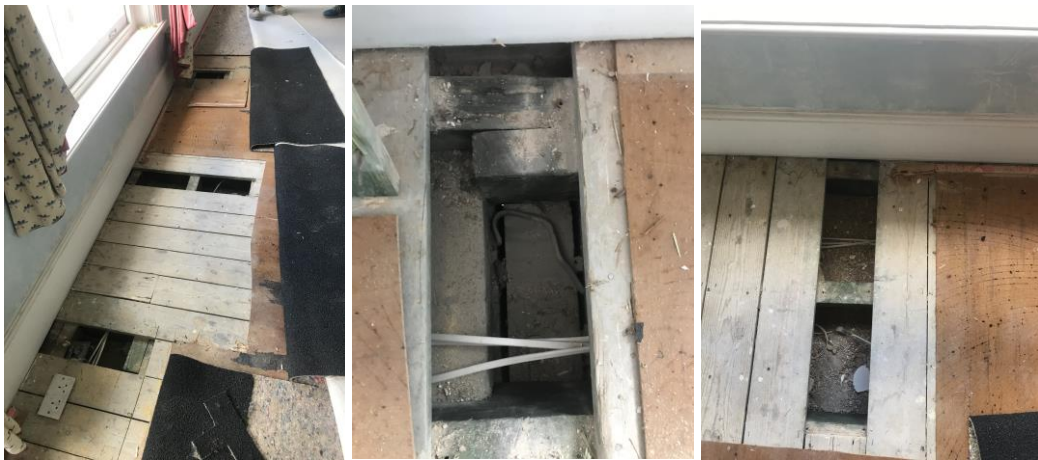
The carpet was lifted up to show a construction of 6mm plywood on top of 20mm floorboards and timber joists of 150mm and revealing a non original Sandela boardceiling below.

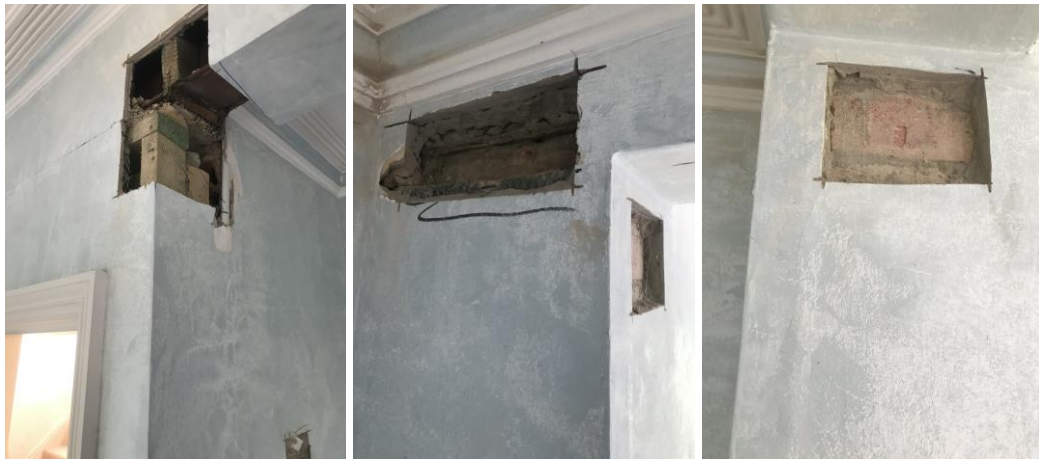
Small opening where made at the connection of the beam with the walls for the structural engineer to inspect the structure behind.

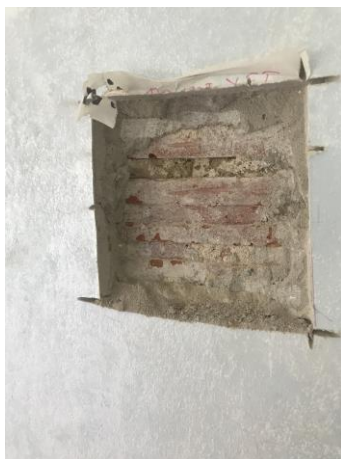
A small portion of the render was removed on the wall separating the bedroom with the hallway showing a ceramic blockwork construction.

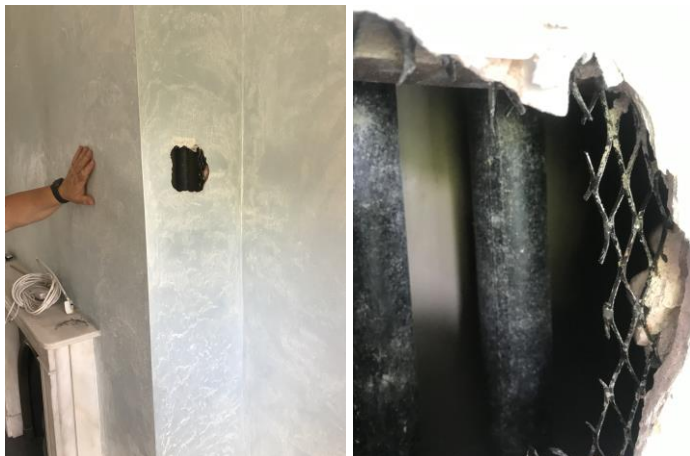
A small opening was made on the side of the chimney breast showing a newly constructed duct concealing pipes.

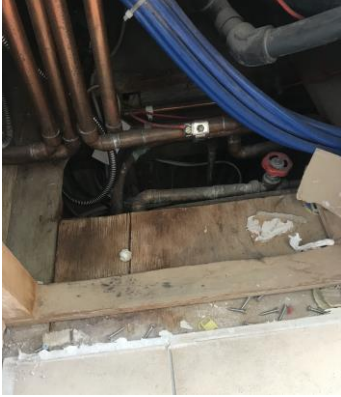
The bath access panel was removed to see the floorboards below.

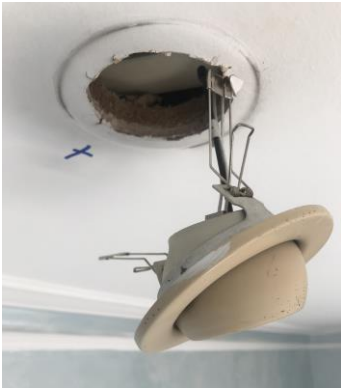
A spotlight was removed showing the non original ceiling construction.

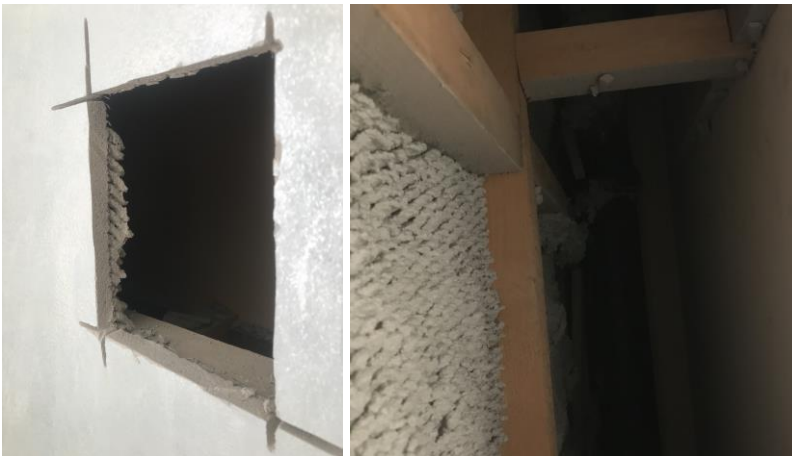
A small opening on the side of the chimney breast was made showing a timber stud construction with EML mesh and plaster

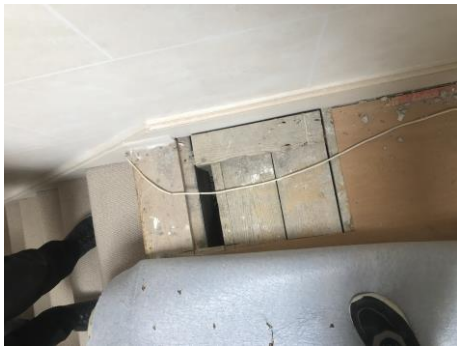
A small portion of the carpet was lifted showing a 6mm plywood over 20mm timber floorboards construction.

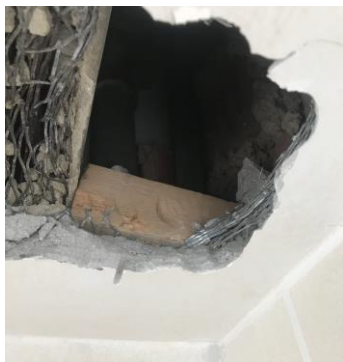
A small opening in the left hand side ceiling bulkhead was made for the structural engineer to inspect the structure behind.

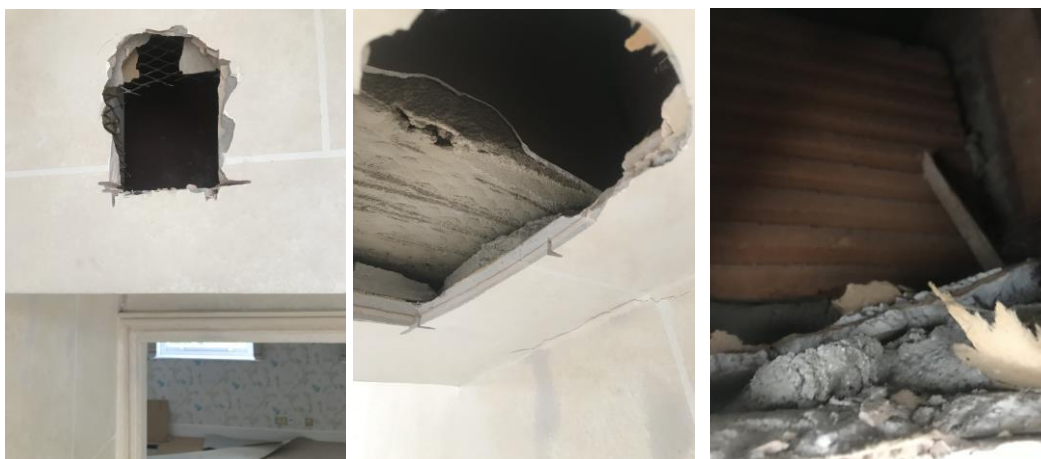
A small opening in the left hand side ceiling bulkhead was made for the structural engineer to inspect the structure behind. It showed also the ceramic blockwork construction of the internal walls on this floor.

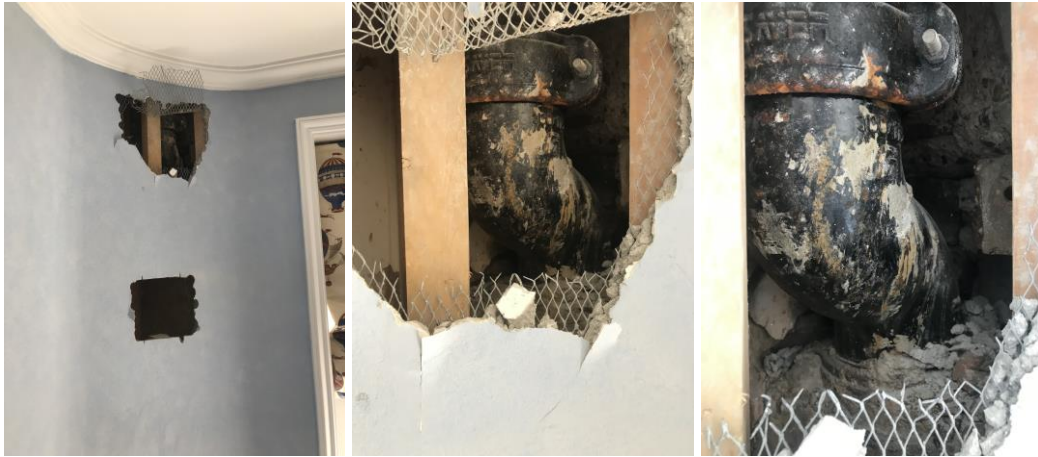
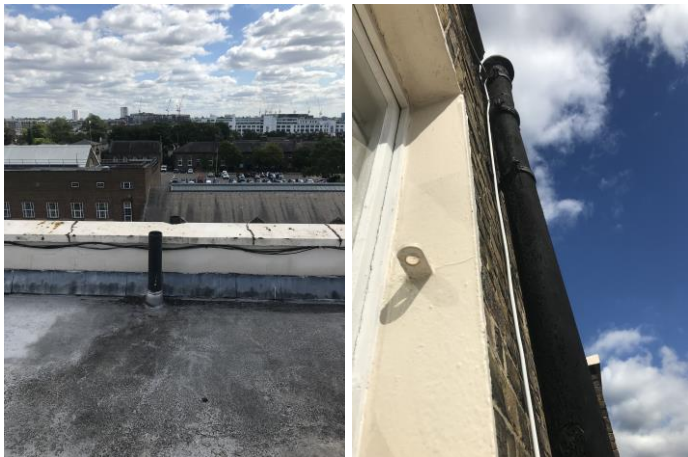
A small part of the curved wall was removed to show the timber studs with EML mesh and plaster construction. It revealed the end of an SVP buried in the rear elevation terminating onto the flat roof above. On the outside of that wall there is also another ventilation pipe coming from the courtyard level.

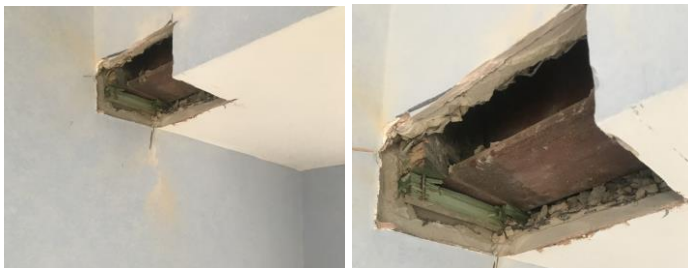
A small opening in ceiling bulkhead was made for the structural engineer to inspect the structure behind.

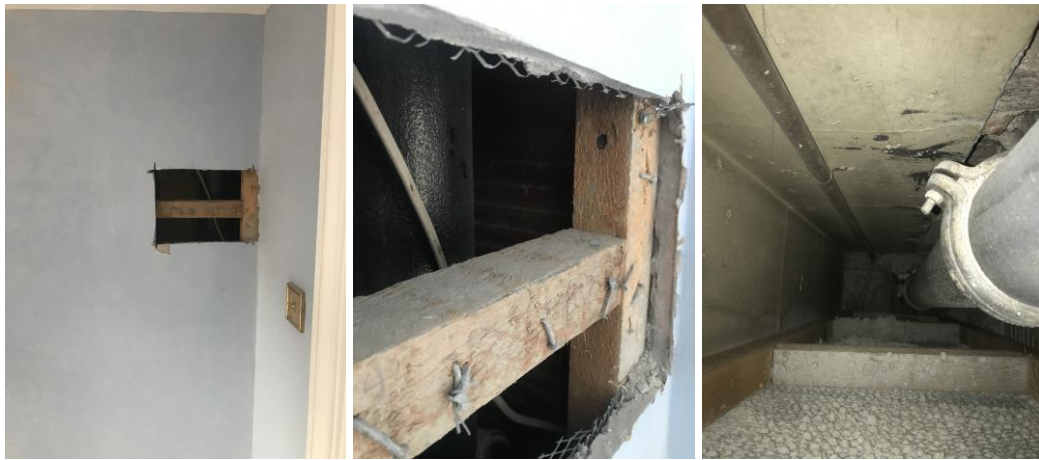
A small opening was made on the party wall to show the timber stud with EML mesh and plaster construction concealing the building service runs.

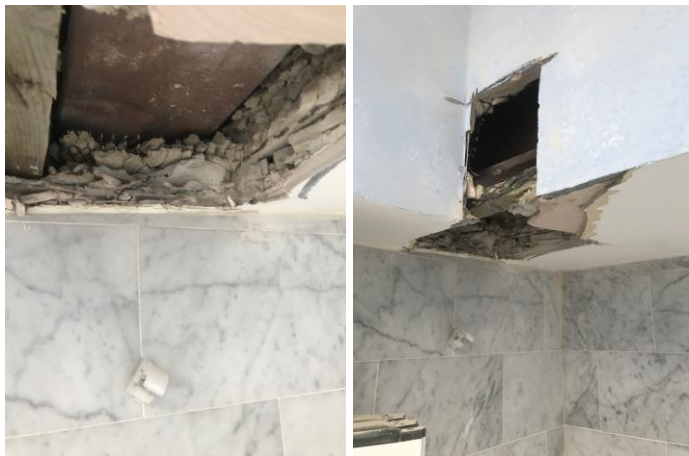
A small portion of the plaster panel from existing bulkhead was removed for the structural engineer to inspect the structure behind.

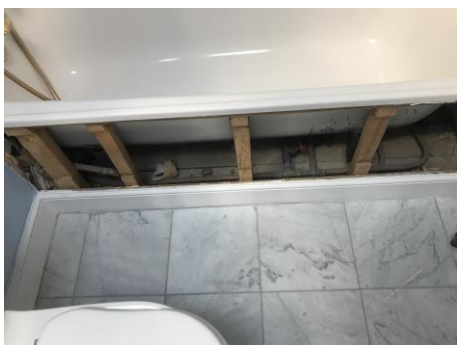
The bath panel was removed showing the timber construction below.

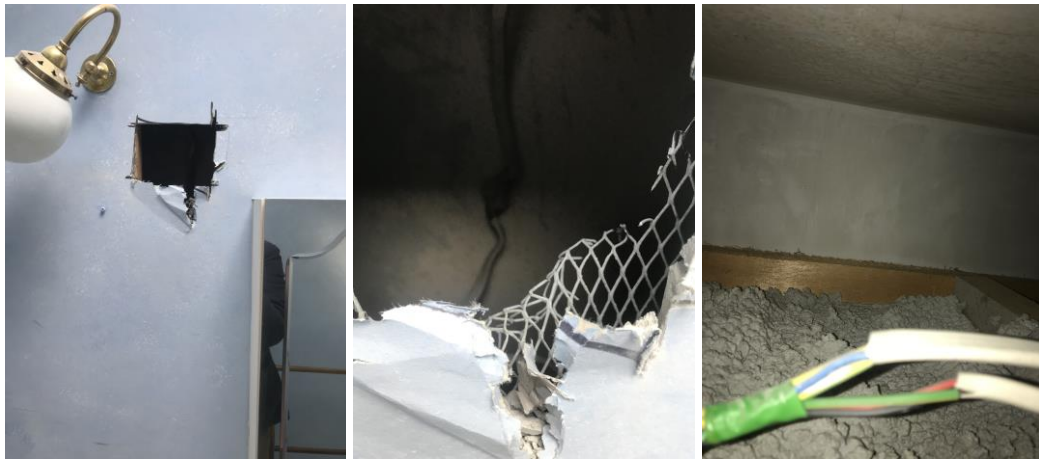
A small opening was made on the party wall to show the timber stud with EML mesh and plaster construction concealing the building service runs

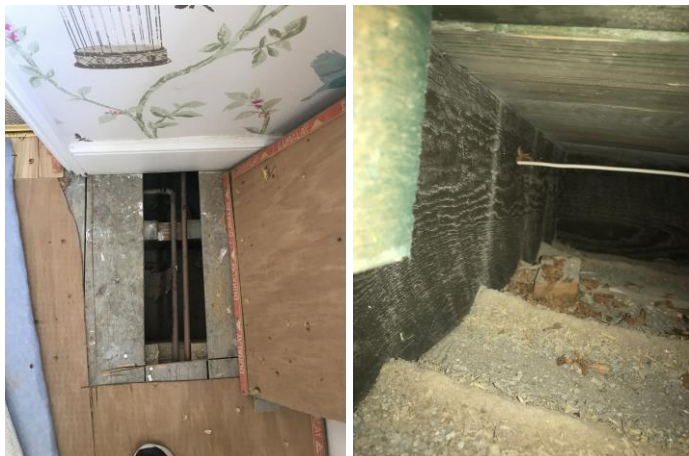
Part of the carpet was lifted showing a 6mm plywood over 20mm floorboards on top of timber joists with a non original ceiling below.

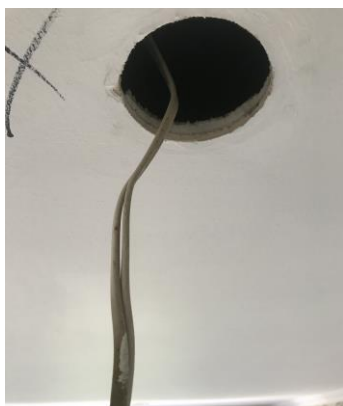
A spotlight was removed showing a non original ceiling construction

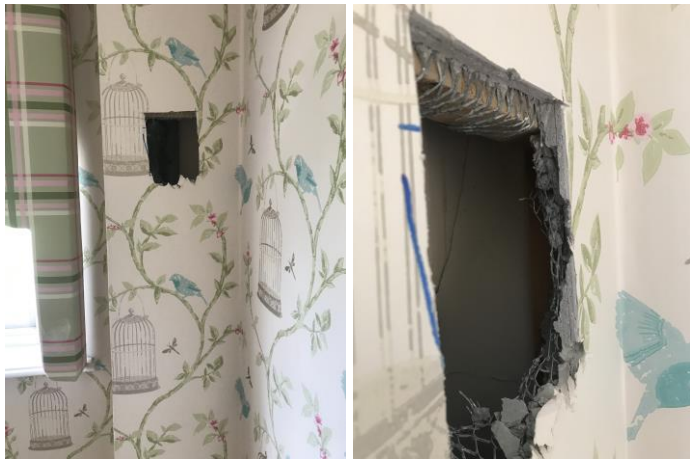
A small section of the duct in corner of the front elevation was removed showing timber stud with EML mesh and plaster construction.

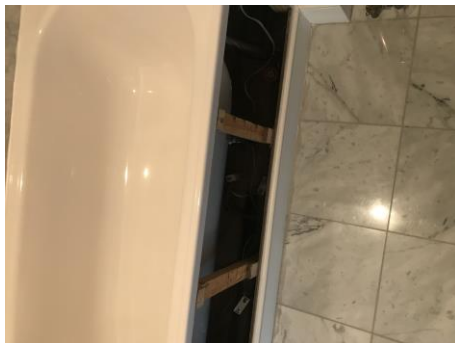
The bath panel was removed showing the timber construction below.

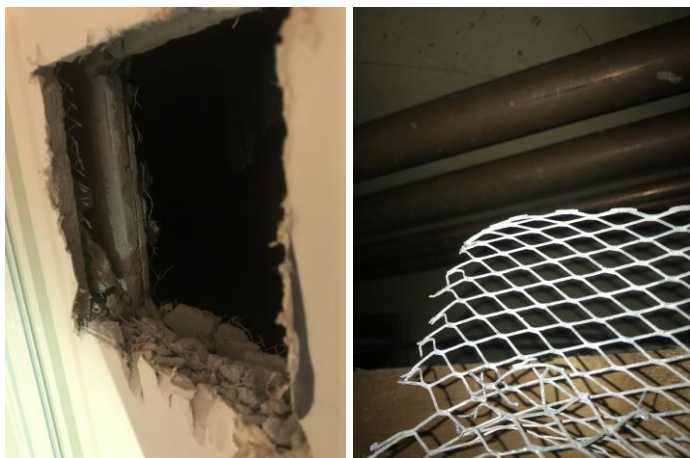
A small portion of wall coverings in party wall was removed to show the void behind with service runs and a EML mesh with plaster construction.
