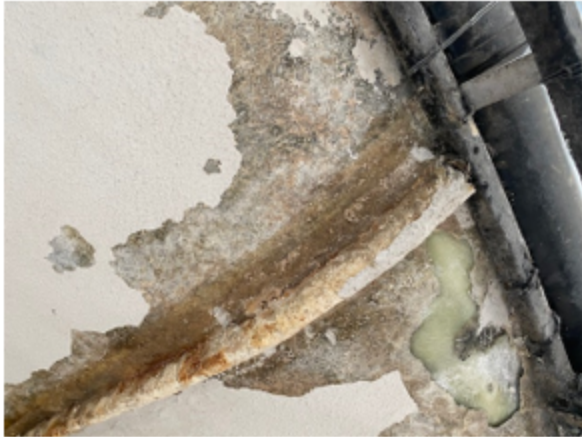
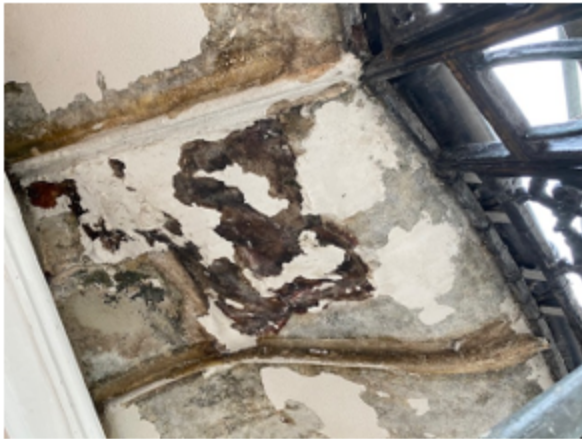
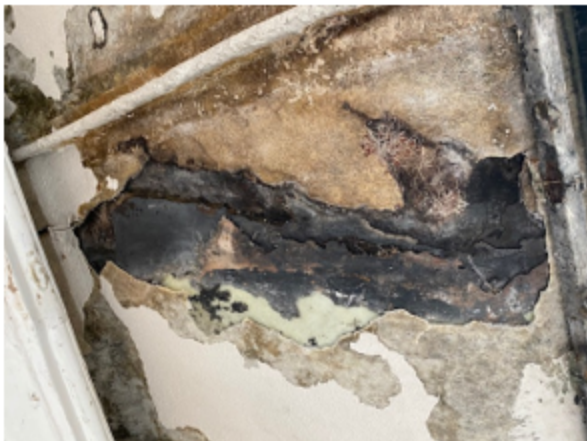
Close ups showing degradation of existing fibreglass canopy:
