Tree Assessment Report

HAVERSTOCK HILL

TREE CONSTRAINTS ASSESSMENT

Project Name and Address
5-17 Haverstock Hill
LB Camden

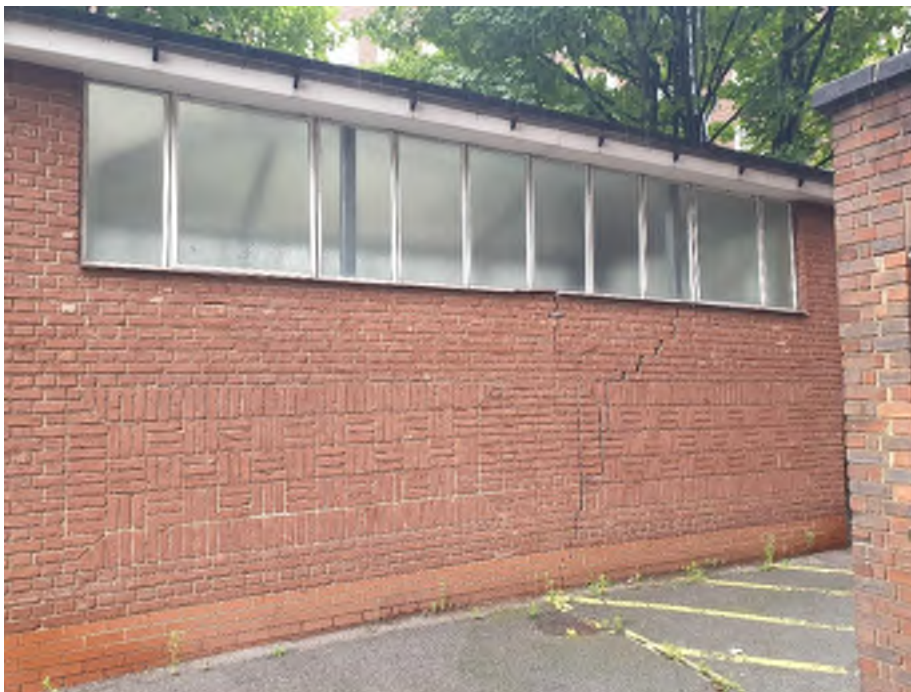
As shown on the Tree Constraints Plan at Appendix 2.0, the majority of trees included in the survey are located just beyond the western perimeter retaining wall and single story garage building, which are both now forming large cracks presumably as a result of tree root growth pressure from the surveyed trees in these locations. The largest area of damage was shown to be adjacent to T8, (Figures 1 and 2) which is very close to both structures.

Fig. 1 Damage to the retaining wall

Based on previous trial dig excavations, the foundation depth of the retaining wall is considered to be around 800 mm, and whilst with roots were shown to penetration the site at this depth, the presence of the wall, garage building and the existing hard standing access road in this location, will have significantly impeded root spread onto the site.

Whilst access to the west of the retaining wall was not possible during the survey (due to third party land ownership behind locked gates and fencing), there was shown to be a level difference between the two sides, with the site side being significantly lower. This then going some way to explain why the wall and garage on the site side have been damaged. Although it should be noted that there may be additional reasons for this damage that are not considered within the remit of this report.

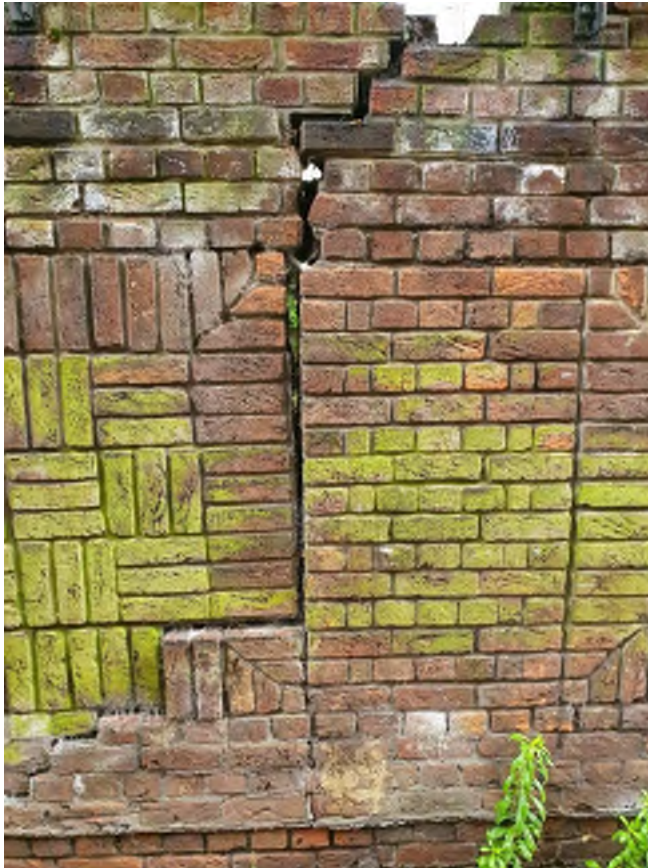
Fig. 2 Damage to the garage structure

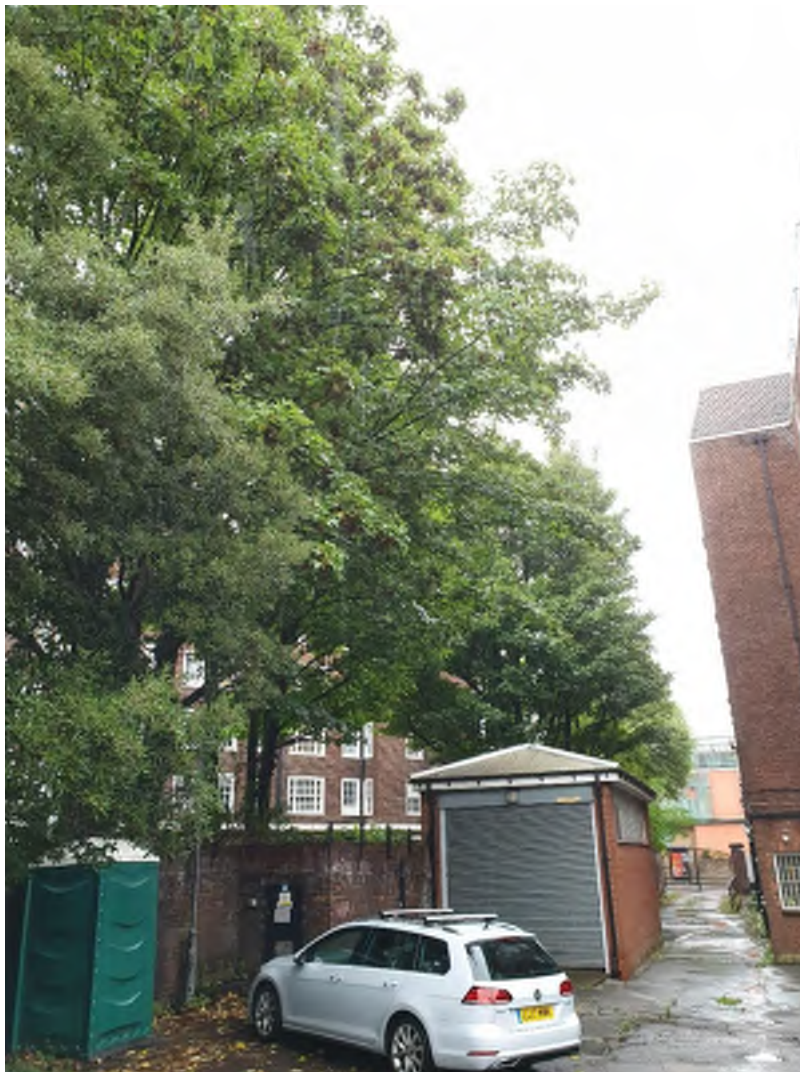
Other than potential onsite root spread and associated structural damage (as described above), the other significant constraint to the development of the site is from the notable overhang from a number of the trees in this location (Figure 3). Whilst clear of the existing building, they are shown to be overhanging the site by several meters and in some locations as low as two meters from the site ground level (Figure 4). Many of these trees though show a history of crown pruning and height reduction work, so lend themselves well to future pruning that would provide much improved site

Fig. 3 Off site tree overhang

clearance in line with arboricultural best practice, as set out within BS3998: Tree Work Recommendations.

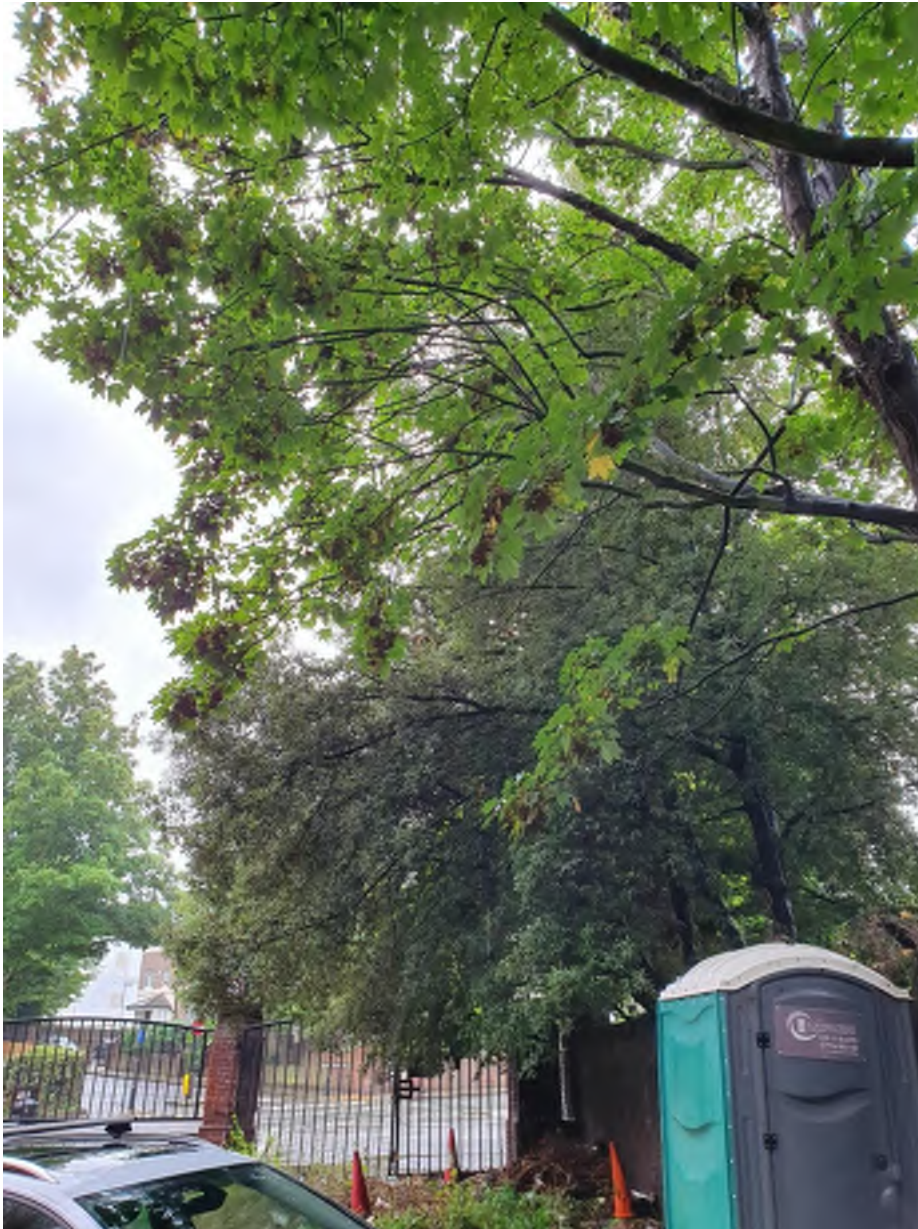
Fig. 4 Onsite low overhang from off site trees
