Haverstock Place. BS5837 Tree Survey & Arboricultural Impact Assessment

Issue/Revision:	Draft V1	Final V2
Date:	October 2020	October 2020
Comments:		
Prepared by:	James Rawlinson	James Rawlinson
Signature:

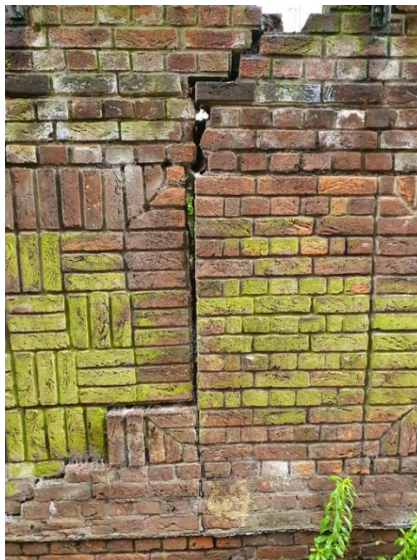
- 4.3 As shown on the Tree Constraints Plan at Appendix 2.0, the majority of trees included in the survey are located just beyond the western perimeter retaining wall and single story garage building, which are both now forming large cracks presumably as a result of tree root growth pressure from the surveyed trees in these locations. The largest area of damage was shown to be adjacent to T8, (Figures 4.1 and 4.2) which is very close to both structures.

Figures 4.1 Damage to the retaining wall

- 4.4 Based on previous trial dig excavations, the foundation depth of the retaining wall is considered to be around 800 mm, and whilst roots were shown to penetrate the site at this depth, the present of the wall, garage building and the existing hard standing access road in this location will have significantly impeded root spread onto the site.

- 5.11 As noted within Section 4, the existing perimeter retaining wall to the west of the site shows cracking due to movement that has largely resulted from tree growth in these isolated locations. Whilst plans are still to be drawn up on the future proposals for the wall in line with ownership and liabilities, the constraints on any such works with respect to the existing trees is largely understood.

- 5.12 Specifically, the design team for the development understand that any future works or reconstruction of this wall would need to factor in the current root structures as well as that anticipated from future growth. With this in mind it is considered that any future build and design work for the wall would need to construct around significant existing roots via piling and/or bridging (for example) to both eliminate the current constraints as well as to allow space within the structure for future root growth.

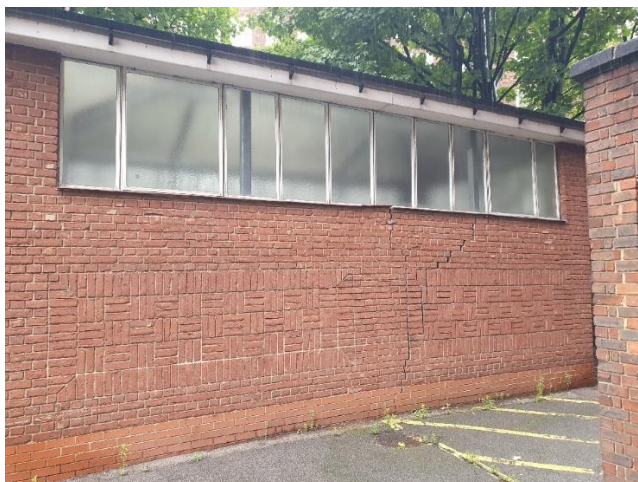
Figures 4.2 Damage to the garage structure

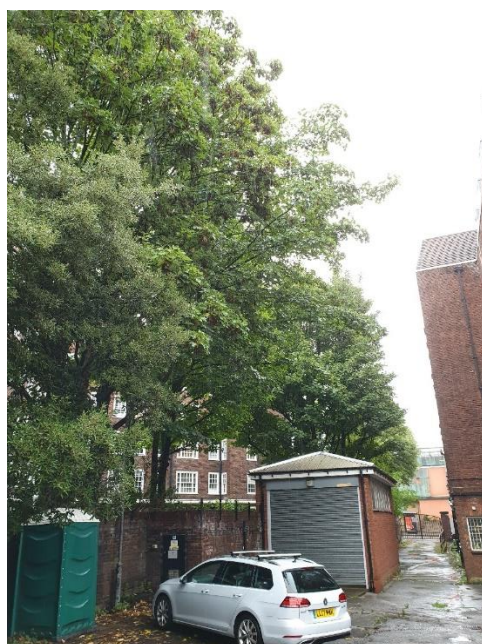
- 4.6 Other than potential onsite root spread and associated structural damage (as described above), the other significant constraint to the development of the site is from the notable overhang from a number of the trees in this location (Figure 4.3).

Figure 4.3 Off site tree overhang

- 4.7 Whilst clear of the existing building, the trees are shown to be overhanging the site by several meters and in some locations the crowns are as low as two meters from the site ground level (Figure 4.4). Many of these trees though show a history of crown pruning and hight reduction work, so lend themselves well to future pruning that would provide much improved site clearance in line with arboricultural best practice as set out within *BS3998: Tree Work Recommendations*.
- 4.8 The final trees included within the survey are two newly planted hornbeams within the pavement area of Haverstock Hill and an early mature false acacia which is already showing heavy phototropic growth away from the existing building, meaning any pruning work here to allow for scaffolding and construction space would be minimal.

- 5.4 At the time of writing this report the overhang (as shown in Figure 4.3) shows sufficient construction and scaffold space, therefore the need for pruning is likely to be avoided. It should though be noted that depending on when any site development takes place further growth of these crowns may well necessitate minor crown pruning.

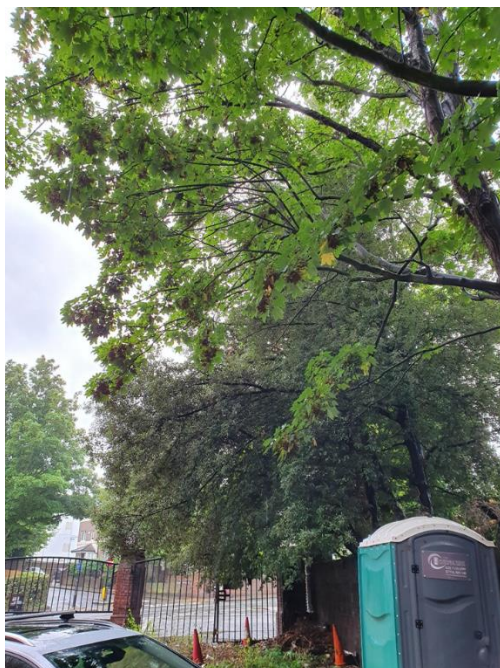
Figure 4.4 Onsite low overhang from off-site trees

- 5.5 The low overhang as shown in Figure 4.4 will though require a moderate crown rise to allow for general construction space and to avoid damage to the tree crowns.
