Rennie House
Torriano Mews
LONDON
NW5 2RZ

INSURANCE CLAIM

CONCERNING SUSPECTED SUBSIDENCE

ENGINEERING APPRAISAL REPORT

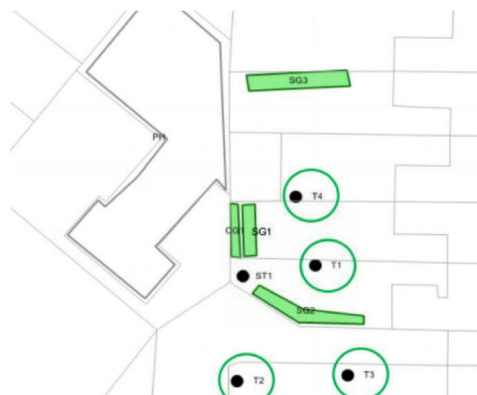
We considered the damage would not progress if appropriate measures are taken to remove the cause. In this instance it was likely that vegetation for which the policyholder and third party are responsible is contributing toward the cause of damage. We appointed Oriel Mitigation to arrange for an arborist report to be prepared in order to identify the vegetation that is required to be removed. The arborist report subsequently recommended that:

2 Recommended vegetation management to address the current subsidence:

| Tree No: | Species | Works Required |
|---|---|---|
| ST1 | Lime | Ensure stump is adequately treated |
| T2 | Poplar | Fell and eco plug stump |
