Site Investigation Report

Job Information	
Client	Sedgwick
Client ref	[Redacted]
Visit date	15/10/2019
Report date	15/10/2019

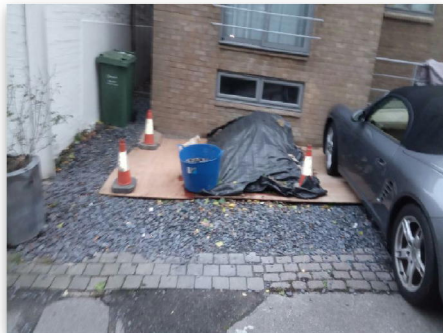
Fig 1.1: Trial Hole 1 Location

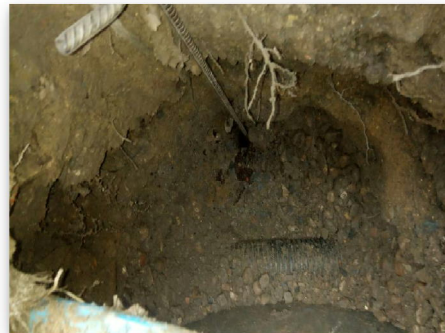
We re attended site with 2 engineers and continued to excavate down. We then were able to locate the foundation and successfully probed the underside. Below is the trial hole log showing the foundation details for the property:

Fig 1.2: Trial Hole 1 Footing

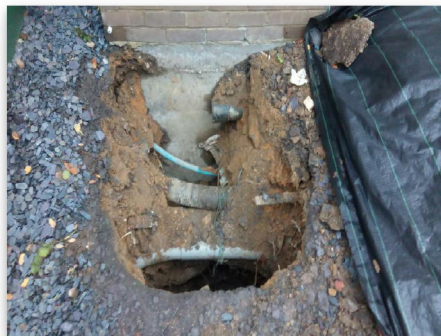
We first attended site and completed a deep excavation to attempt to locate the foundations to the property. We were unsuccessful in doing this due to the amount of services running through the hole and the suspected depth of the foundations.

Fig 7.1: Services running through hole
