3 LYNDHURST TERRACE, HAMPSTEAD, LONDON  
HISTORIC INTERIORS RESEARCH AND ANALYSIS REPORT

PROJECT CONTACT: : MAX CURTIS-DONNELLY, tmd BUILDING CONSULTANTS

5<sup>th</sup> SEPTEMBER 2020

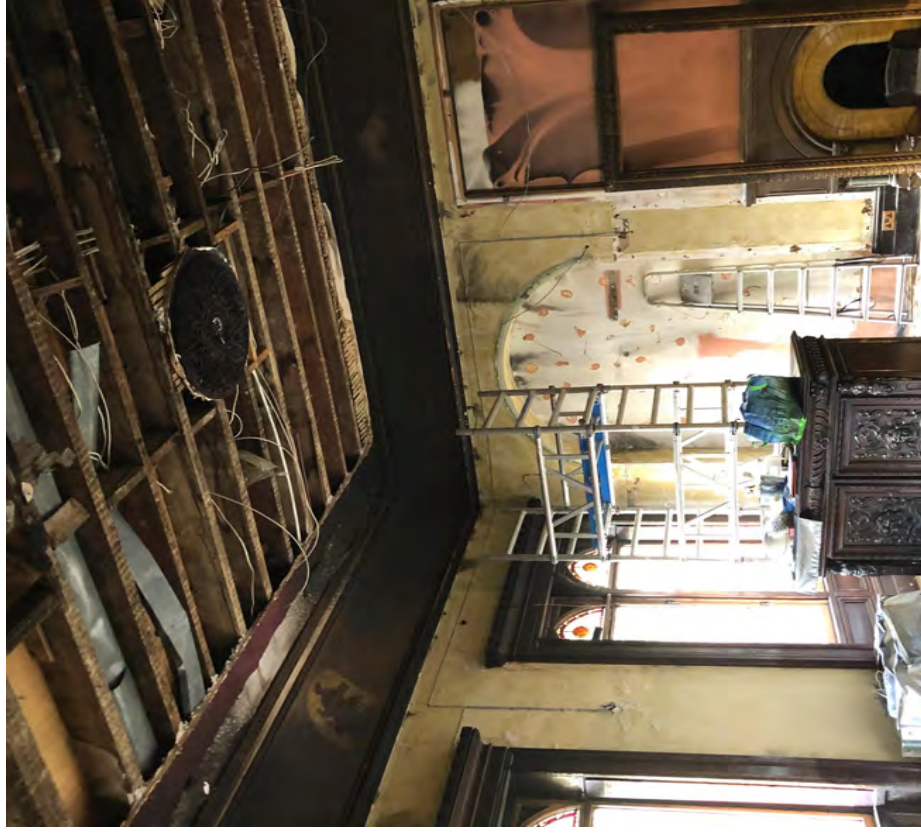
Figure 4: Room 1, Reception after the fire (approximately the same orientation)

This image records the interior as it appeared at the time of this survey.

This coincided with ongoing clearance of the interior by the clients contractor. It is not known if all elements were fully recorded prior to removal. For example, the ceiling, where only fragmentary traces adjacent to the cornice were available for sampling and analysis.

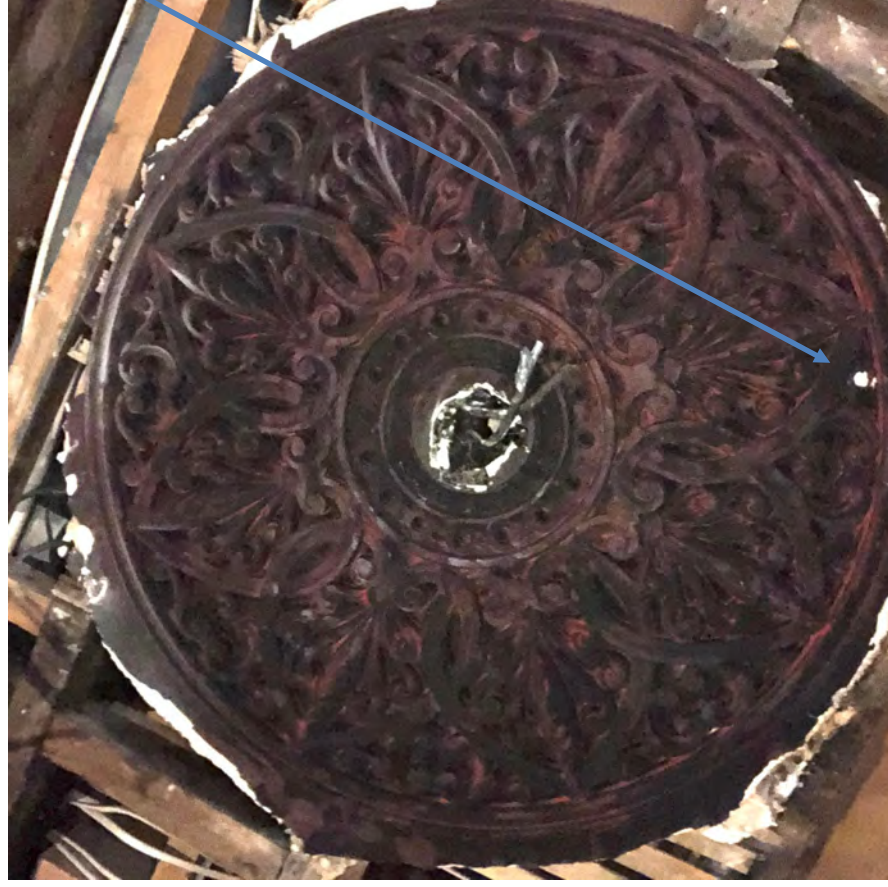
Figure 7: Room 1 Ceiling Rose

Despite its original appearance, the ceiling rose, which analysis has identified is made of a hard casting plaster of a Jesmonite type, appears to be a later twentieth century introduction. This perhaps explains its neoclassical styling of anthemion and foliate scrolls, which depart from the Gothic nature of the property and its interiors.

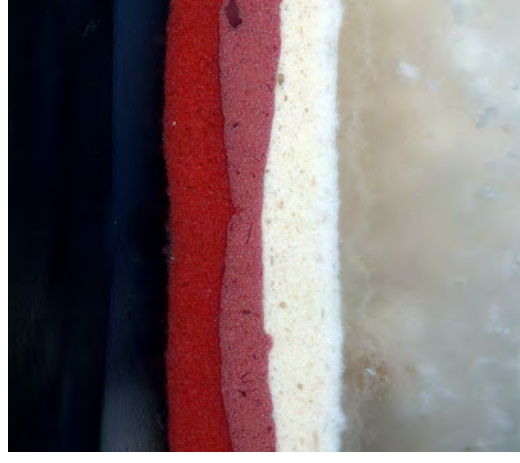
Figure 8: Sample 1.1 Room 1 Ceiling Rose

The paint schemes on the ceiling rose date from during or after the second half of the twentieth century. The earliest paint scheme, which is in post 1950 alkyd paint, is applied directly to the plaster substrate. This confirms that this element is in reality a relatively modern introduction

The paint layers are here recorded as three separate schemes. However, it is possible that these are only a single finish with high quality preparation coats. The evidence could also suggest a white alkyd primer, dusky pink alkyd undercoat and a dark red alkyd finish coat.

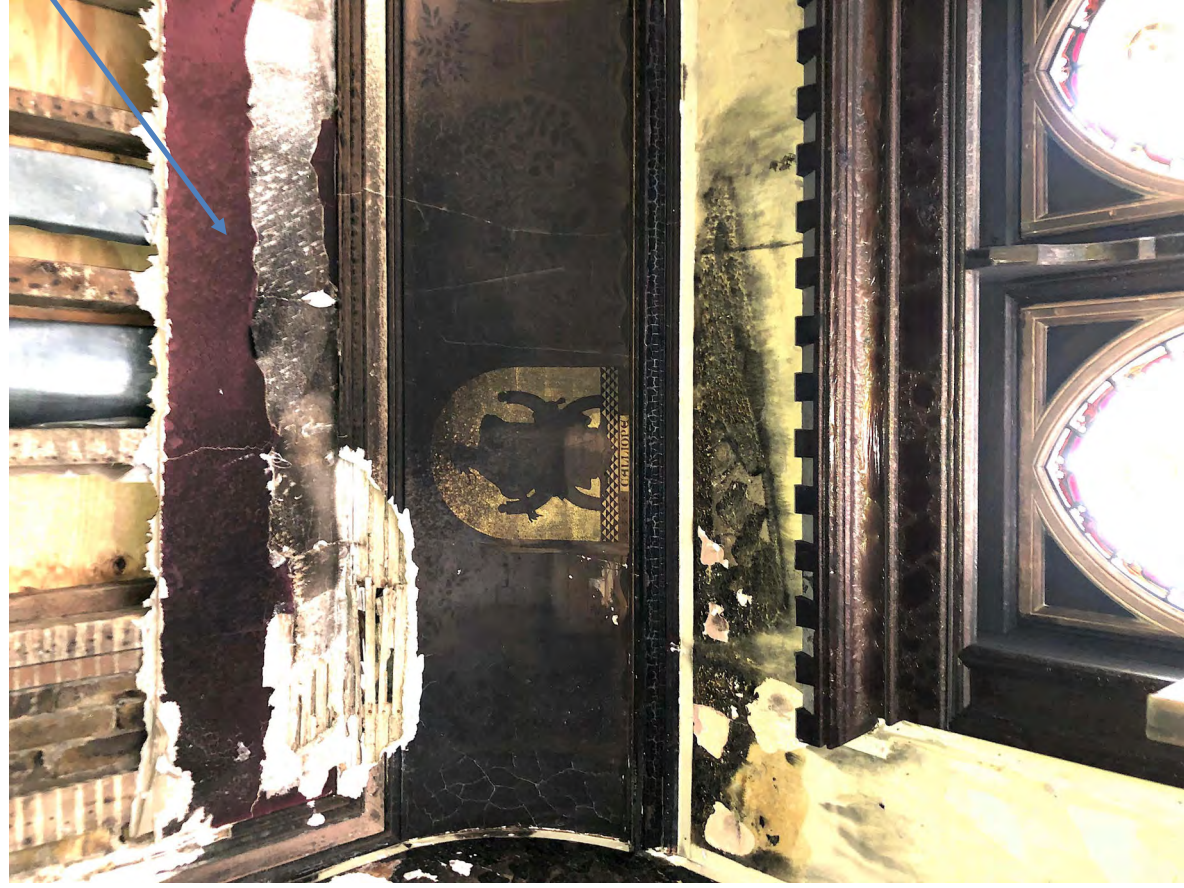
Figure 9: Room 1, surviving fragment of ceiling after the fire

As recorded previously, the vast majority of ceiling material had been removed prior to our attendance at site. Small areas survived around the perimeter of the bed, adjacent to the upper cornice. While these can be accepted as representative, the will not record and features which may have been sited more centrally.

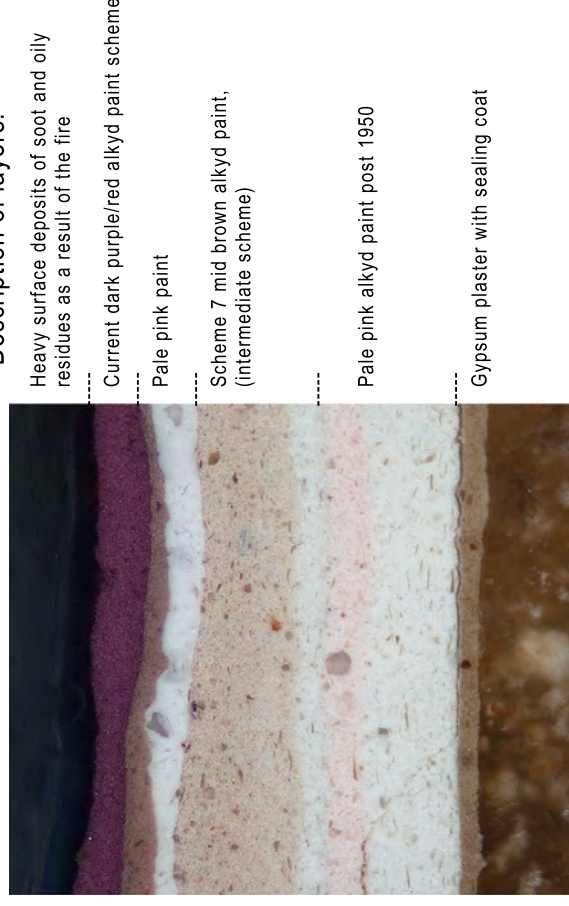
Figure 10: Sample 1.2 Room 1 Ceiling Bed Representative Description of layers:

The ceiling was a modern replacement of gypsum plasterboard, with a series of modern alkyd paint finishes. This indicates a later twentieth century introduction or perhaps even more recently created.

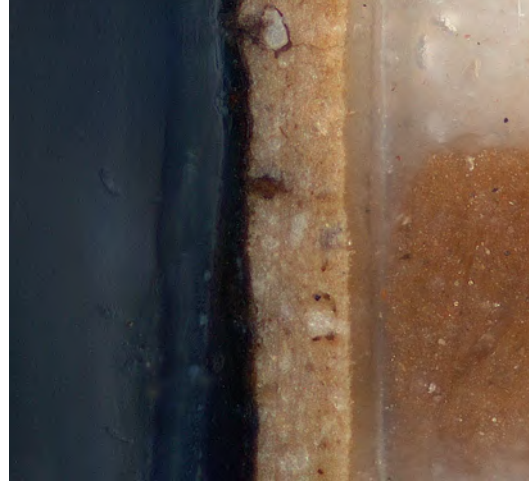
Figure 12: Sample 1.3 Room 1 Large Mouldings Above Ceiling Cove

Heavy surface deposits of soot and oily residues as a result of the fire over a varnish coat which appears to be original

Original dark cream and brown lead oil paints

The earliest decoration consists of a Builder's Finish, which is necessary when painting alkaline (plaster-based) surfaces. It consists of a water based soft distemper, applied thinly, which was then washed off once the plaster had carbonised from the atmosphere. No longer being alkaline the surface can take oil based finishes. If applied too soon the oil base saponifies (turns to soap) under the alkaline condition and fails.

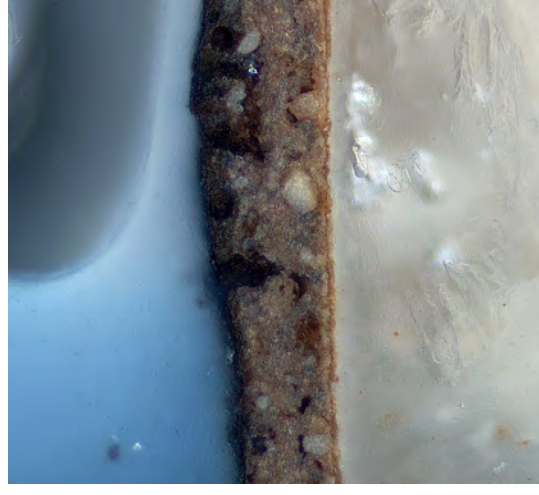
Figure 14: Sample 1.4 Room 1 Large Musical Muses Decorative Cove

Heavy surface deposits of soot and oily residues as a result of the fire over a varnish coat which appears to be original

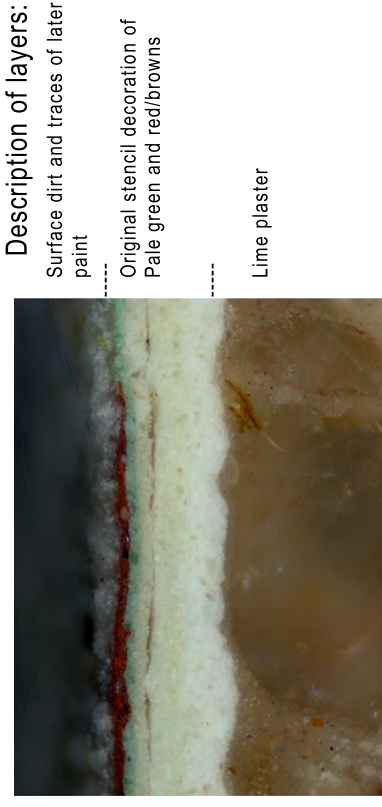
Figure 16: Sample 2.6 Room 1 Main Wall Face Areas

It is with respect to wall face treatments that the interior has moved furthest away from the original intention. By consequence losing original decorative stencil and border details, beneath later paint schemes and then obscured totally by the modern silk hangings.

The cross-section recorded above shown the off white base coats for the stencil, the green finish coat and the red decorative work.

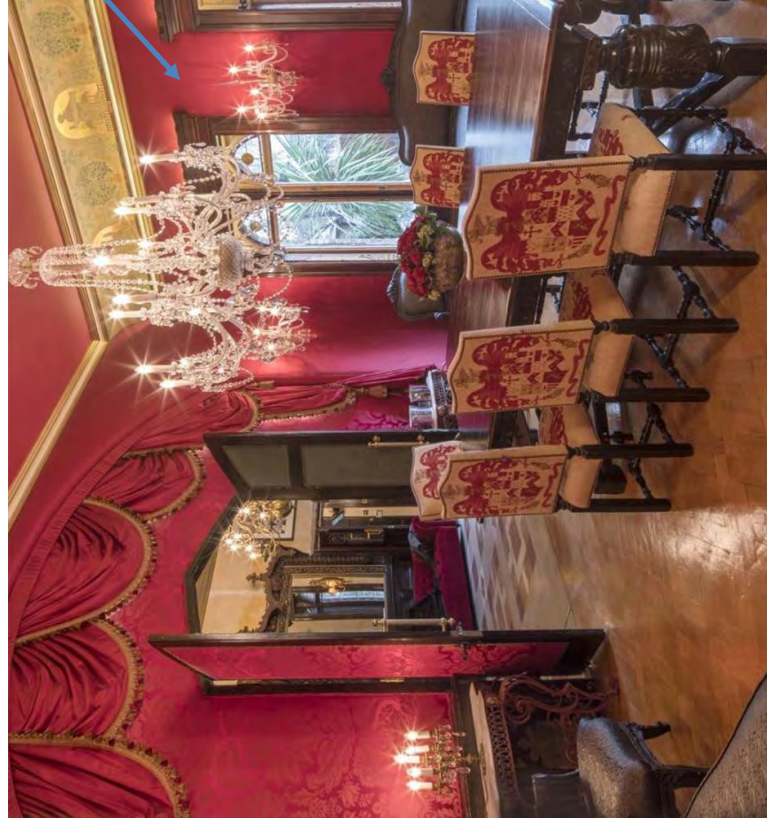
Figure 19: Room 1 Showing Silk Damask Hangings Before the Fire

This image prior to the fire shows the whole interior lined with modern silk, with no respect for the original and surviving architectural detailing of the interior. Even the characteristic wide arch the unifies the two interiors is hidden behind silk drapes.

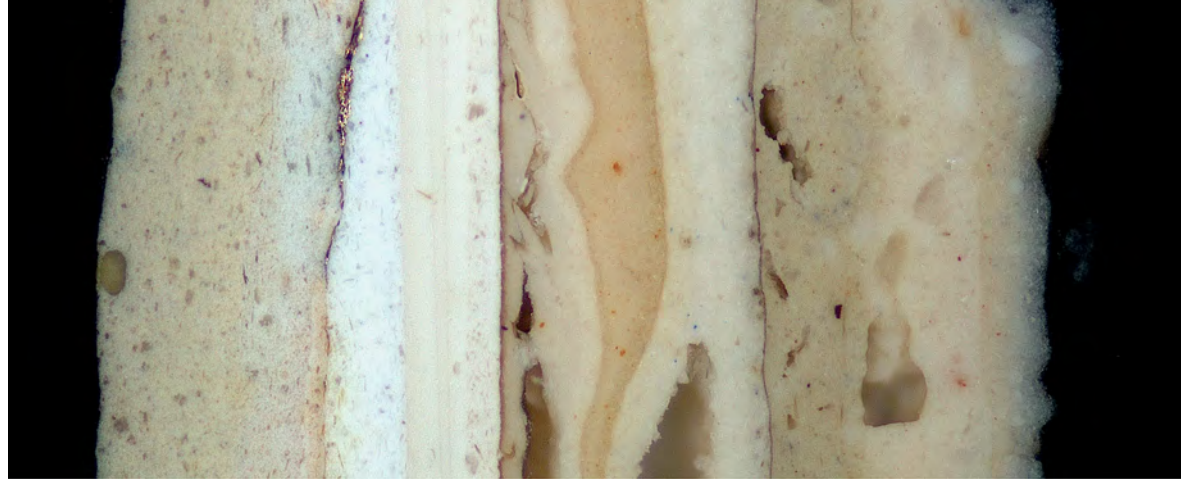
Figure 22: Sample 2.12 Room 1 Large Arch to Hallway Intrados

Surface dirt, behind silk hanging

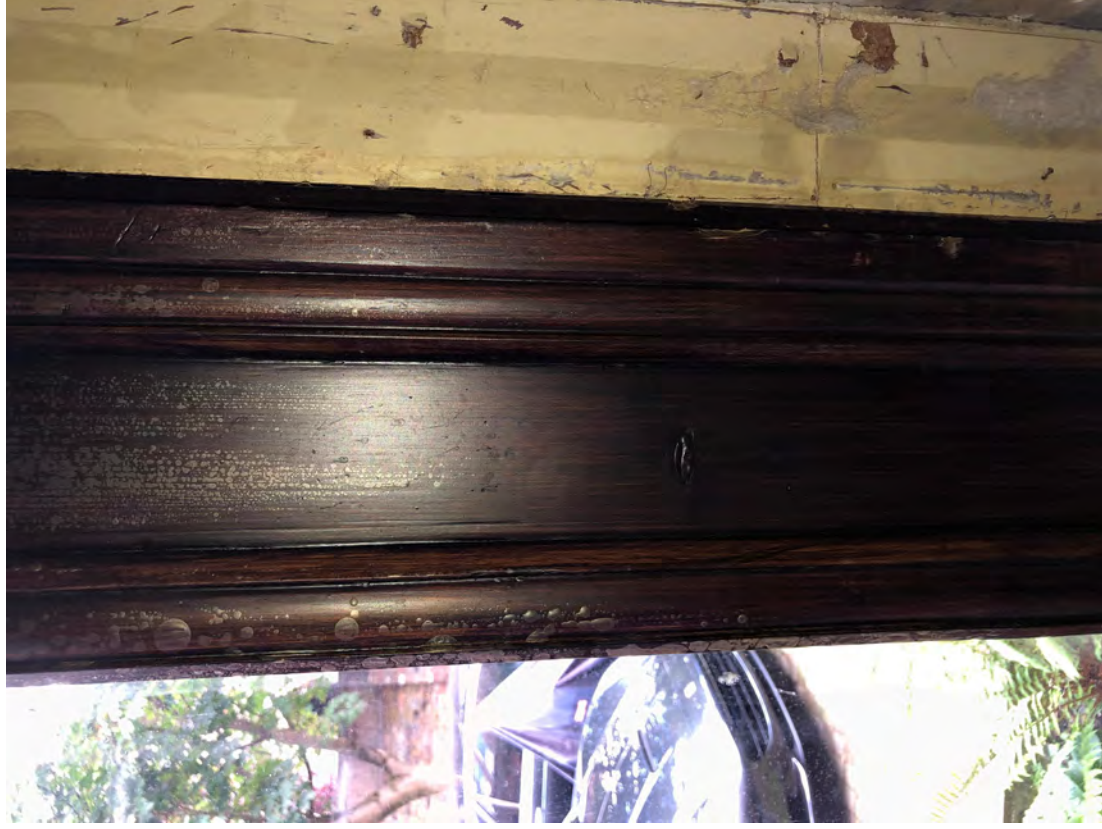
Figure 23: Window joinery showing the retouched original scheme beneath a degraded later acrylic varnish

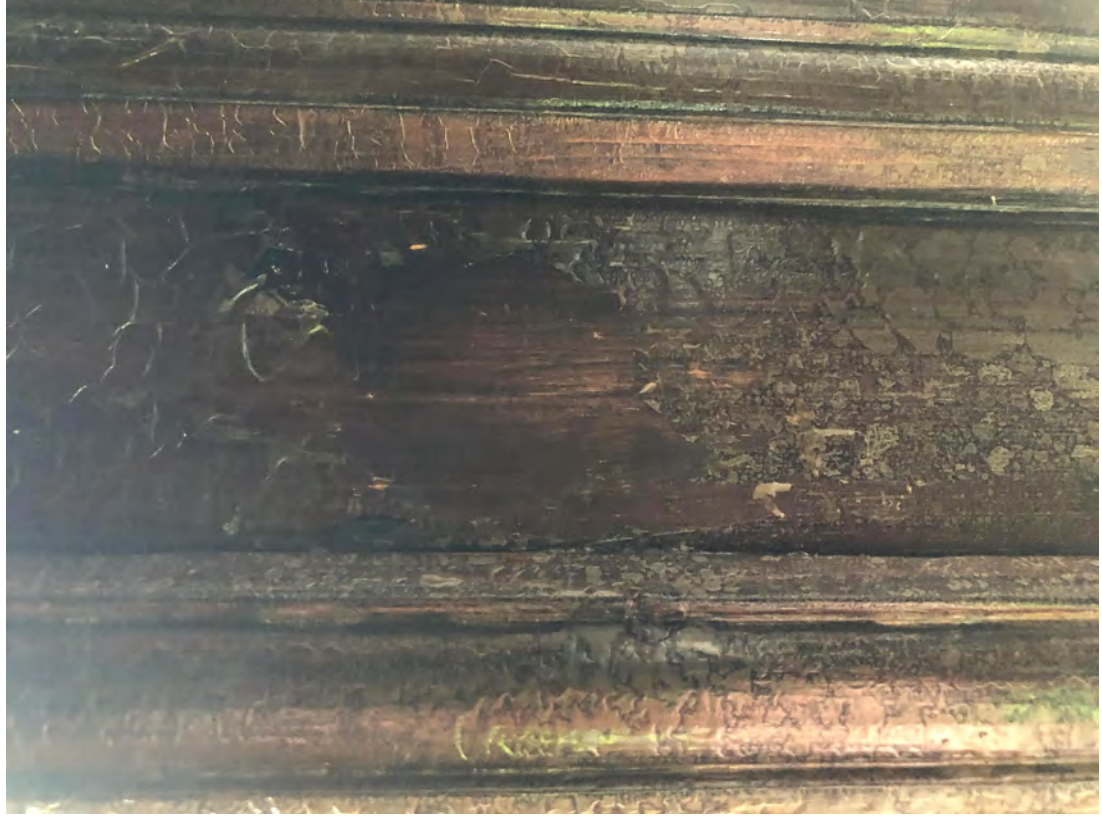
Figure 24: On closer inspection the acrylic varnish can be seen to have bubbled and readily peels away from the paint surface beneath

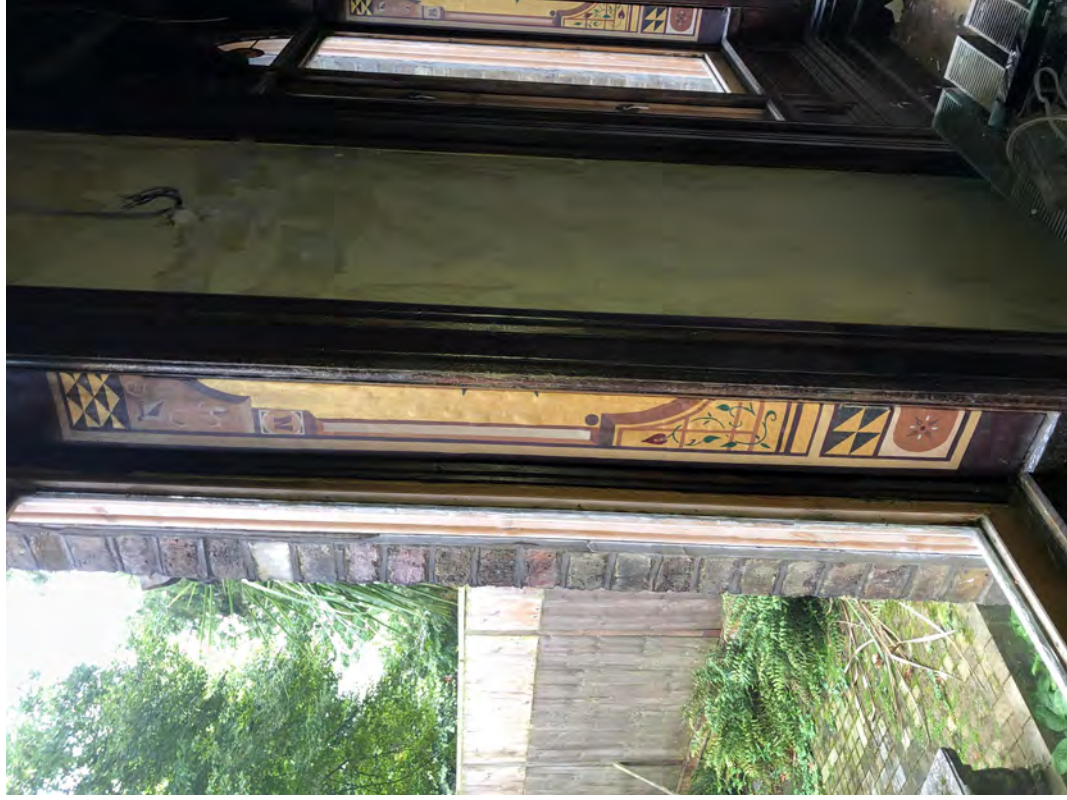
Figure 25: The window shutters are modern replacements in a style loosely associated with the original

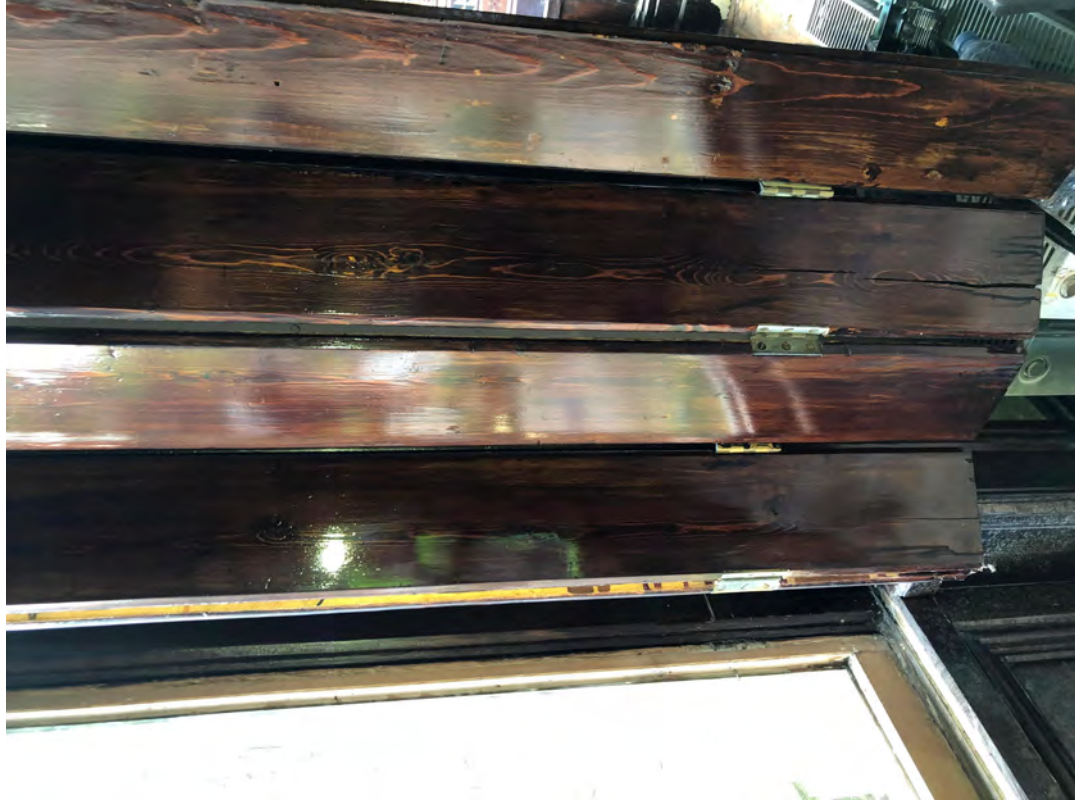
Figure 26: The timber base of the shutters is of modern softwood, thickly coated with a dark varnish to loosely imitate the original joinery

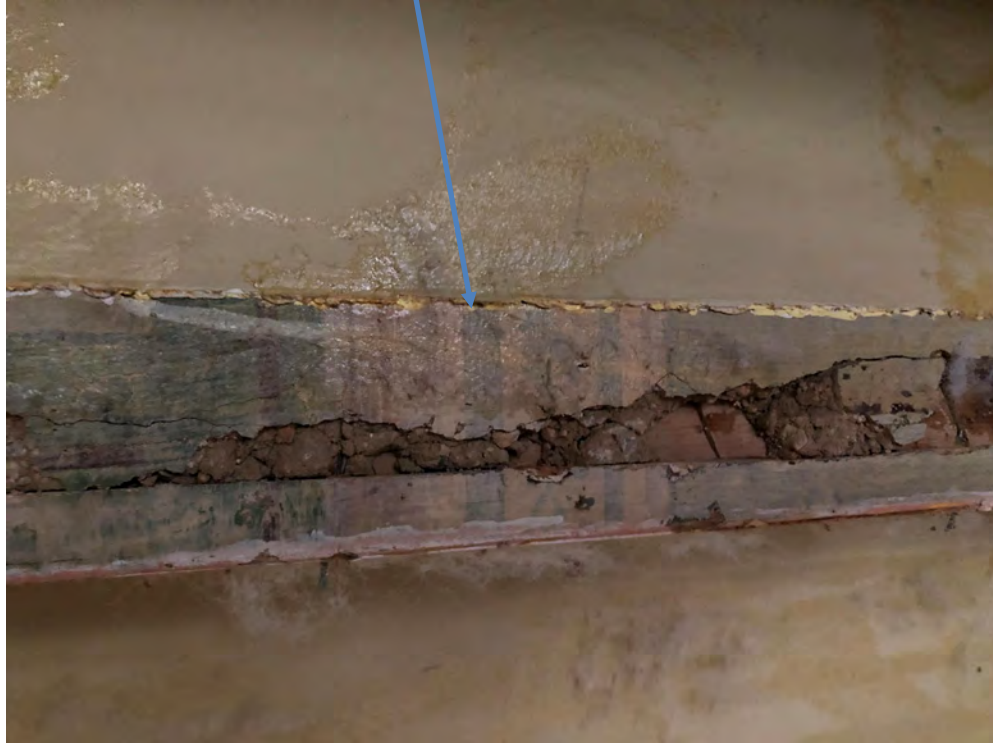
Figure 27: A scar where a later timber has been removed exposing the original stencil frieze applied to the wall faces

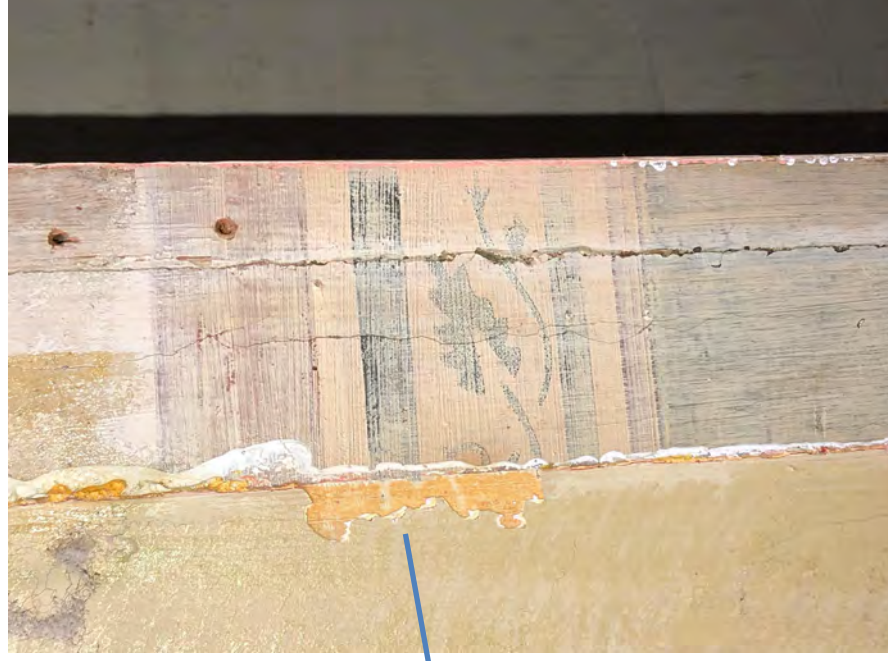
Figure 28: a clearer area of the original frieze with light overpaint

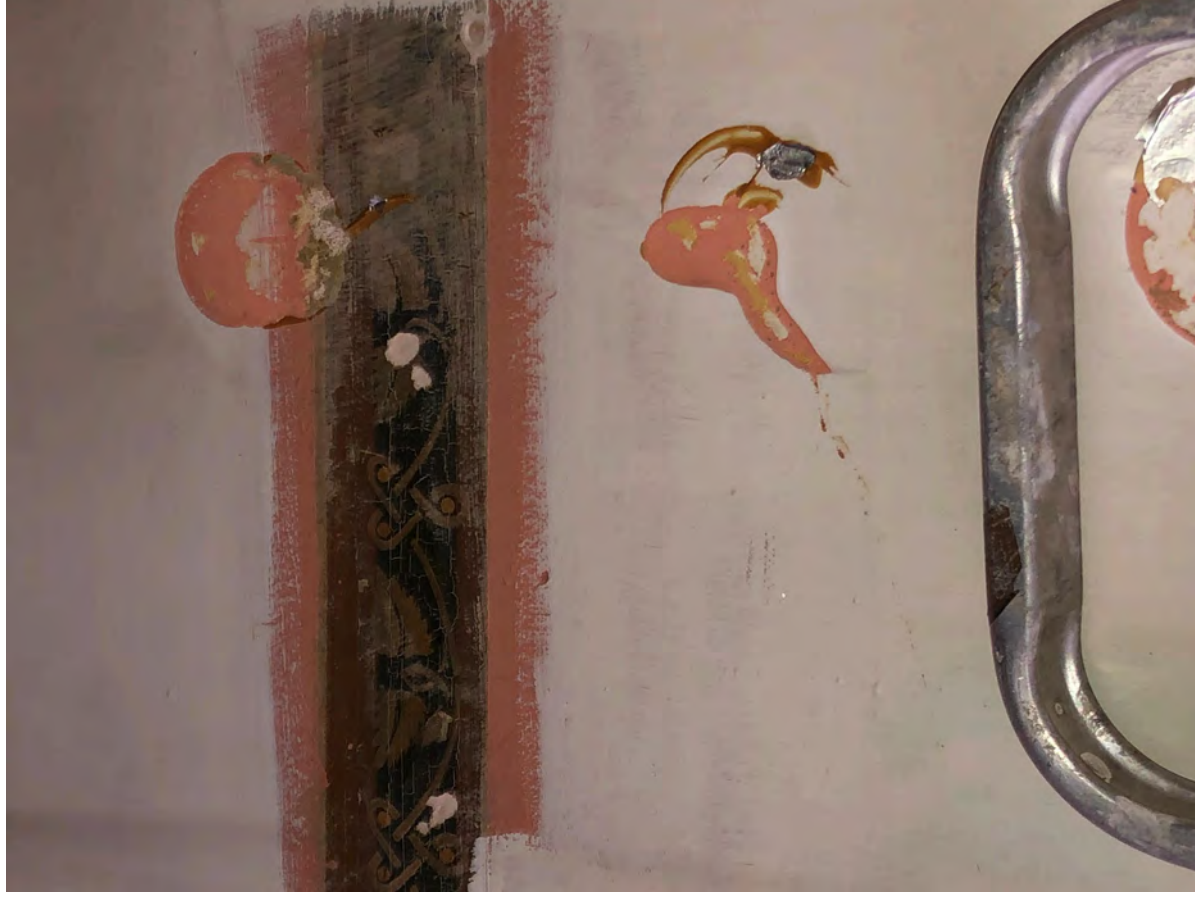
Figure 29: Area of original stencil surviving in the wall face arch recess

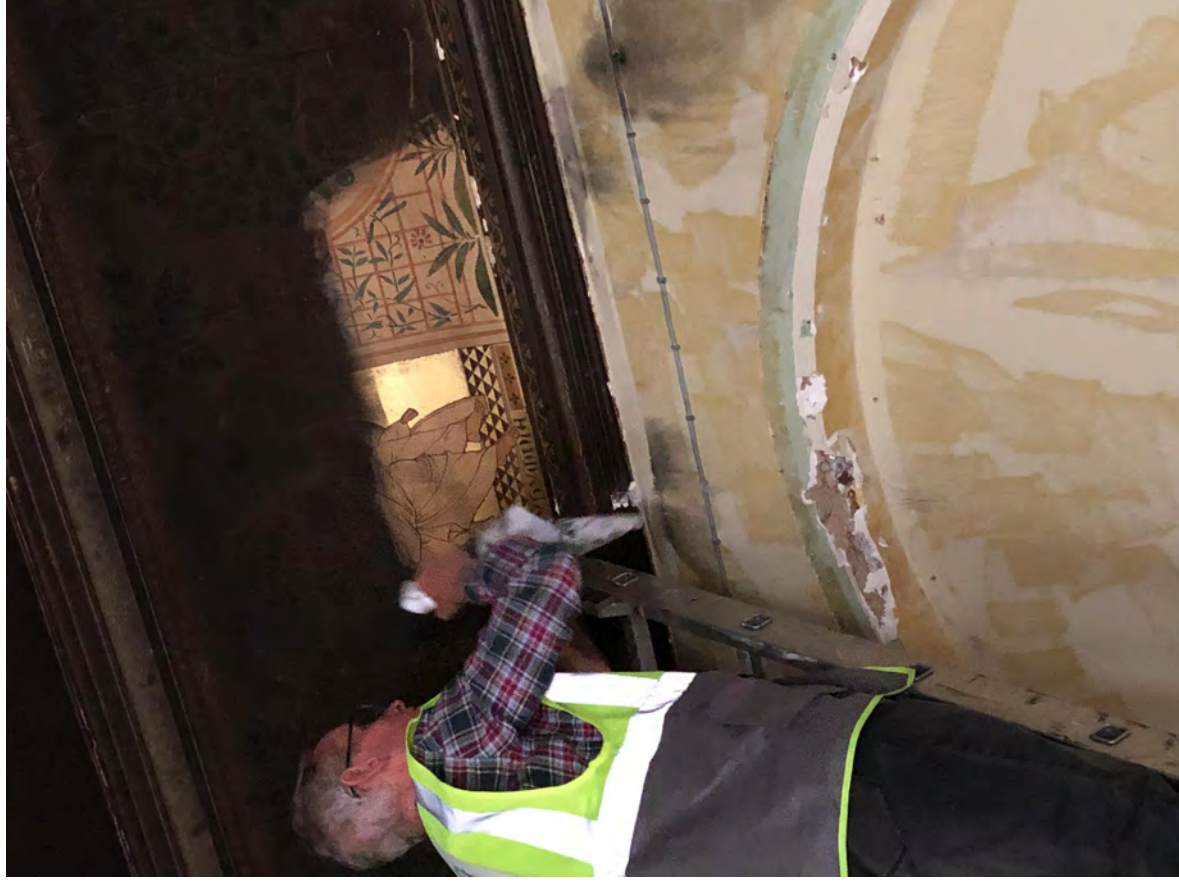
Figure 30: Initial test cleaning of the fire and smoke damaged frieze

1. Record photograph of each area to record current condition
2. Light brushing to remove loose surface deposits (on larger areas thus should be accompanied by vacuuming)
3. Gentle rubbing with 'Smoke Sponges' to lift if more tenacious surface dirt.

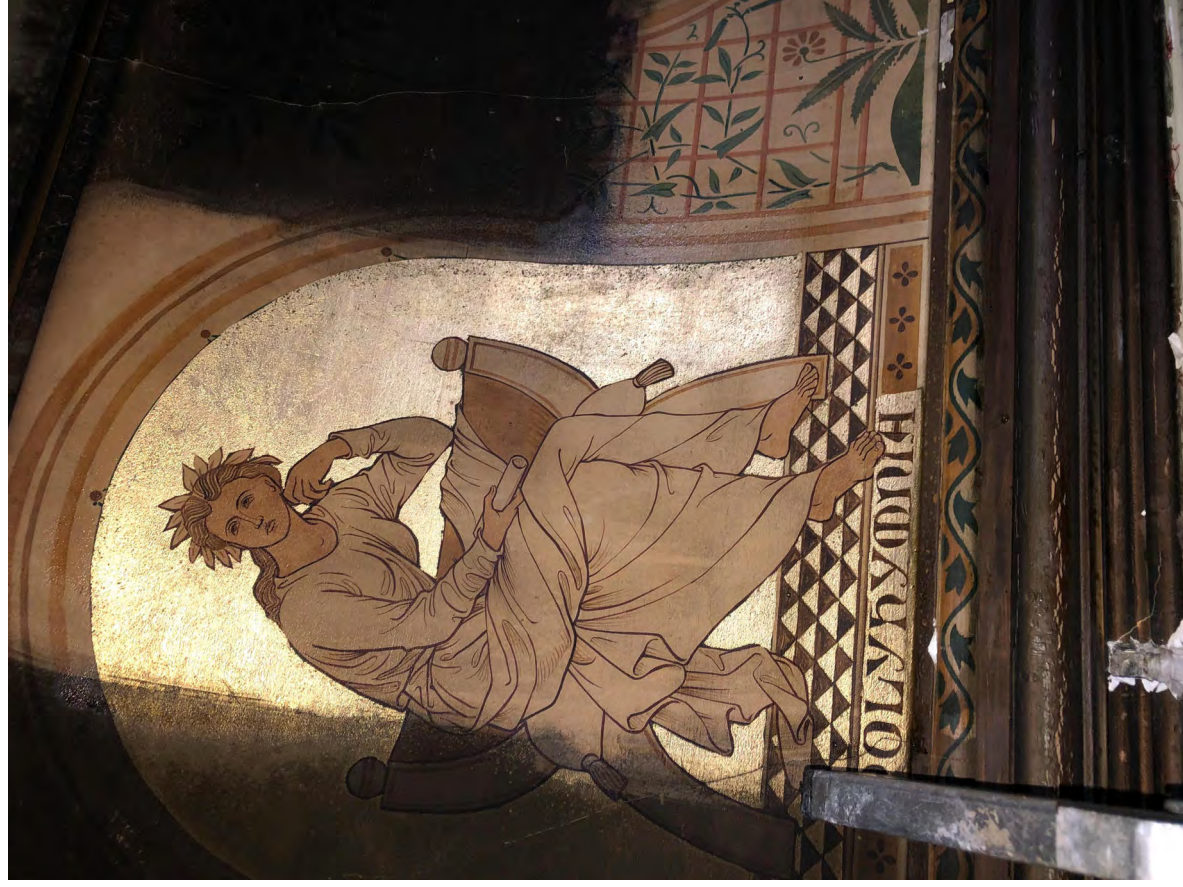
Figure 31: Frieze sited opposite the source of the fire after initial clean

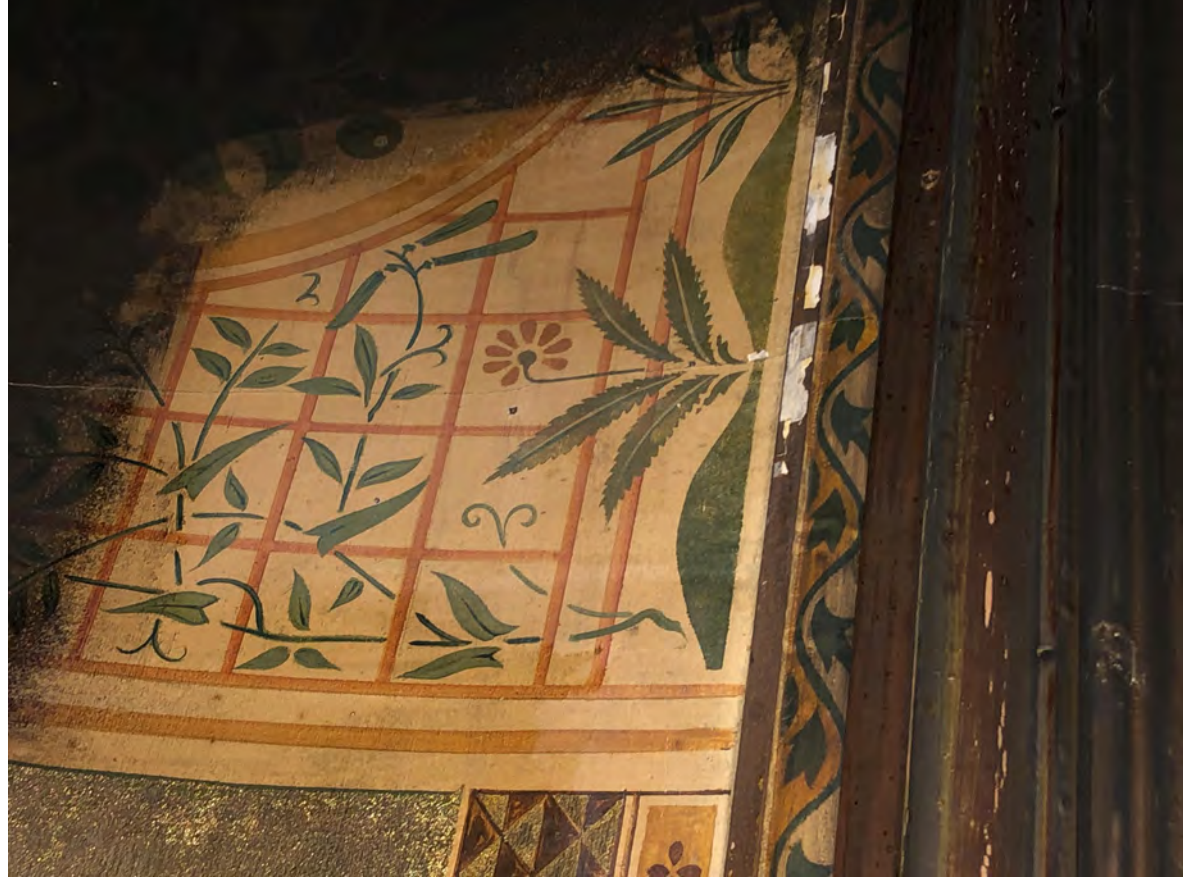
Figure 32: Detail of plain painted design area after initial clean

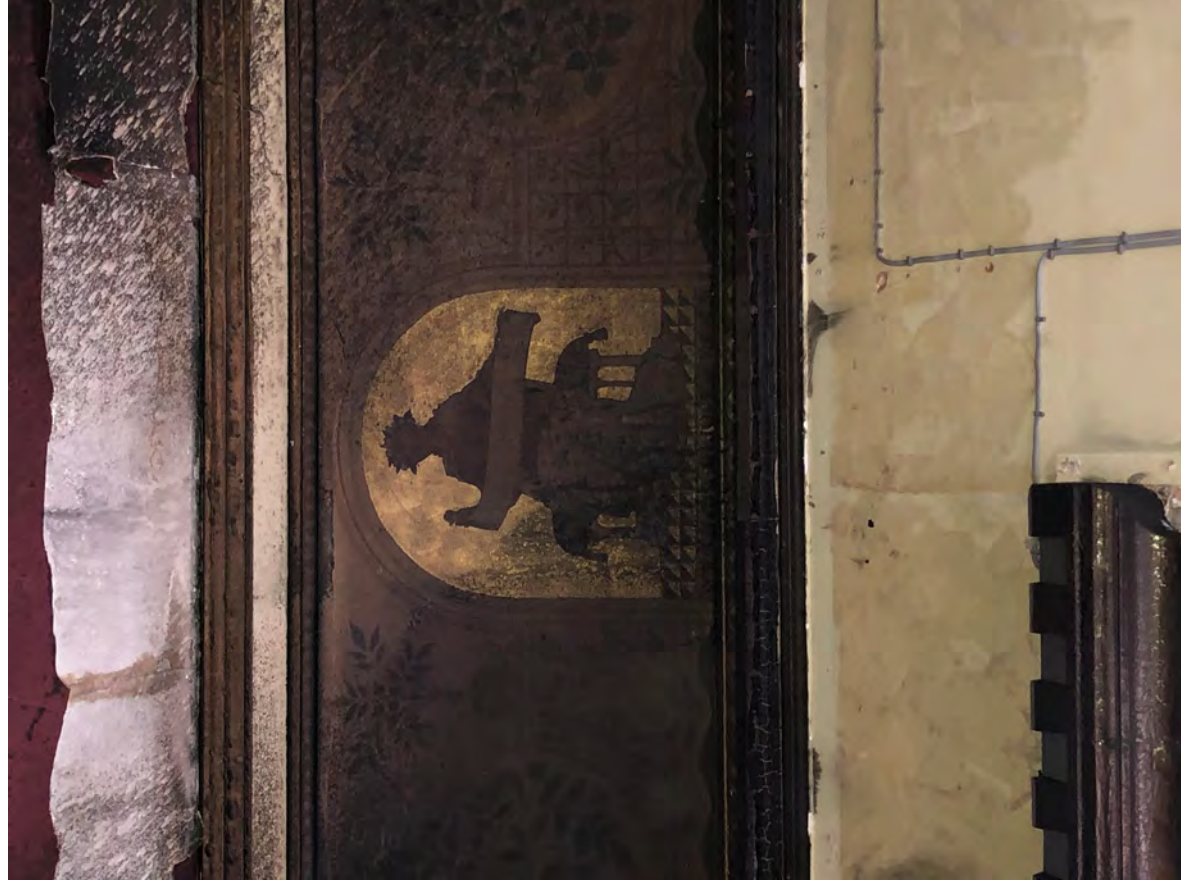
Figure 33: frieze area above the source of the fire after initial clean

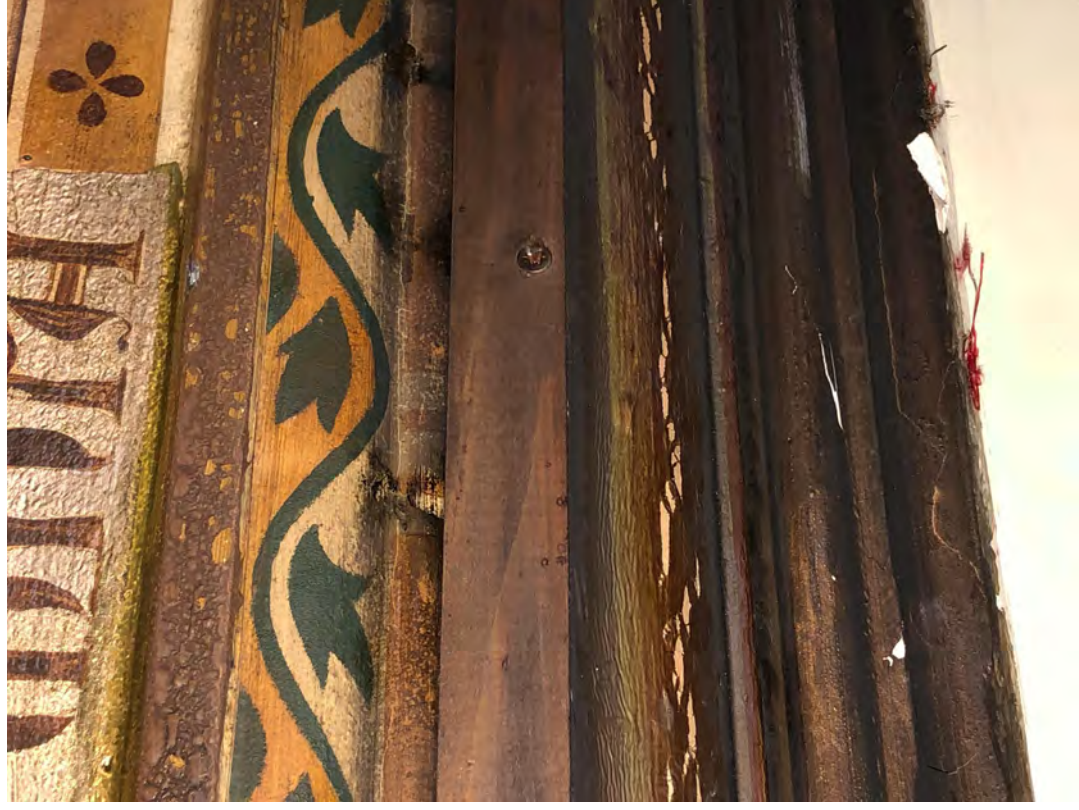
Figure 34: Detail of frieze showing bubbling to the paint layers and the buckled modern plastic conduits for recent cable installations (not included in this report)

The interior has been severely affected by the fire, particular to the north corner, close to the original source site. This research has been able to identify and record. The decorative history, which is of high importance at a time when the necessarily interventive repair works may necessitate the removal of surfaces and elements.

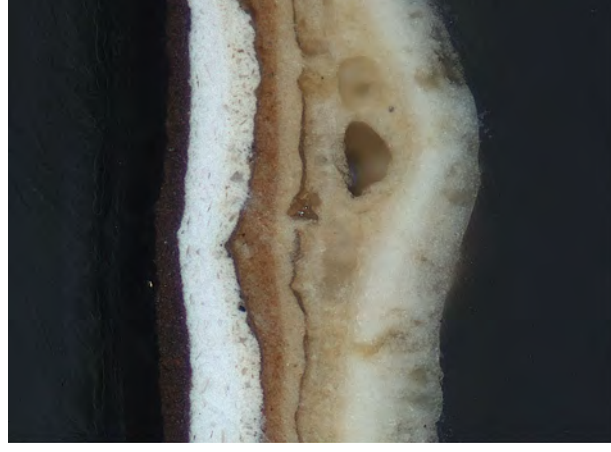
Figure 39: Room 2. Sample 5.26 ceiling panel mouldings,

Sample shows schemes 1 – 3 only

-----  
Surface soot, dirt and oily residues

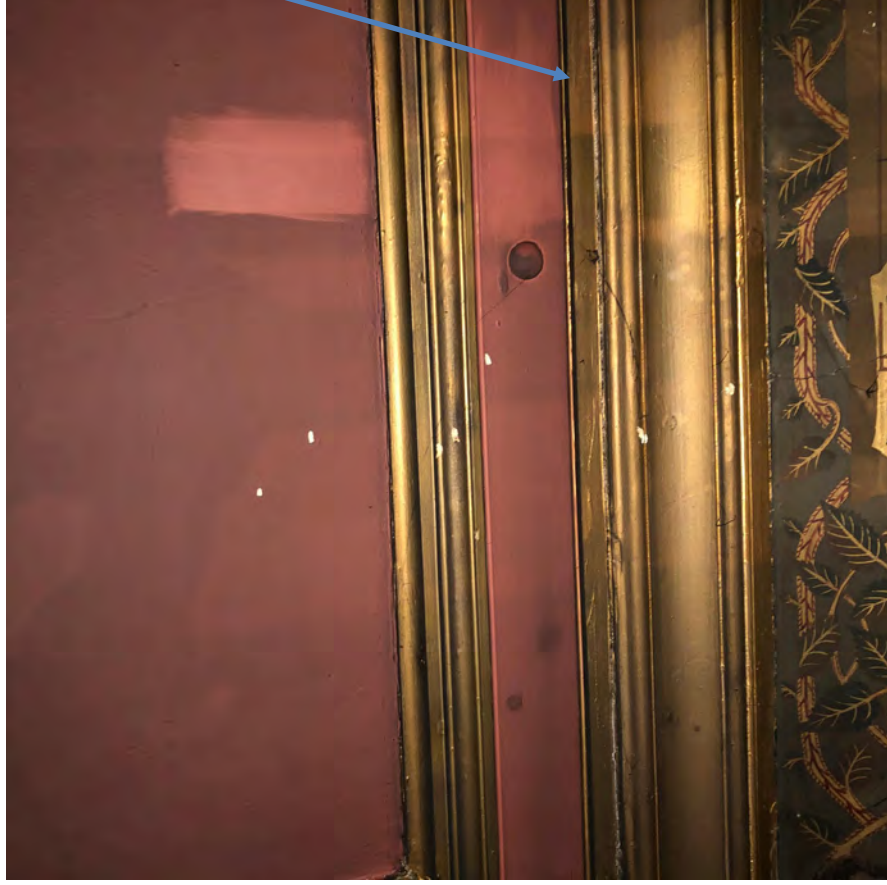
Figure 40: Room 2. Ceiling and large cove

These images record both the decorative history and the condition of the cornice and ceiling within the Entrance Hall. The schemes applied appear to be of a significant age, albeit not original. They respond well to cleaning using the methods outlined in this report and require only minimal filling, retouching and stabilisation.

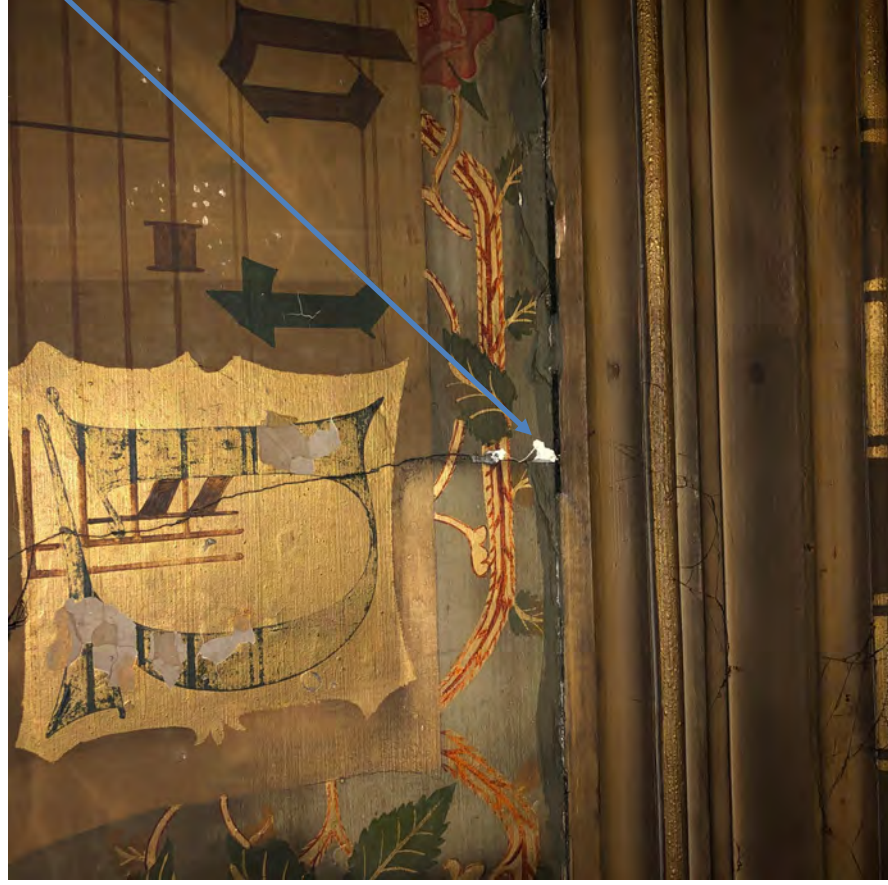
Figure 42: Room 2. Detail of Large Cove Frieze

This image shows test cleans on site and areas of damage, possibly caused by heat expansion caused by the fire. However, cracks in room 3 to the rear of this location, appear to be of some age and have indeed been filled, repaired and repainted. It must be assumed that the two are a result of the same historical cause.

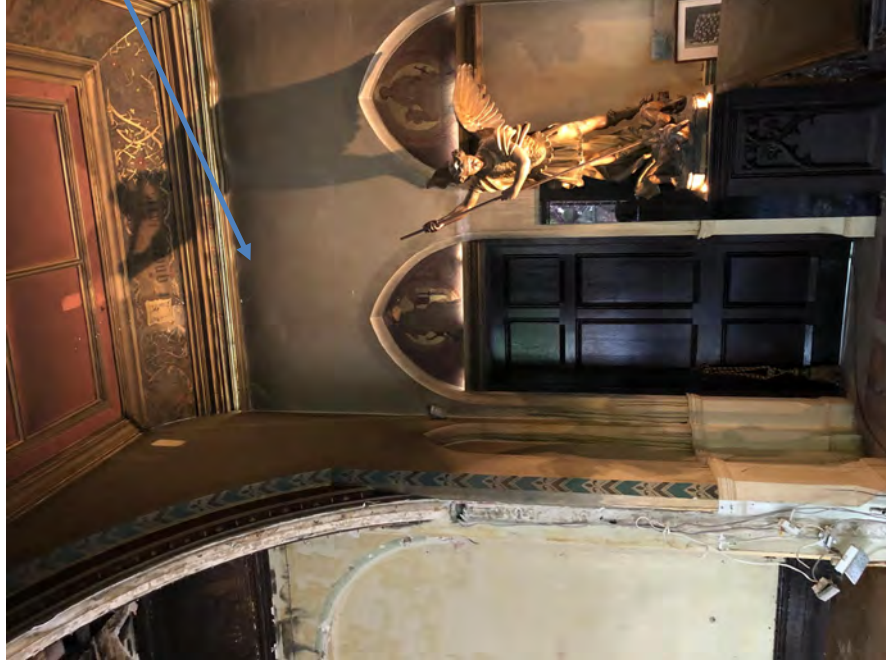
Figure 44: Room 2. Detail of interior facing door to Room 3

It is clear that the wall faces of this area have been repeatedly repainted throughout its history, dramatically moving away from the original ochre decoration, through a series of green and then red schemes, before returning to a paler off white stone colour. The wall surfaces clean well and could be readily prepared for a complete redecoration.

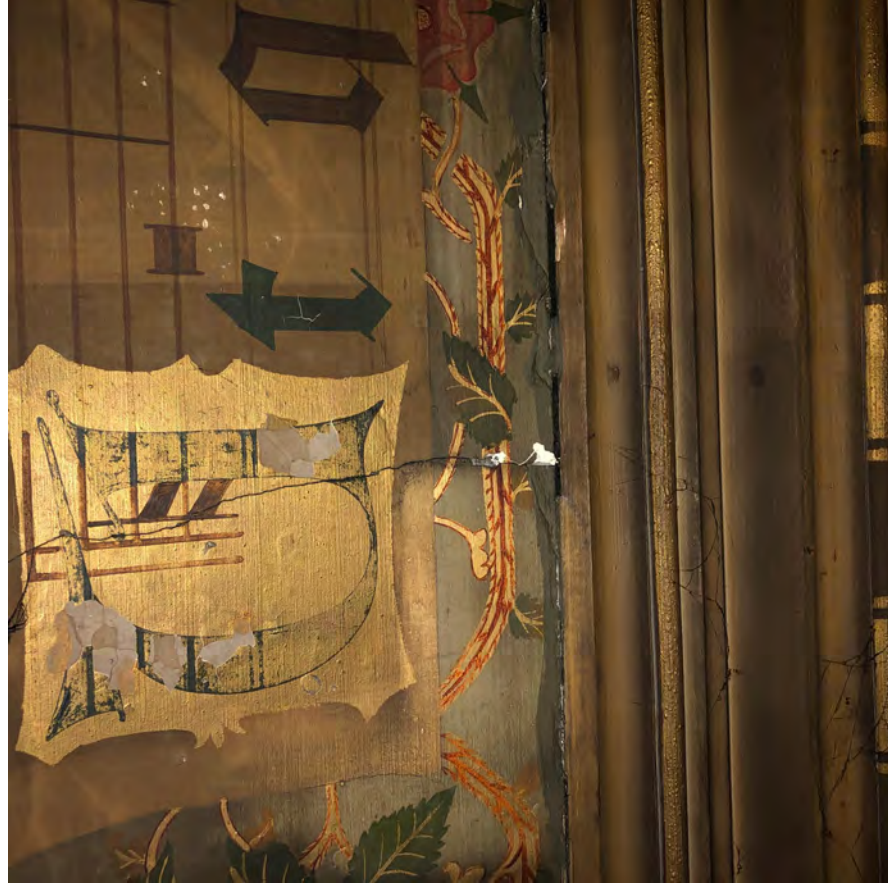
Figure 46: Room 2. Cleaning tests on Cove

It was explained previously that unlike Room 1, the decorative cove in Room 2 has not had a surface varnish applied. This has allowed the discolouring and potentially harmful deposits from the fire to adhere more firmly to the painted surfaces

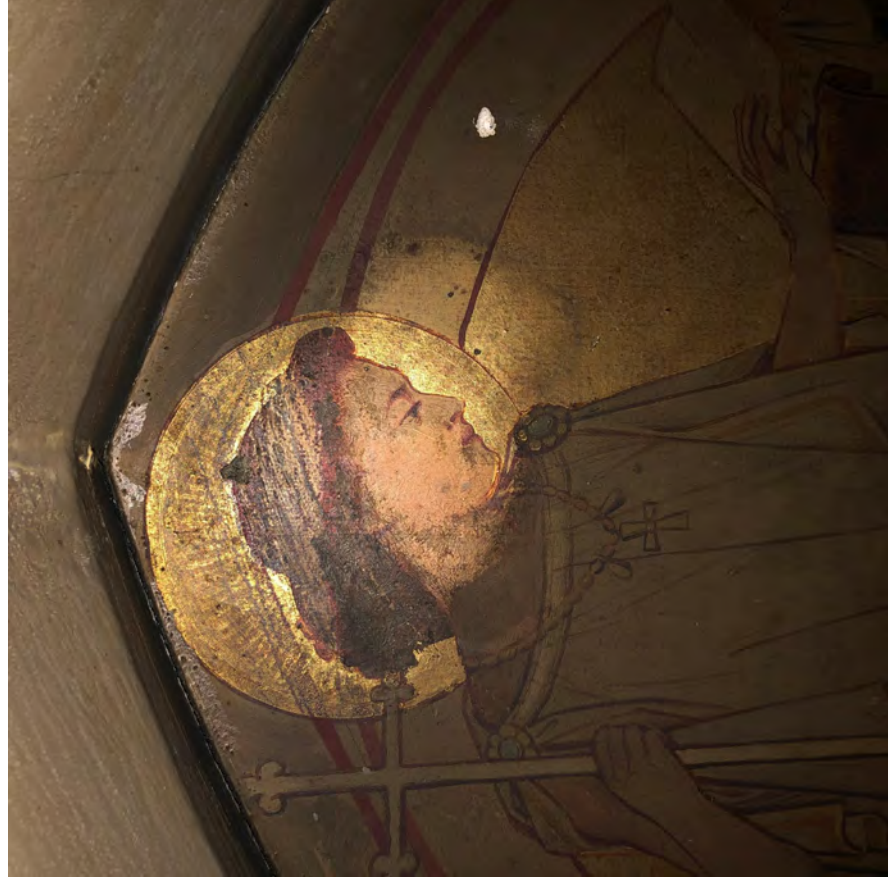
Figure 47: Room 2. Overdoor panel leading to Room 3.

A cleaning trial in a more protected area, shows how the original scheme can be cleaned and retrieved, although this will be a lengthier and more complex exercise that some areas in Room 1.
