3 LYNDHURST TERRACE, HAMPSTEAD, LONDON  
HISTORIC INTERIORS RESEARCH AND ANALYSIS REPORT

PROJECT CONTACT: : MAX CURTIS-DONNELLY, tmd BUILDING CONSULTANTS

5<sup>th</sup> SEPTEMBER 2020

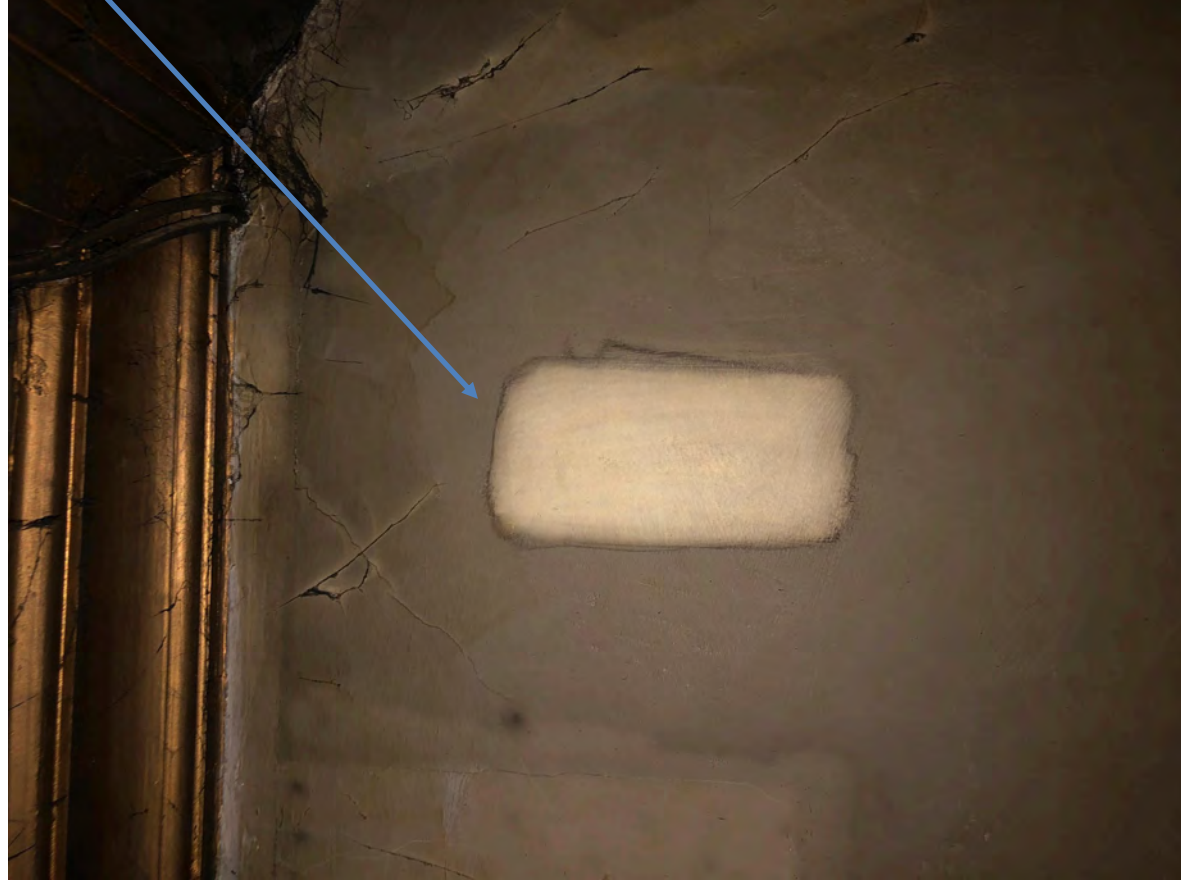
Figure 48: Room 2. Test clean to main wall face

Figure 48 adjacent shows how a very quick and simple test clean removes the dirt from the wall surface. Although it is recommended that the walls be redecorated, it will be necessary to thoroughly clean the surfaces to allow for a required standard of redecoration and avoid staining coming through.

It is recommended that the cleaning method again consists of the following stages:

1. Record photograph of each area to record current condition
2. Light brushing to remove loose surface deposits (on larger areas thus should be accompanied by vacuuming)
3. Gentle rubbing with 'Smoke Sponges' to lift if more tenacious surface dirt.
4. Gentle cleaning with lint free cotton cloths, using a dilute Synperonic detergent solution in deionised water.
5. Repeat stage 4 using an alkaline soap solution at low percentage strength (5-10%) in deionised water.
6. Cleaning down with pure deionised water to remove and neutralise any surface cleaning product in the surface

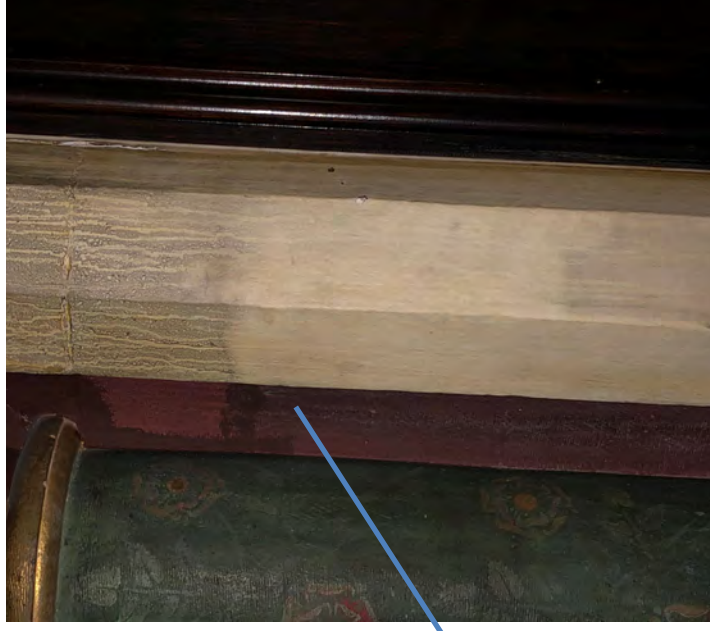
Figure 50: Room 2. Test clean to painted stone detailing

The column within the interior were not sampled as they appeared to retain original historic finishes in good condition. Instead the research focused on following the same cleaning processes as detailed in room 1 and as seen here proved very effective.

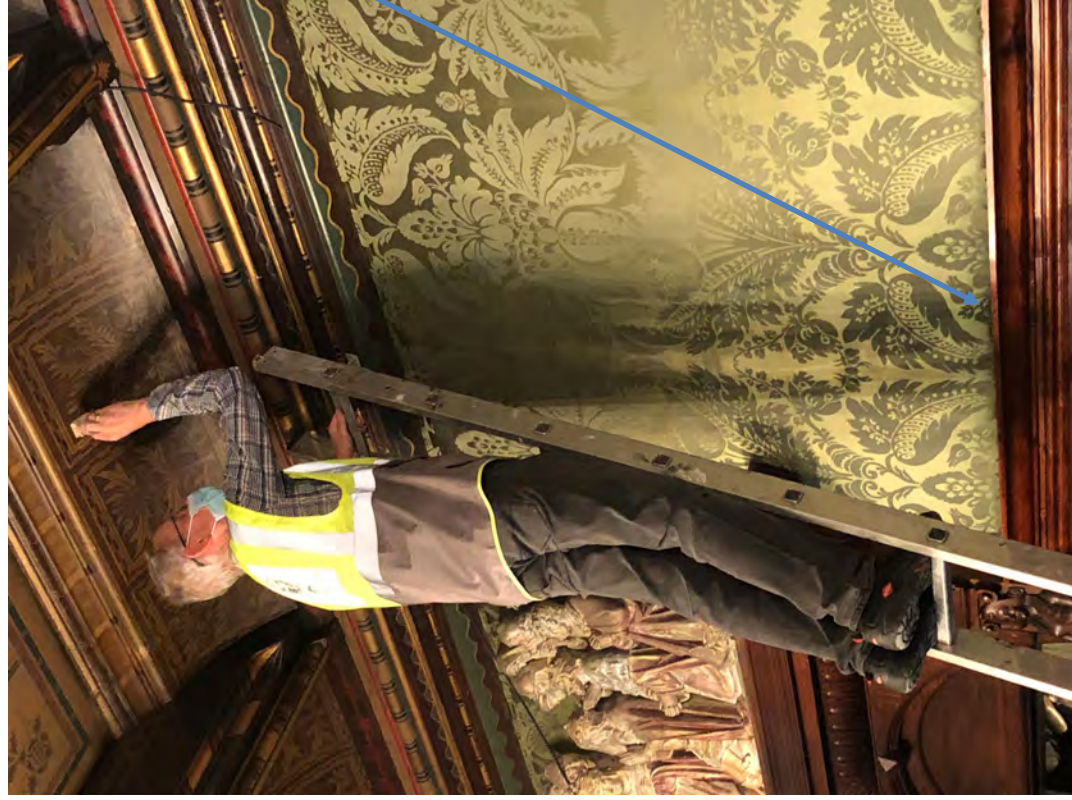
Figure 53: Room

Cleaning trials remove surface dirt, which could cross-link to the historic surfaces over time, but visually very little difference results

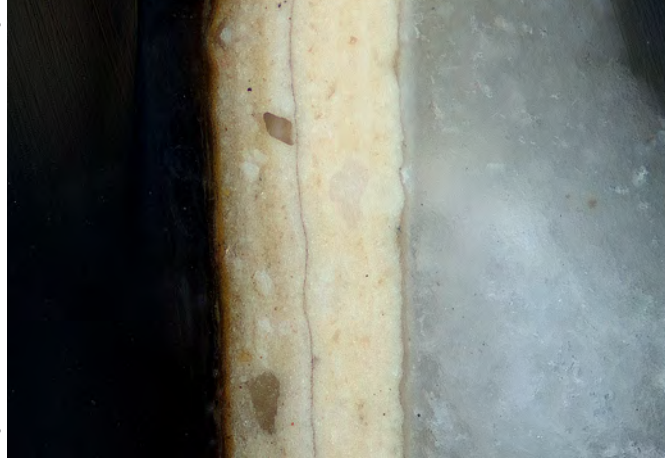
Figure 56: Room 3. Sample 6.1. Large Cove Painted Panel

There is evidence for repair and retouching to the second scheme, where historic settlement has occurred. There are also more recent fitted joinery introductions

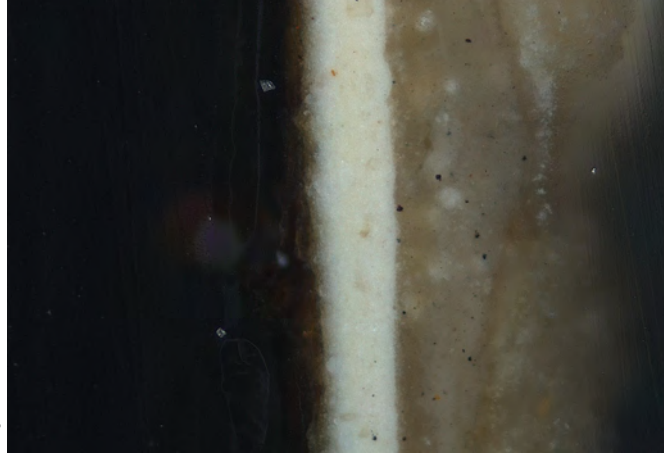
Figure 58: Room 3. Sample 6.2 Cornice and downstand beams

There is evidence for repair and retouching to the second scheme, where historic losses has occurred. There are also more recent fitted joinery introductions

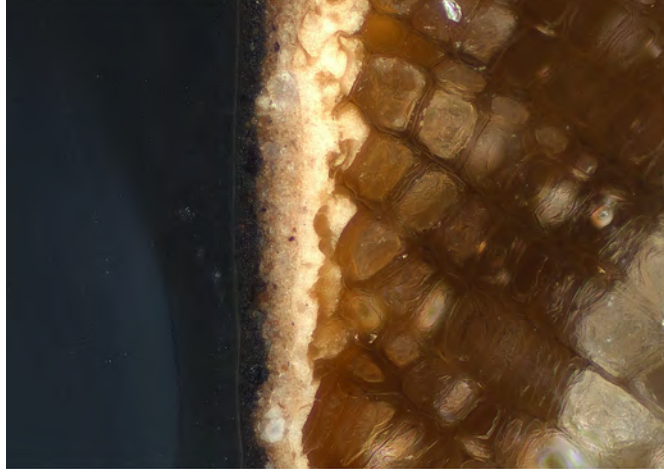
Figure 60: Room 3. Sample 6.3 Wall Panelling, Panel Bed

-----  
There is evidence for repair and Retouching where historic movement has occurred. There are also more recent fitted joinery introductions

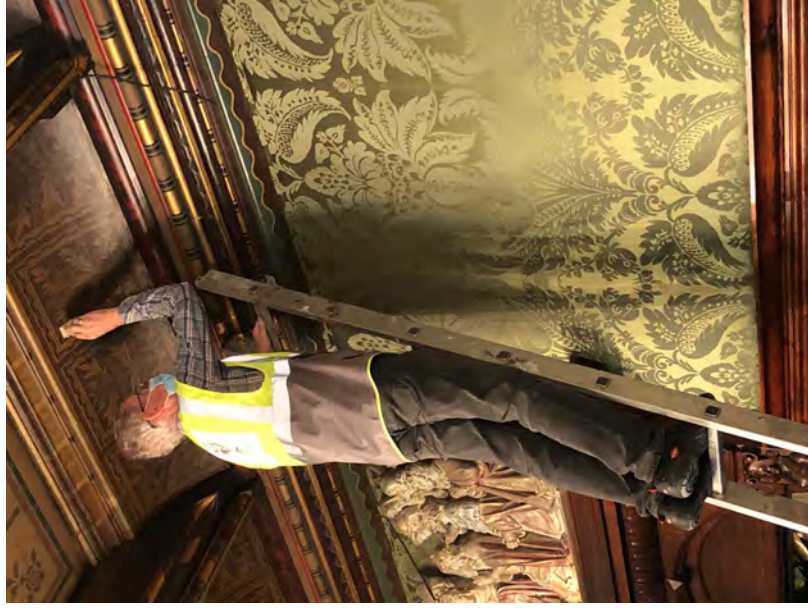
Figure 63: Room 3. Cleaning Trials

Light cleaning following the established method proved beneficial. There are no issues specific to this interior, so this restrained approach will be sufficient.

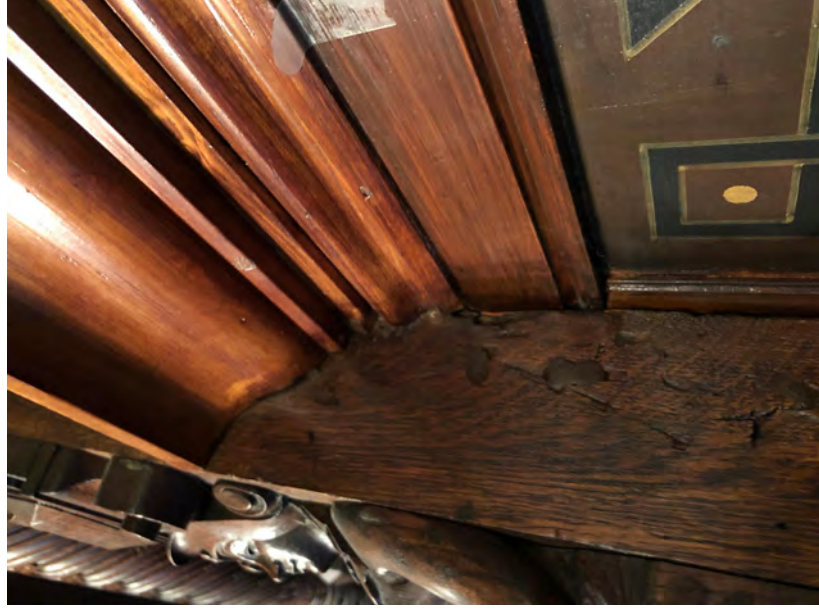
Figure 64: Room 3, mismatch of timber types and finishes. Also, poorly aligned joints, which suggests a recent reworking.

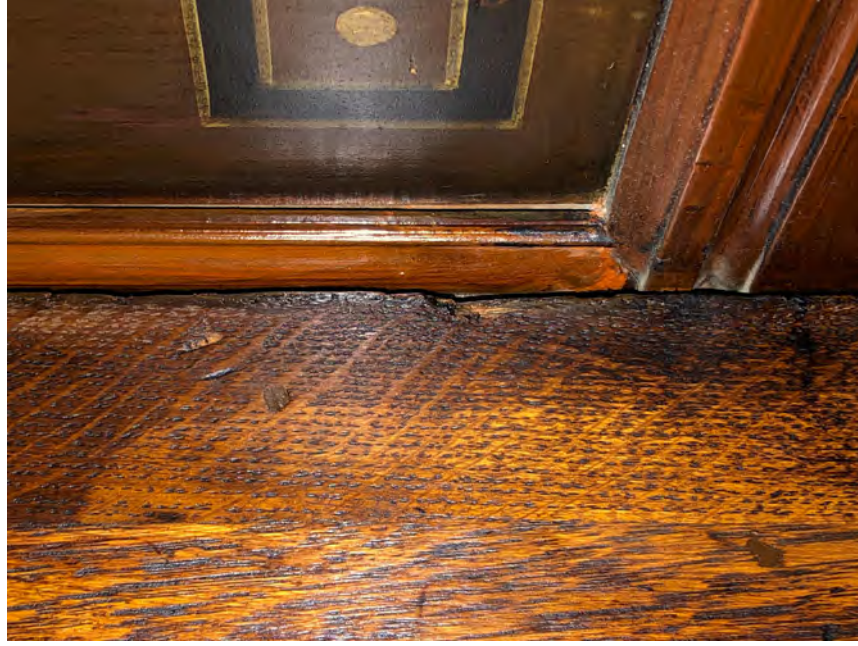
Figure 65: Room 3, poor alignment of panels and adjacent mouldings which again would suggest a more recent reworking of the interior.

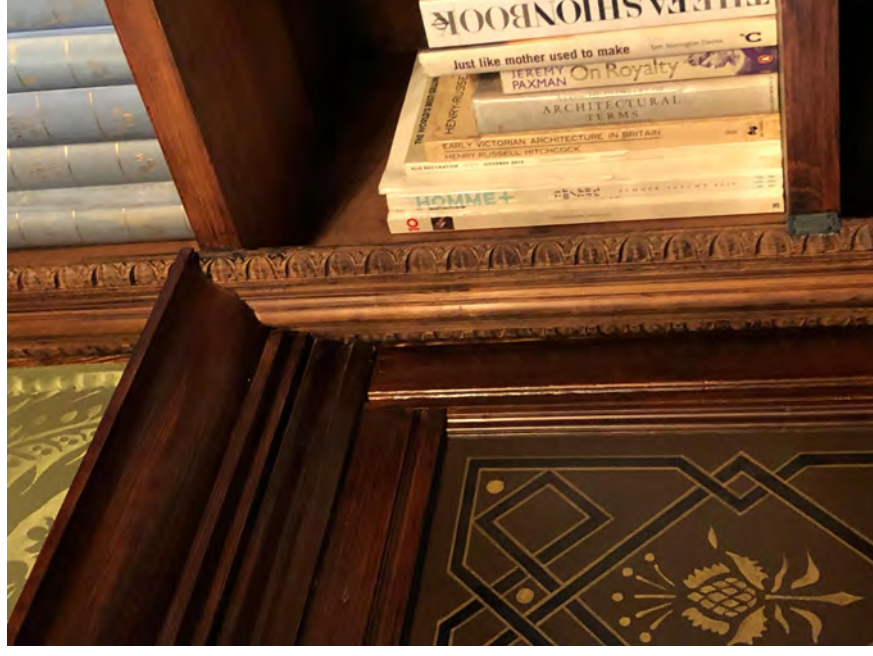
Figure 66: Jarred alignment of the modern cornice to the panels and the historic bookcase.

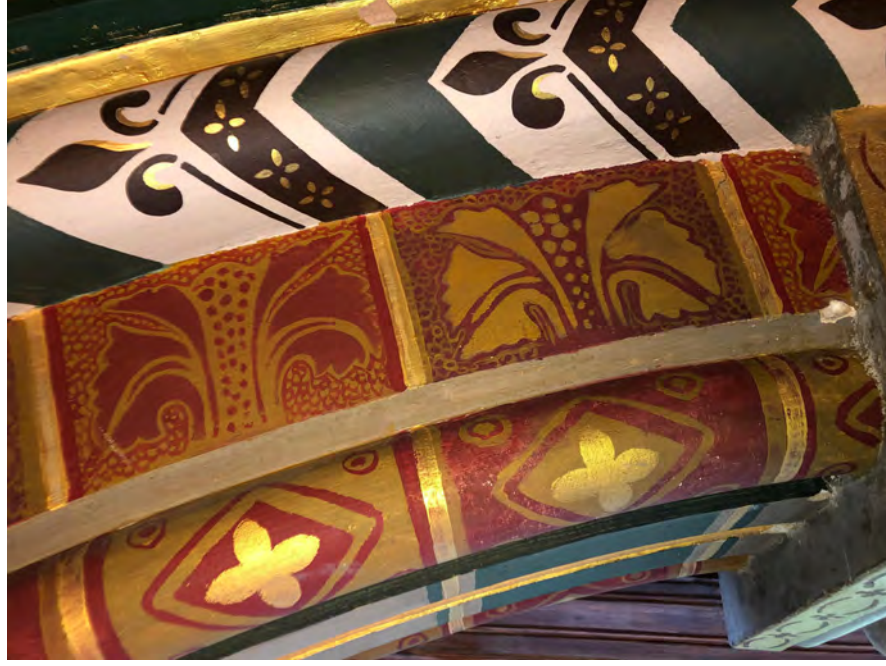
Figure 67: Current neo-gothic paint scheme in modern materials

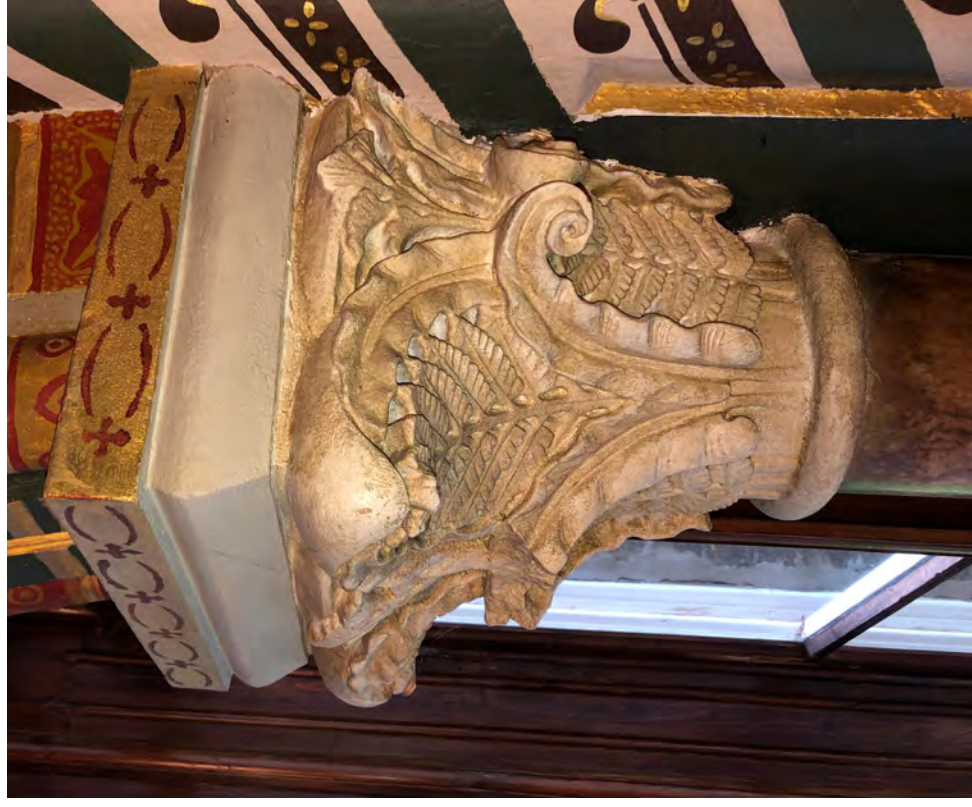
Figure 68: Modern 'stone colour' wash over the limestone capitals
