### Arboricultural Survey (BS5837:2012) & Impact Assessment

45 Highgate West Hill  
London  
N6 6DB

December 2020

AIA/MF/069/20

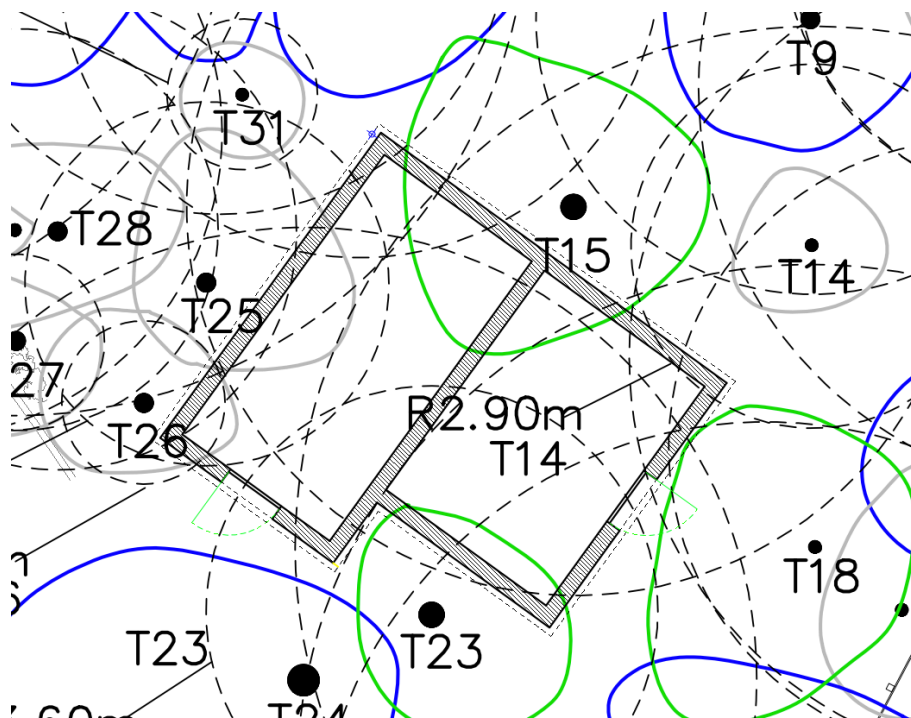
5.12 The proposed structure and access entrance to the outbuilding is sited within the RPA of the following trees:

T7, T8, T14, T15, T23, T24, T25, T26, T27

5.13 Additionally the proposed outbuilding is sited within very close proximity of the main stems of the following trees:

T15, T23, T25 & T26

5.14 The following extract from the TCP, drawing T002 demonstrates how the structure is sited within the central area where the trees do not exist meaning that the structure can be constructed without the loss of trees.

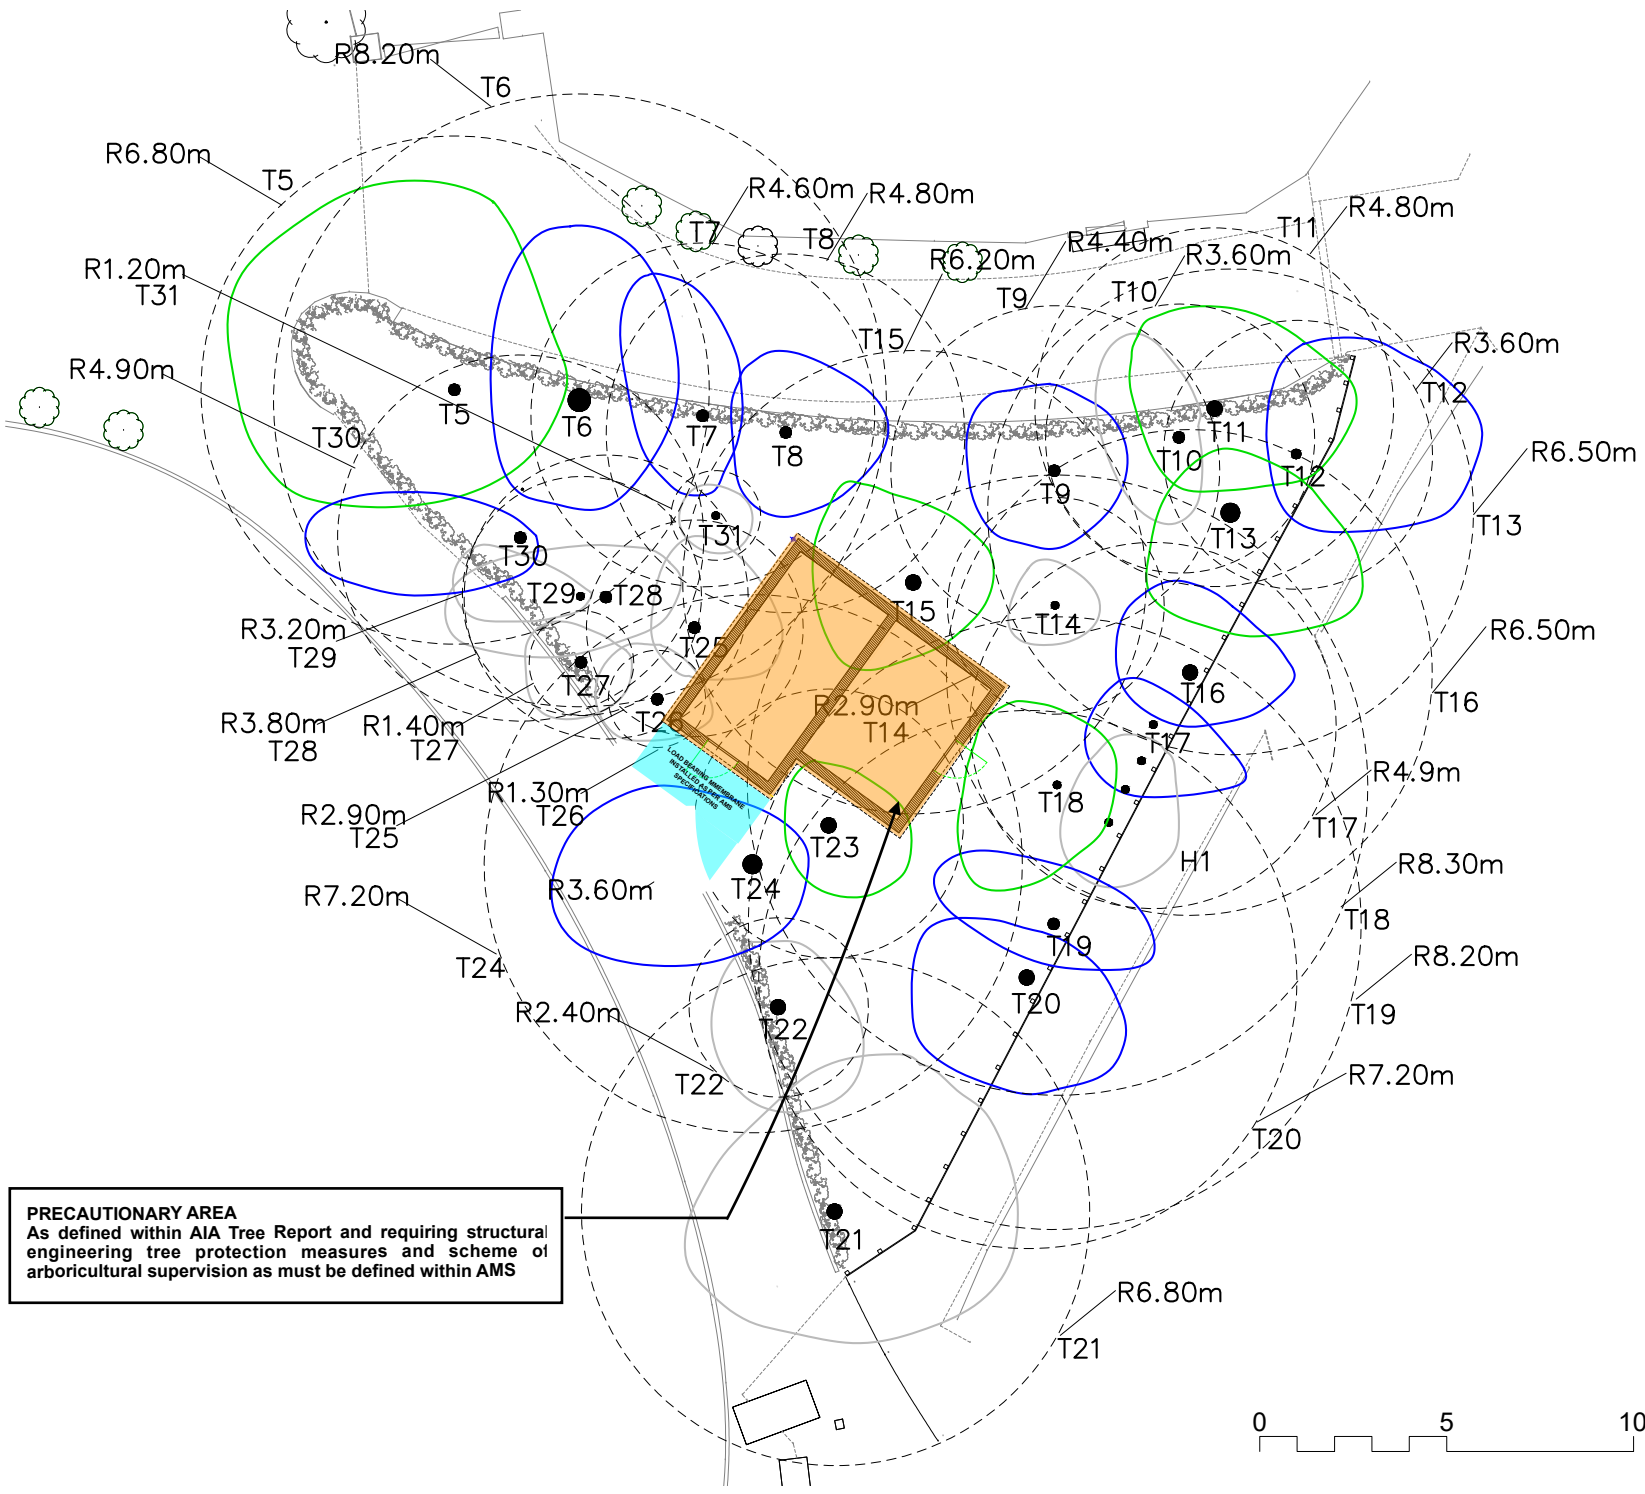
**PRECAUTIONARY AREA**  
 As defined within AIA Tree Report and requiring structural engineering tree protection measures and scheme of arboricultural supervision as must be defined within AMS

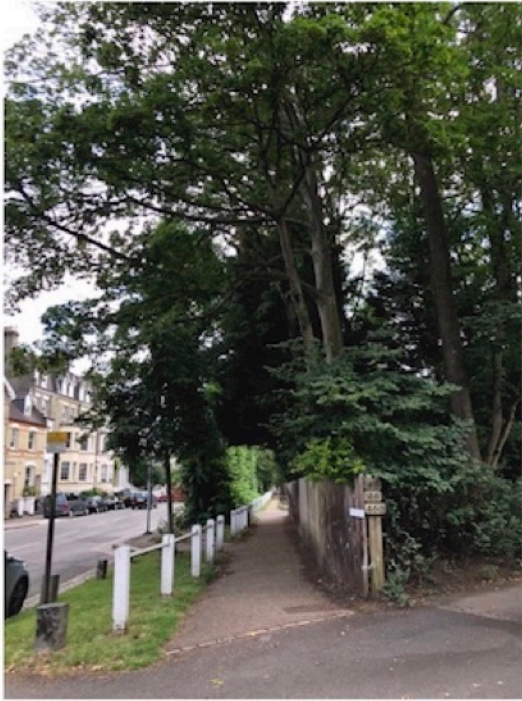
Trees T12-T21 at frontage with 45 Highgate West Hill as viewed in a southerly direction

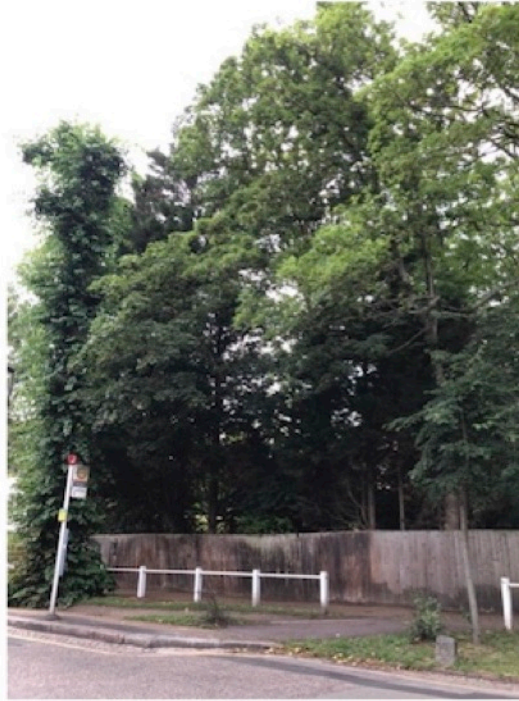
Trees T12-T21 at frontage with 45 Highgate West Hill as viewed in a westerly direction

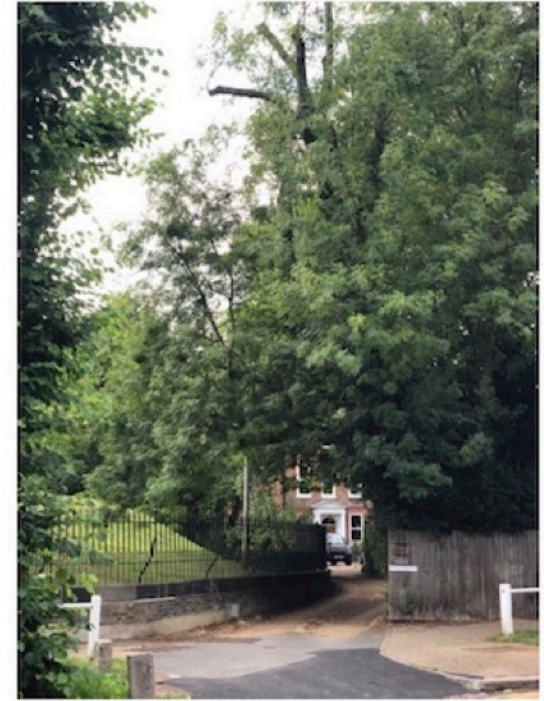
5.11 The exception is tree T21 - Ash, which is in declining condition and having been selectively heavily reduced. This tree also has low growth over the driveway which would require remedial works for significant access to the proposed development site. Remedial action may be required for reasons of health and safety which should be addressed independently or within the AMS.

Tree T21 as viewed in a westerly direction showing moderate form and declining vigour

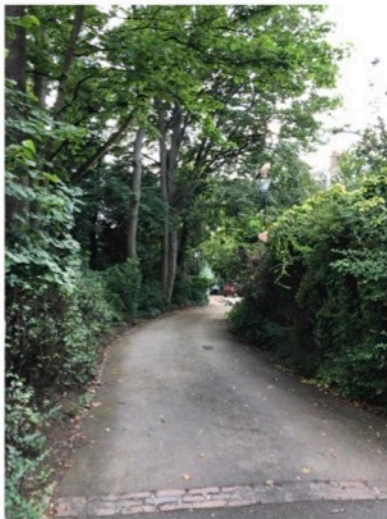
Northern access driveway from 45 Highgate West Hill with trees within woodland area to south as viewed to west

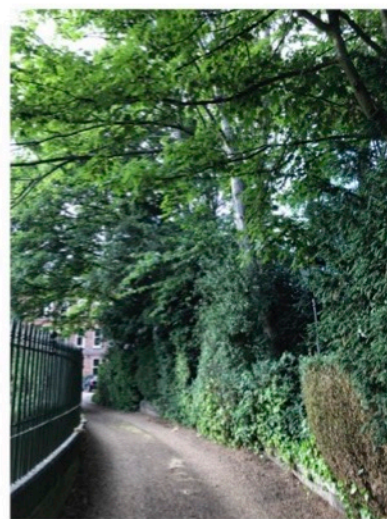
Southern access driveway from 45 Highgate West Hill with trees within woodland area to north

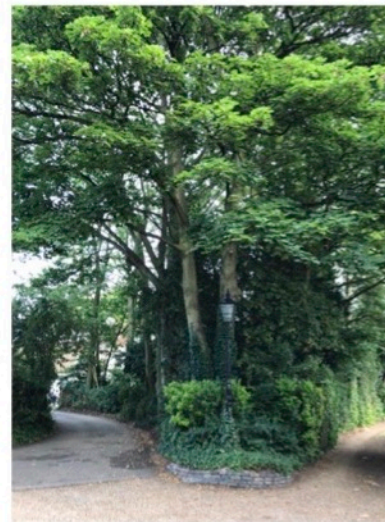
Southern and northern access driveway from 45 Highgate West Hill with trees within woodland area and T5 notably

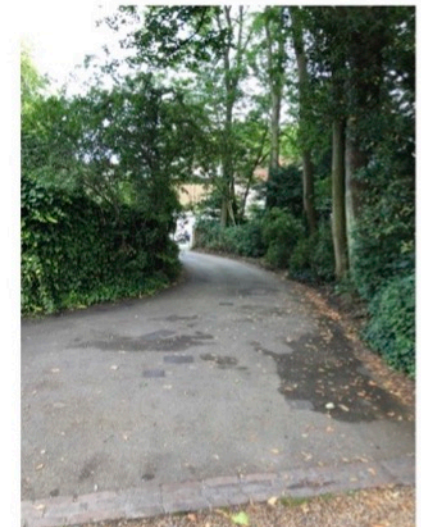
Northern access driveway from 45 Highgate West Hill with trees within woodland area to south as viewed to east
