Asbestos Demolition Survey

13-15 Johns Mews, London, WC1N 2PA

Job Ref: 1923

Survey Type: Asbestos Demolition Survey

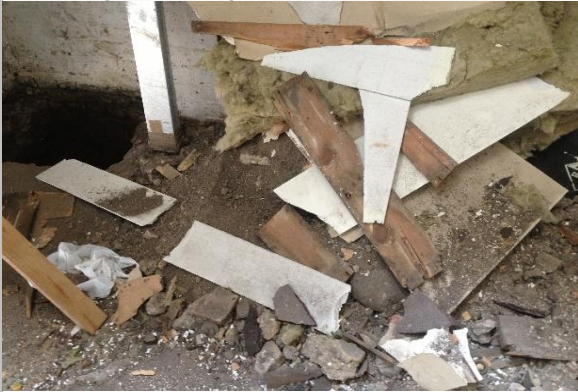
Item	Level	Location / Room number	Survey Type	Quantity	Sample Reference	
1	Ground	03 Garage	Asbestos Demolition Survey	5sqm	B04

Material Description		Material Risk			
	Insulation board		Product Type	2		
	Asbestos Type		Extent of Damage	3		
	Amosite		Surface Treatment	2		
			Asbestos Type	2		
	Additional Information		Score - Material Risk			
	Floor Debris		9	Medium		
	Recommendations		Accessibility			
	REMOVE BY LICENSED CONTRACTOR OR COMPETENT PERSON		Routinely disturbed			
			Review Date			
Ceiling	Wall	Flooring	Other

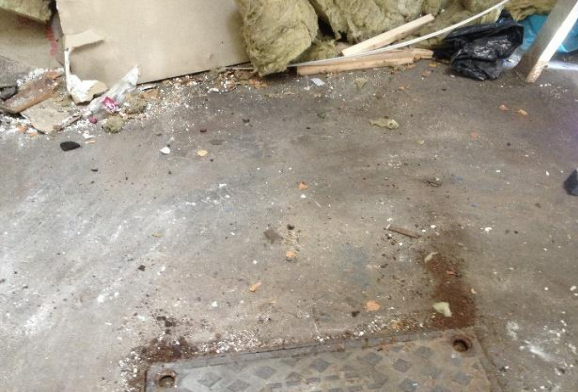
Item	Level	Location / Room number	Survey Type	Quantity	Sample Reference	
2	Ground	03 Garage	Asbestos Demolition Survey	5sqm	B05

Material Description		Material Risk			
	Insulation board		Product Type	2		
	Asbestos Type		Extent of Damage	3		
	Amosite		Surface Treatment	2		
			Asbestos Type	2		
	Additional Information		Score - Material Risk			
	Floor Debris		9	Medium		
	Recommendations		Accessibility			
	REMOVE BY LICENSED CONTRACTOR OR COMPETENT PERSON		Routinely disturbed			
			Review Date			
Ceiling	Wall	Flooring	Other

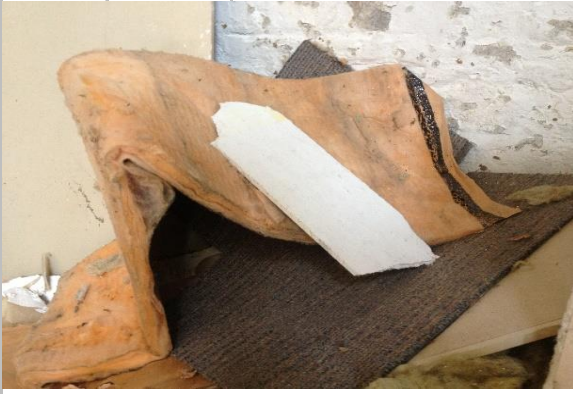
Item	Level	Location / Room number	Survey Type	Quantity	Sample Reference	
3	Ground	03 Garage	Asbestos Demolition Survey	5sqm	B06

Material Description		Material Risk			
	Insulation board		Product Type		2	
	Asbestos Type		Extent of Damage		3	
	Amosite		Surface Treatment		2	
			Asbestos Type		2	
	Additional Information		Score - Material Risk			
	Floor Debris		9		Medium	
	Recommendations		Accessibility			
	REMOVE BY LICENSED CONTRACTOR OR COMPETENT PERSON		Routinely disturbed			
			Review Date			
Ceiling	Wall	Flooring	Other

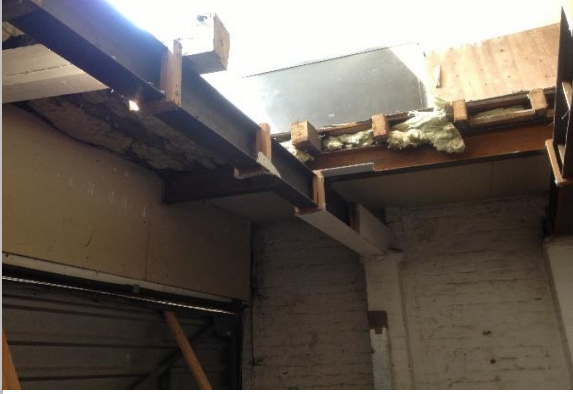
Item	Level	Location / Room number	Survey Type	Quantity	Sample Reference	
4	Ground	03 Garage	Asbestos Demolition Survey	6lm	B07

Material Description		Material Risk			
	Insulation board		Product Type		2	
	Asbestos Type		Extent of Damage		3	
	Amosite		Surface Treatment		2	
			Asbestos Type		2	
	Additional Information		Score - Material Risk			
	Beam		9		Medium	
	Recommendations		Accessibility			
	REMOVE BY LICENSED CONTRACTOR OR COMPETENT PERSON		Routinely disturbed			
			Review Date			
Ceiling	Wall	Flooring	Other

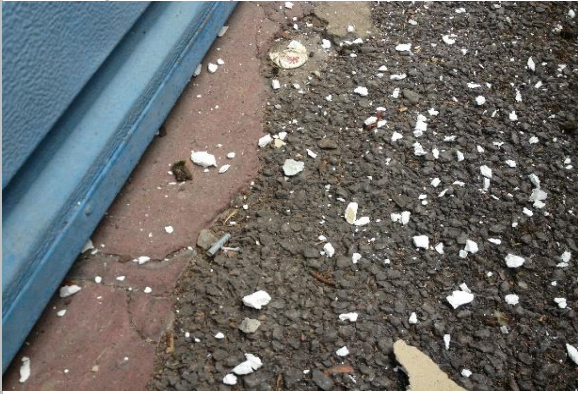
Item	Level	Location / Room number	Survey Type	Quantity	Sample Reference
5	Ground	External	Asbestos Demolition Survey	15sqm	B08

Material Description		Material Risk		
	Insulation board		Product Type	2	
	Asbestos Type		Extent of Damage	3	
	Amosite		Surface Treatment	2	
			Asbestos Type	2	
	Additional Information		Score - Material Risk		
	Floor Debris		9	Medium	
	Recommendations		Accessibility		
	REMOVE BY LICENSED CONTRACTOR OR COMPETENT PERSON		Routinely disturbed		
			Review Date		
Ceiling	Wall	Flooring	Other

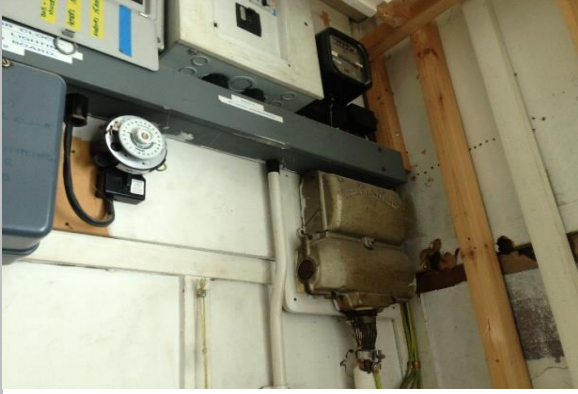
Item	Level	Location / Room number	Survey Type	Quantity	Sample Reference
6	Ground	02 Open Area	Asbestos Demolition Survey	1 unit	Pres 1

Material Description		Material Risk		
	Asbestos Textiles		Product Type	2	
	Asbestos Type		Extent of Damage	0	
	Crocidolite		Surface Treatment	2	
			Asbestos Type	3	
	Additional Information		Score - Material Risk		
	Fuse Box		7	Medium	
	Recommendations		Accessibility		
	REMOVE BY LICENSED CONTRACTOR OR COMPETENT PERSON		Likely to be disturbed during reburishment		
			Review Date		
Ceiling	Wall	Flooring	Other
