Regent's Canal Wall Survey

Revision A 2/12/2020

1 St Mark's Crescent London NW1 7TS

October 2020 Jonathan Freegard Architects

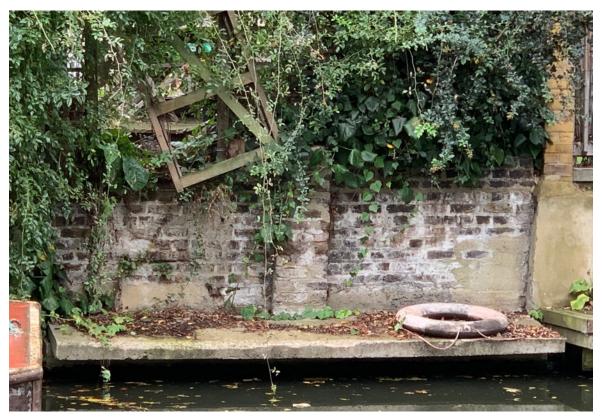
Canal Wall Photos

The canal wall is a 225mm – 750mm thick battered retaining brick wall. The width reaches 750mm thick at a depth of 1650mm with a three piers on the Canal side 340mm wide and projecting 110mm from the point just above water level where the wall steps. A trial pit carried out on 4/12/2019 showed the profile of the wall and is recorded with photos and an excavation log at the end of this survey report. There is a projecting 150mm thick concrete slab 300mm above water level forming a jetty. This slab was built pre-WWII and has rotated slightly over the last 80 years or so under its own weight. The jetty it forms matches the width of those at the properties on either side that are constructed of timber. The brickwork below the water line is firm and undisturbed by the slight rotation of the wall above.

It is proposed first to strengthen the wall from the rear garden side with a 250mm thick concrete retaining wall behind it, all hidden below ground level. This retaining wall will be secured from rotation by a 1m toe projecting beneath the garden and also by two transverse concrete walls containing in-set steps. This will spread the load over a greater width than at present thus reducing any load on the old brickwork beneath. The cantilevered slab (jetty) will then, subject to any necessary consents by The Canal and River Trust, be re-formed anchored to the concrete retaining wall and the facing brickwork towards the Canal rebuilt in the existing or matching reclaimed buff-coloured London stock bricks with the central pier retained as a feature. The slab and steps will be faced with yorkstone paving stones on the both the landing treads and step risers.

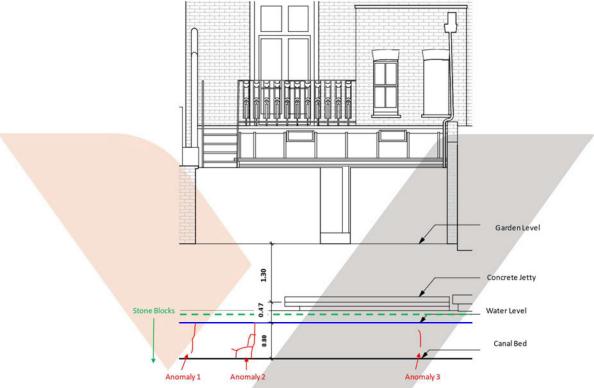
ROV INSPECTION AT 1 St Marks Crescent London 21/10/2020 (Regents Canal)

Anomaly 1 was located approximately 1.4 meters to the left of the outer edge of the jetty, this was a vertical crack approximately 5 to 10mm wide.

Anomaly 2 was the worst of the 3 anomalies, this was located approximately 1 meter to the left of the outer edge of the jetty, this crack has migrated across as seen in the diagram. The crack at its widest was at approximately 30mm.

Anomaly 3 was located approximately 875mm from the centre of the jetty, this was vertical and was approximately 20mm wide at is widest, this appears to be mortar that has come away from in between the brickwork.

Repairs to the limited cracks found in the canal wall below the water line will be carried out by a specialist firm using Rockbond Underwater Super Accelerated Mortar (RB UWSAM) powder. This is a blend of special cement powders, high quality graded sands, water soluble polymers and an unique combination of accelerating agents. The powder, when mixed with water, produces a rapid early strength mortar for underwater void filling and concrete repairs at freezing temperatures, and to fast stop the flow of water through cementitious surfaces, masonry, brick and stone.

After filling and sealing any leaking joints, cracks and channels, the mortar will be built up to the profile of the surrounding stonework and form a bridge of mortar over the joint.
