Addendum Arboricultural Report

Subsidence Damage Investigation at:

37 Lancaster Grove
London
NW3 4HB

CLIENT: Crawford & Company
 CLIENT REF: [REDACTED]
 MWA REF: [REDACTED]
 MWA CONSULTANT: George Peters BSc. (Hons), M.Arbor.A
 REPORT DATE: 17/12/2020

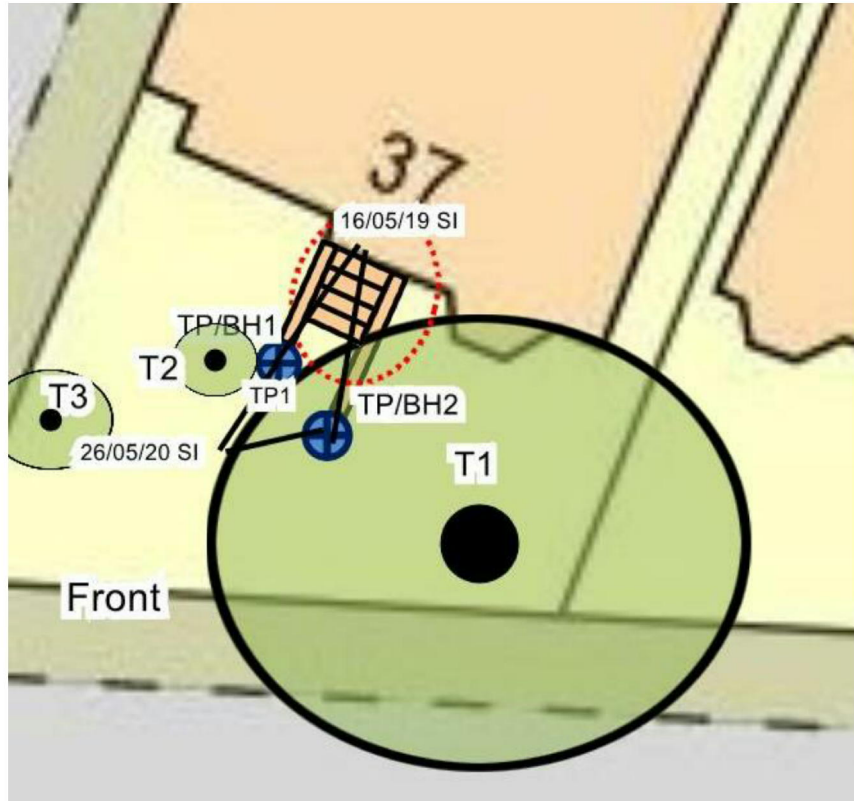
Site Plan

Approximate areas of damage

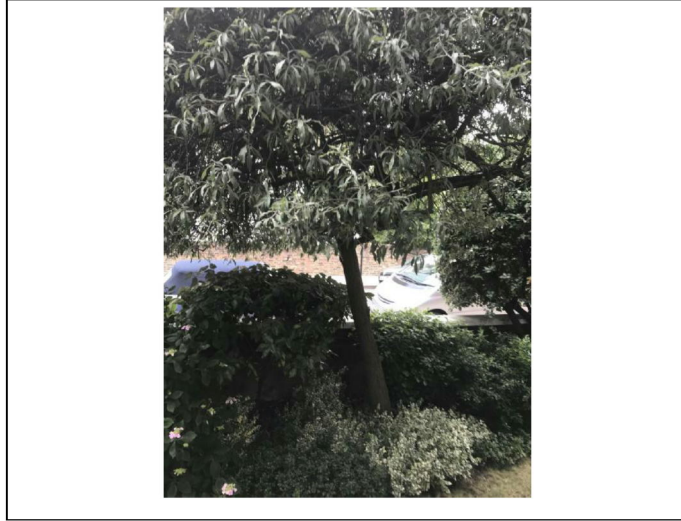
Tree No.	Species	Ht (m)	Dia (mm)	Crown Spread (m)	Dist. to building (m)	Age Classification	Ownership
T2	Cordyline	4	150	2.5	1	Younger than Property	Policy Holder
Management history		No recent management noted.					
Recommendation		None.					
T3	Willow Leaved Pear	3	120 *	2.8	4.5	Younger than Property	Policy Holder
Management history		No recent management noted.					
Recommendation		Maintain broadly at no more than current dimensions by periodic pruning.

View of T2 Willow leaved pear
