INITIAL TECHNICAL REPORT
Retained

DATE OF ISSUE:	20 th March 2020
OUR REFERENCE NO:	
YOUR REFERENCE NO:	
JR Clare MS Amlin Davies Group Ltd (Stoke) 2nd Floor, East Court Riverside Park Stoke-on-Trent Staffordshire ST4 4EY	Contover Trading Co Ltd 73 Aberdare Gardens London NW6 3AN

General view of property

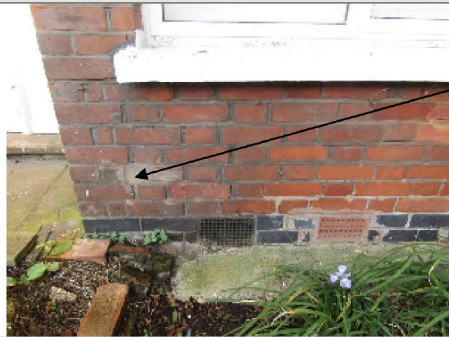
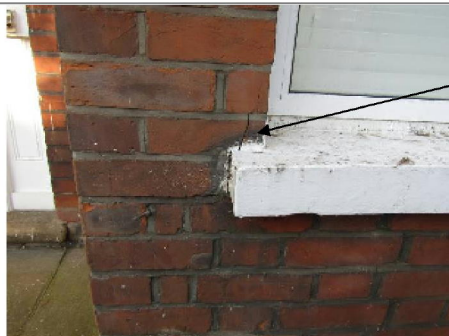
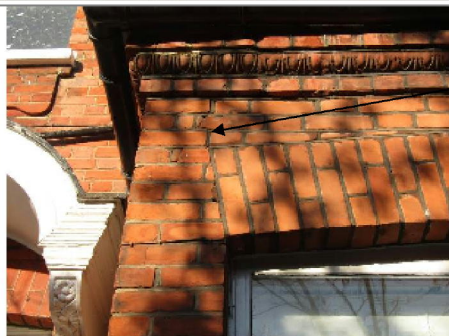
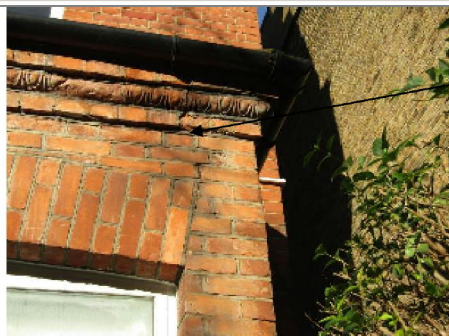
Diagonal and vertical tapering crack damage is evident within the face brickwork to the right and left front bay windows measuring up to 3mm in width.

Photograph 4 front RHS bay

Photograph 5 front RHS bay

Photograph 6 front RHS bay – above window

Photograph 7 front RHS bay – above window

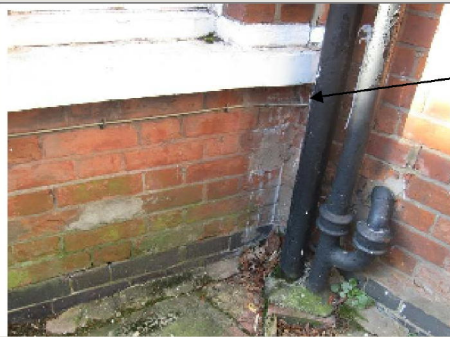
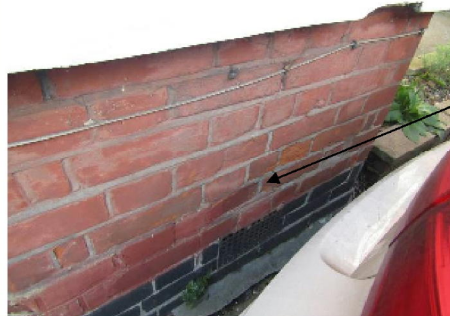
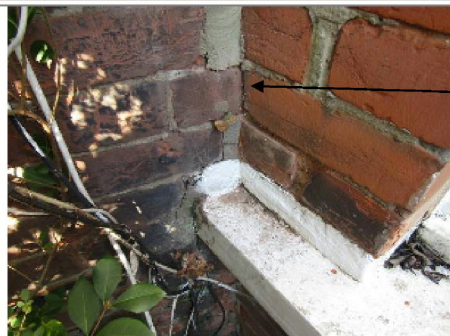
Photograph 8 front LHS bay – below window

Photograph 9 front LHS bay – below window

Photograph 10 front LHS bay – below window

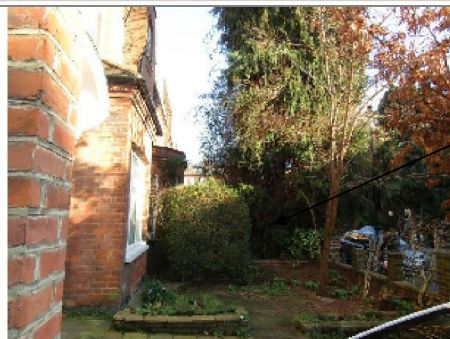
We suspect the underlying subsoil are being adversely affected by the presence of the trees growing within the boundaries of the front garden and the nearby tree vegetation located outside the boundaries of the garden to the right hand side.

Photograph 11 front PH and TP vegetation

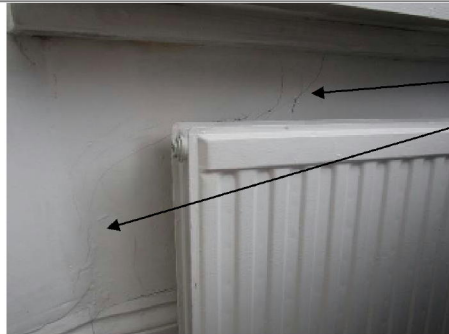
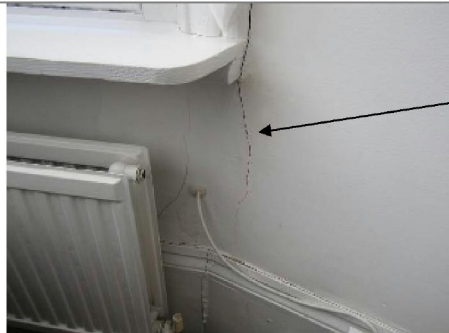
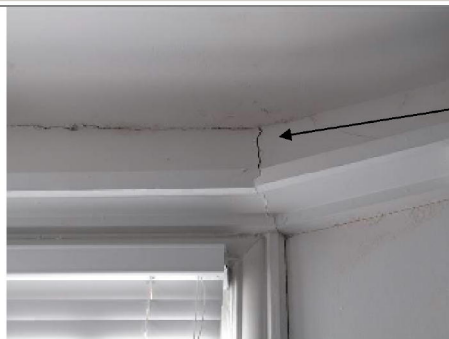
Internally crack damage measuring up to 3mm in width is located within the ground floor front bedrooms to either side of the left hand bedroom bay and to the return within the right hand bedroom.

Photograph 13 Front LHS bedroom – below bay window

Photograph 14 Front LHS bedroom – below bay window

Photograph 15 Front LHS bedroom – above bay window

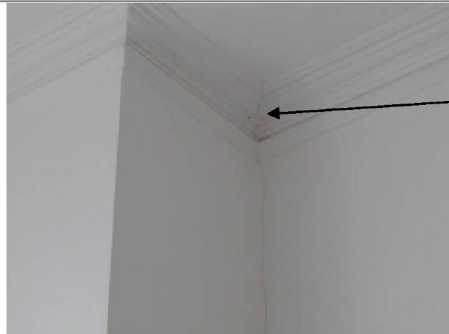
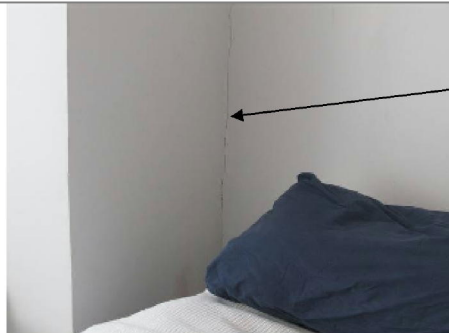
Photograph 17 Front RHS bedroom – high level
at bay return

Photograph 18 Front RHS bedroom – lower level
at bay return
