Addendum Arboricultural Report

Subsidence Damage Investigation at:

73 Aberdare Gardens
London
NW6 3AN

CLIENT: Davies Group Ltd
CLIENT REF: [REDACTED]
MWA REF: [REDACTED]
MWA CONSULTANT: Andy Clark
REPORT DATE: 07/10/2020

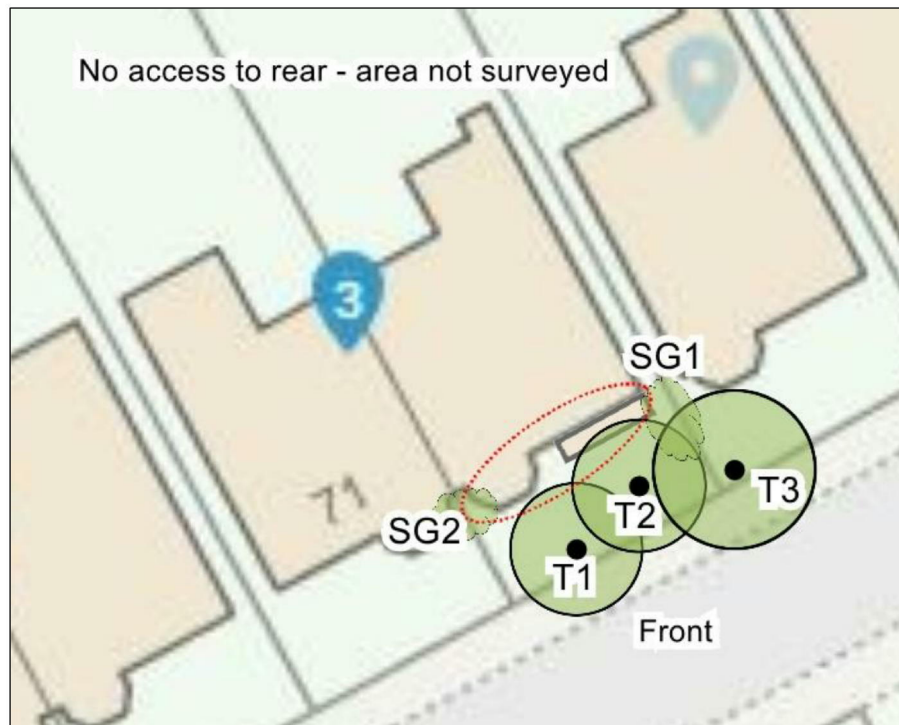
Site Plan

Approximate areas of damage

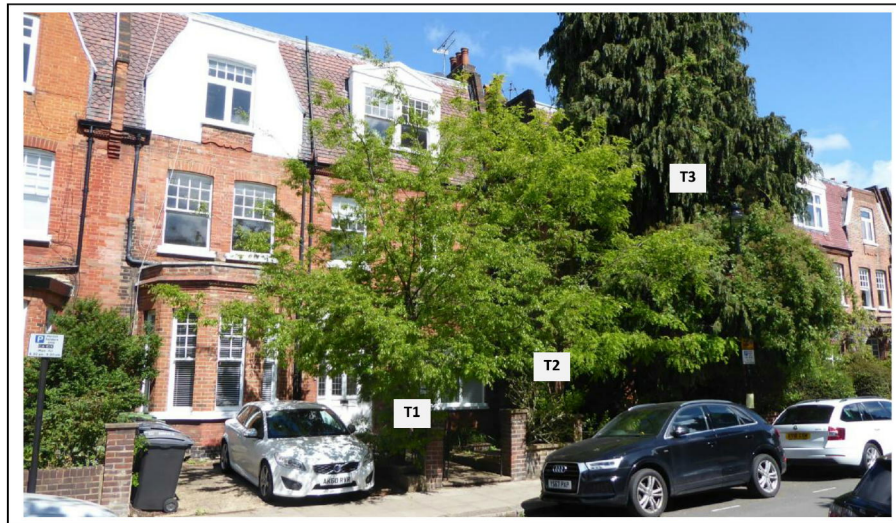
Our survey has previously identified vegetation within influencing distance of the building with a current potential to influence soil volumes below foundation level, the most significant of which in relation to the current damage were identified as T1 Oak [Quercus spp.], T2 False Acacia [Leguminosae spp.] and T3 Cypress [Cupressaceae spp.]. A potential for localised influence from SG1 and SG2 Privet groups [Oleaceae spp.] was also identified. The presence of corresponding roots samples retrieved from below the property foundations now confirms the influence of the related vegetation.

Overview of T1 Oak, T2 False Acacia and T3 Cypress

If an arboricultural solution is to be implemented to mitigate the influence of the trees/shrubs considered to be responsible for the damage we recommend that T1 Oak, T2 False Acacia, T3 Cypress are removed and that SG1 and SG2 Privet groups are reduced.

Tree No.	Species	Ht (m)	Dia (mm)	Crown Spread (m)	Dist. to building (m)	Age Classification	Ownership
T1	Oak	8.0	150	7.0	4.3	Younger than Property	Policy Holder
Management history		No significant past management noted.					
Recommendation		Remove (fell) to near ground level and treat stump to inhibit regrowth.					
T2	False Acacia	8.0	160	5.5	3.8	Younger than Property	Policy Holder
Management history		No significant past management noted.					
Recommendation		Remove (fell) to near ground level and treat stump to inhibit regrowth.					
T3	Cypress with climbing shrub throughout	16.0	420 *	5.0	4.1	Younger than Property	Third Party: 75 Aberdare Gdns, NW6 3AN
Management history		No significant past management noted.					
Recommendation		Remove (fell) to near ground level and treat stump to inhibit regrowth.					
SG1	Privet	3.0	30 Ms *	2.5	1.4	Younger than Property	Policy Holder
Management history		Subject to past management/pruning - appears regularly trimmed.

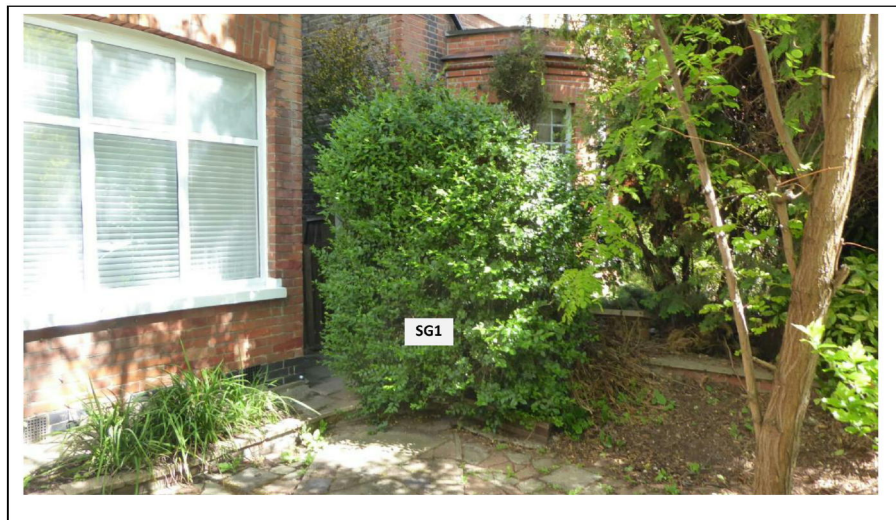
View of SG1 Privet

Recommendation		Reduce to ~2.0m height and prune annually to maintain at reduced size.					
SG2	Privet	3.5	30	2.5	0.8 *	Younger than Property	Policy Holder
Management history		No significant past management noted.					
Recommendation		Reduce to ~2.0m height and prune annually to maintain at reduced size.

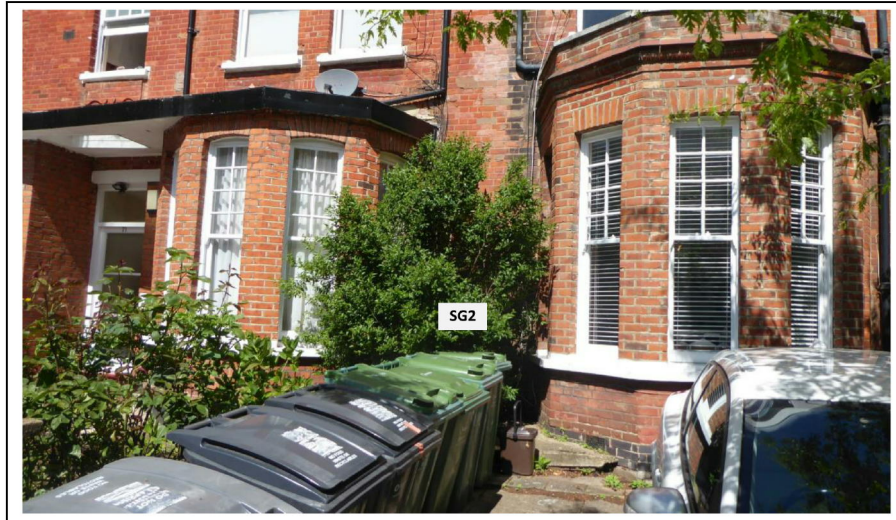
View of SG2 Privet
