Ref:
 LR02-20443-R1

#### **RE: 20-23 GREVILLE STREET LONDON – DISCHARGE OF CONDITION 13**

## Pre-construction & Construction Dust Monitoring

20-23 Greville Street, London

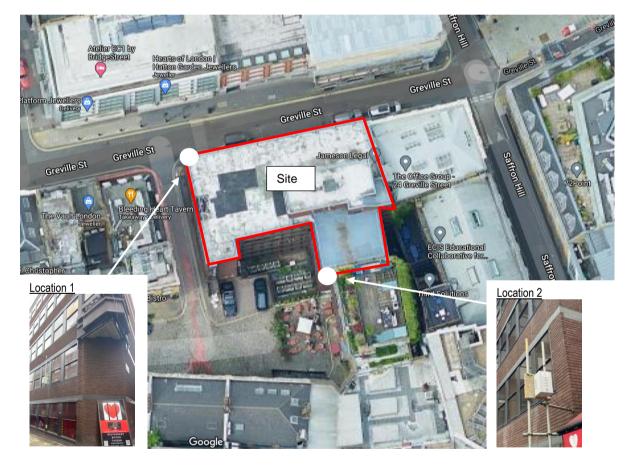
#### Figure 1 Construction Monitoring Locations

2.1 Two MCERTS <u>dust monitoring systems</u> are installed along the north-west and south-east site boundaries, as per the requirements of the project air quality monitoring plan prepared by Hilson Moran (report reference 28477-RP-SU-001 dated 3 June 2020). Camden Council expressed concerns regarding the siting of these monitoring units and this is discussed in further detailed in our letter report LR01-20443 dated 6 October 2020, included within Appendix 3 of this report. The monitoring positions were relocated on 30<sup>th</sup> September and the current positions are shown in Figure 1 below.

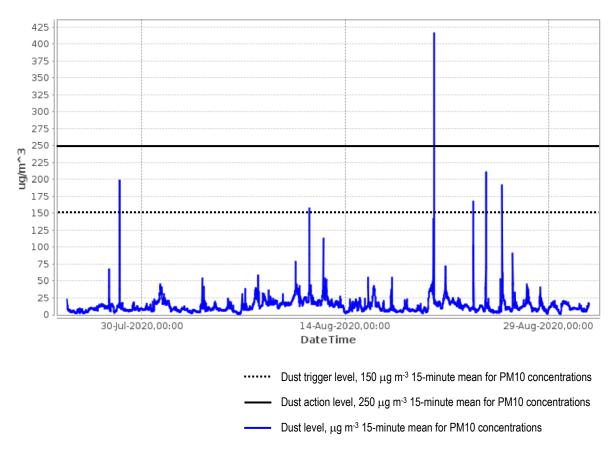
Location 1 – North-west corner of site

Average PM10 level during monitoring period – 13 µg/m<sup>3</sup>

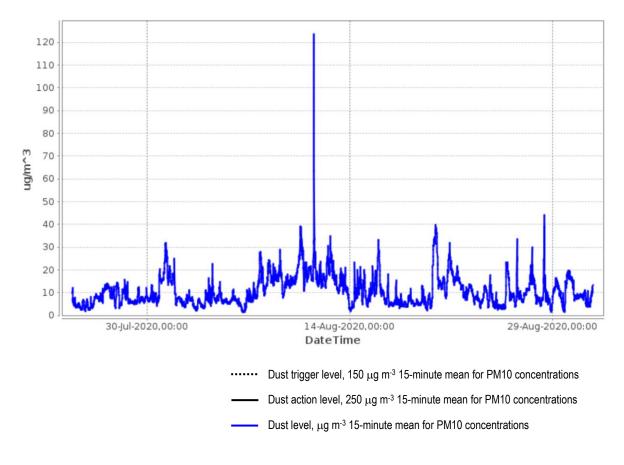
#### Location 2 - South-east corner of site

Average PM10 level during monitoring period – 11 µg/m<sup>3</sup>

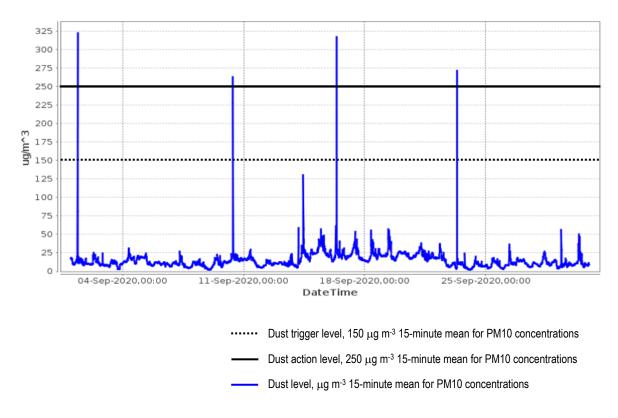
Location 1 – North-west corner of site

Average PM10 level during monitoring period – 15 µg/m<sup>3</sup>

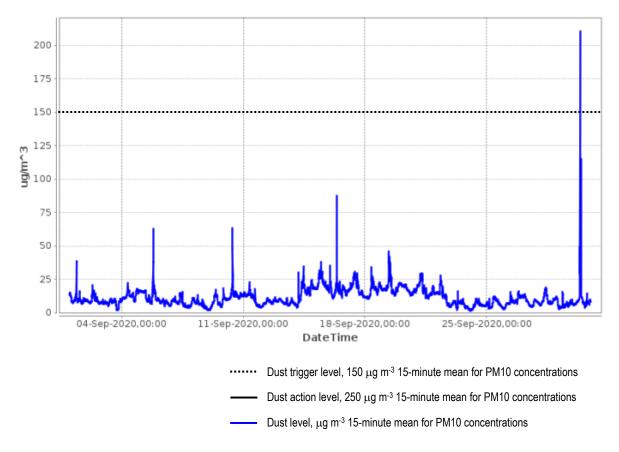
Location 2 - South-east corner of site

Average PM10 level during monitoring period – 11  $\mu$ g/m<sup>3</sup>

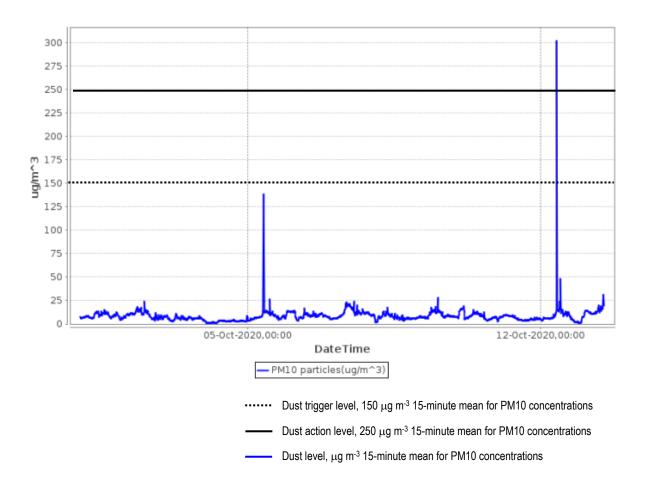
Location 1 – North-west corner of site

Average PM10 level during monitoring period (1st October to 13th October) - 9 µg/m<sup>3</sup>

Unfortunately, the monitor stopped working on 13<sup>th</sup> October unexpectedly and no data was recorded between midday on the 13<sup>th</sup> October until 11:15 hours on 27<sup>th</sup> October when a temporary replacement unit was installed whilst the permanent monitor is fixed by the equipment manufacturer.

It is understood that the replacement monitor will be shipped from the manufacturer w/c 9<sup>th</sup> November until the clients dust monitor is repaired under warranty.

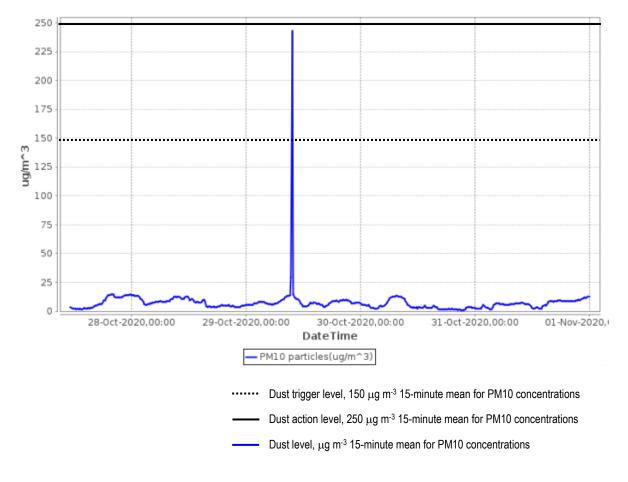
Average PM10 level during monitoring period (27<sup>th</sup> October to  $31^{st}$  October) – 7  $\mu$ g/m<sup>3</sup>

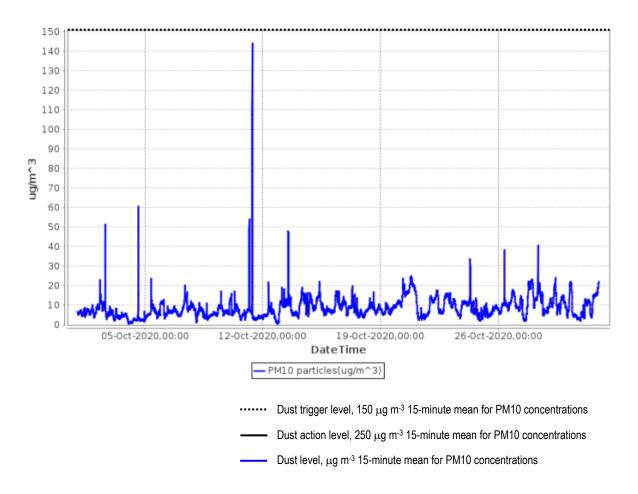
#### Location 2 - South-east corner of site

Average PM10 level during monitoring period –  $9 \ \mu g/m^3$

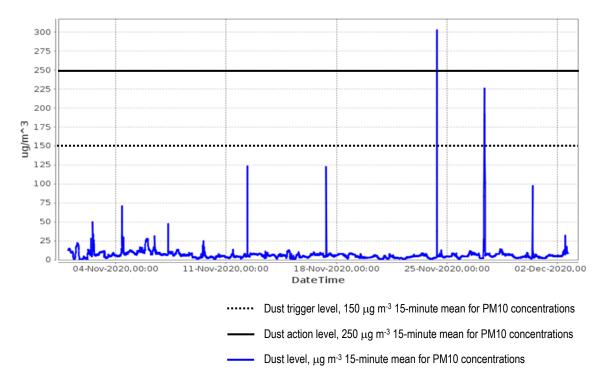
Location 1 - North-west corner of site

Average PM10 level during monitoring period - 7 µg/m<sup>3</sup>

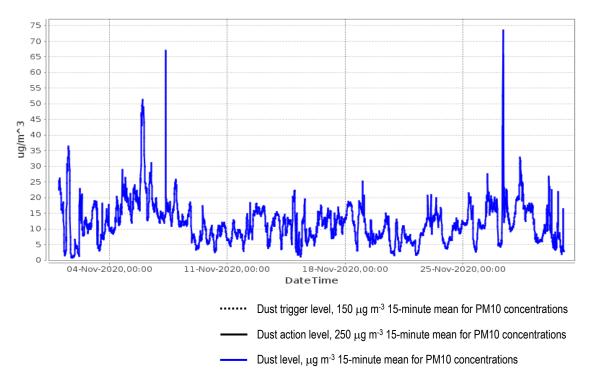
Average PM10 level during monitoring period – 12  $\mu$ g/m<sup>3</sup>

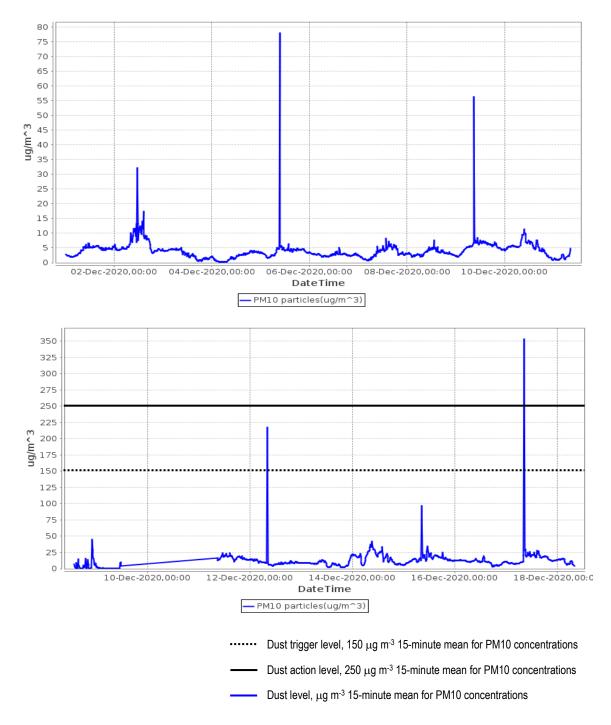
Location 1 - North-west corner of site

Average PM10 level during monitoring period – 4-13 µg/m<sup>3</sup>.

Unfortunately, the monitor stopped working at 0810 hours on 18<sup>th</sup> December unexpectedly and no further data was recorded. It is understood that this is due to a power issue (possibly a faulty power supply unit).

Cass Allen will visit the site as soon as possible in January following the Christmas shut down to resolve the issue and resume data collection.

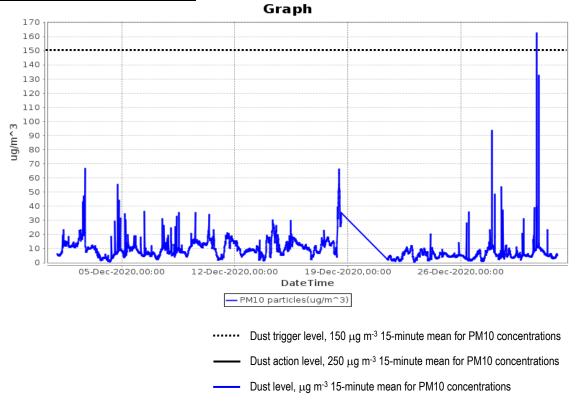
#### Location 2 - South-east corner of site

Average PM10 level during monitoring period –  $9 \mu g/m^3$ .
