**INITIAL TECHNICAL REPORT**  
**Retained**

| DATE OF ISSUE: | 20 <sup>th</sup> March 2020 |
| JR Clare<br>MS Amlin<br> | Contover Trading Co Ltd<br>73 Aberdare Gardens<br>London<br>NW6 3AN |

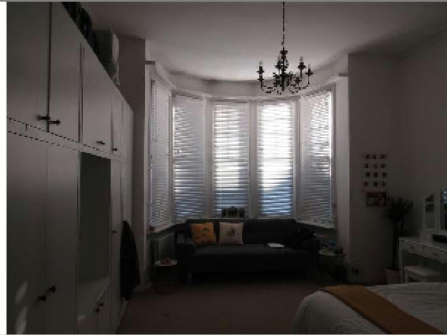
Photograph 12 Front LHS bedroom

Internally crack damage measuring up to 3mm in width is located within the ground floor front bedrooms to either side of the left hand bedroom bay and to the return within the right hand bedroom.
