# St Pancras Commercial Centre 63Pratt Street London NW1 oDQ

# Document Title: Asbestos and Demolition Survey

**Document number: Jo26352**

# **Demolition Survey**

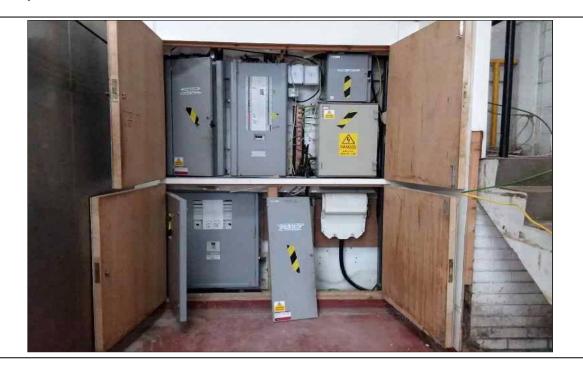
Analysis Product Type		Surface Treatment	Condition	Accessibility				
N/A	N/A	N/A	N/A	N/A				
Material Risk Score								
N/A

Material Risk Score	
Recommendation	Inspection Required
Comment	Inspect when isolated.

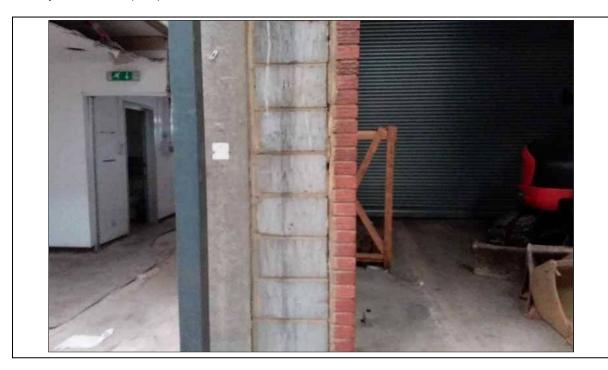
Analysis	Product Type	Surface Treatment	Condition	Accessibility
	Chrysotile (1)	Well Bound Material (1)	1	Low Damage (1)	Usually inaccessible or unlikely to be disturbed
ı	Material Risk Score				
	4			-

Material Risk Score	
Recommendation	Remove in accordance with CAR 2012
Comment	N/A

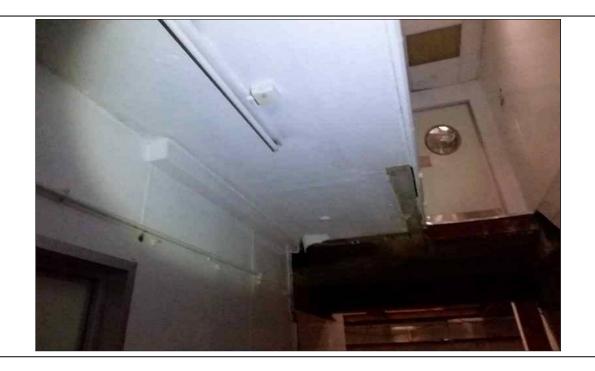
Analysis	Product Type	Surface Treatment	Condition	Accessibility
Chrysotile (1)	Textured Coating (1)	1	Medium Damage (2)	Usually inaccessible or unlikely to be disturbed
Material Risk Score				
5

Material Risk Score	
Recommendation Remove in accordance with CAR 2012	
Comment	N/A

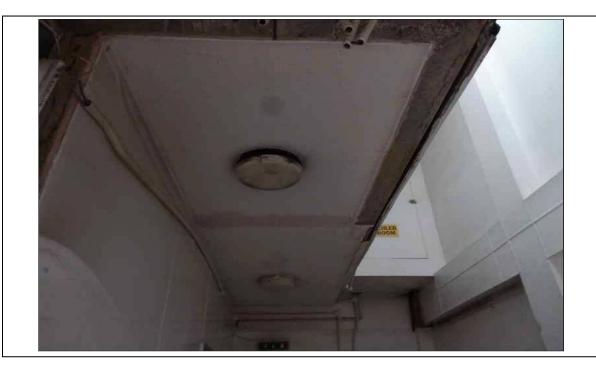
A	Analysis	Product Type	Surface Treatment	Condition	Accessibility
(	Chrysotile (1)	Textured Coating (1)	1	Low Damage (1)	Usually inaccessible or unlikely to be disturbed
1	Material Risk Score				
4	1			-

Material Risk Score		
Recommendation	Remove in accordance with CAR 2012	
Comment	N/A

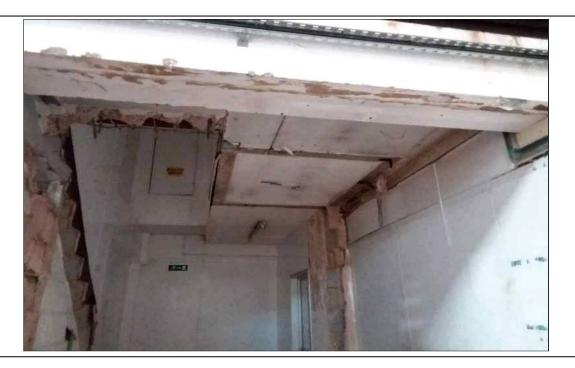
Analysis	Product Type	Surface Treatment	Condition	Accessibility
Chrysotile (1)	Textured Coating (1)	1	Low Damage (1)	Usually inaccessible or unlikely to be disturbed
Material Risk Score				
4			-

Material Risk Score	
Recommendation	Remove in accordance with CAR 2012
Comment	N/A

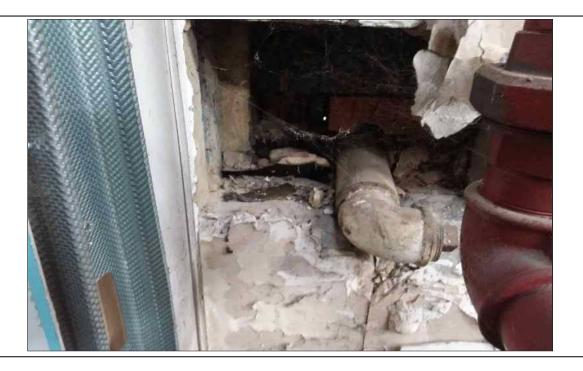
Building	Floor	Room
St Pancras Commercial Centre	Ground	Units 7,8,9,10. G01

Analysis	Product Type	Surface Treatment	Condition	Accessibility
Chrysotile (1)	Well Bound Material (1)	0	Low Damage (1)	Usually inaccessible or unlikely to be disturbed
Material Risk Score				
3			-

Material Risk Score	
Recommendation	Remove in accordance with CAR 2012
Comment	N/A

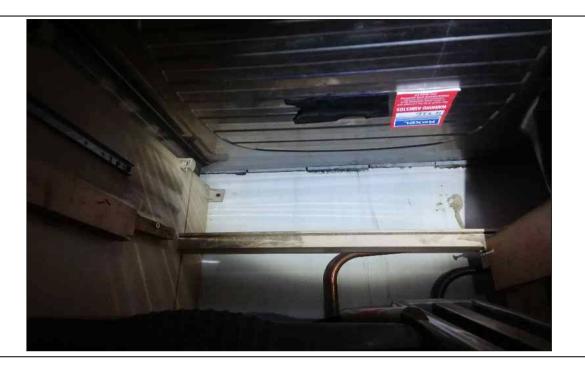
Analysis	Product Type	Surface Treatment	Condition	Accessibility
Chrysotile (1)	Well Bound Material (1)	0	Low Damage (1)	Usually inaccessible or unlikely to be disturbed
Material Risk Score				
3

Material Risk Score	
Recommendation	Remove in accordance with CAR 2012
Comment	N/A

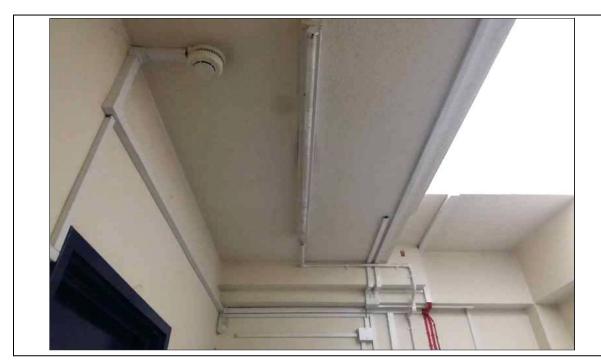
A	Analysis	Product Type	Surface Treatment	Condition	Accessibility
(	Chrysotile (1)	Textured Coating (1)	1	Low Damage (1)	Usually inaccessible or unlikely to be disturbed
1	Material Risk Score				
4	1			-

Material Risk Score	
Recommendation	Remove in accordance with CAR 2012
Comment	N/A

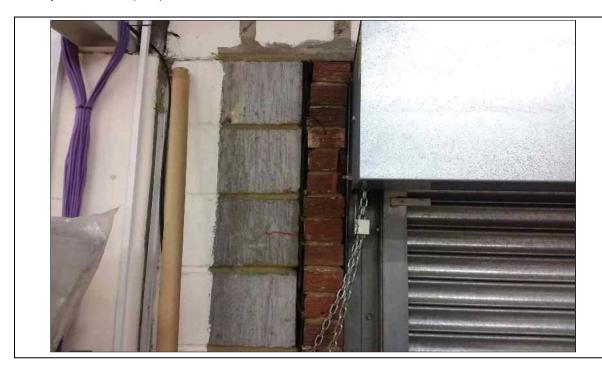
Analysis	Product Type	Surface Treatment	Condition	Accessibility
Chrysotile (1)	Well Bound Material (1)	2	Low Damage (1)	Usually inaccessible or unlikely to be disturbed
Material Risk Score				
5			-

Material Risk Score	
Recommendation	Remove in accordance with CAR 2012
Comment	N/A

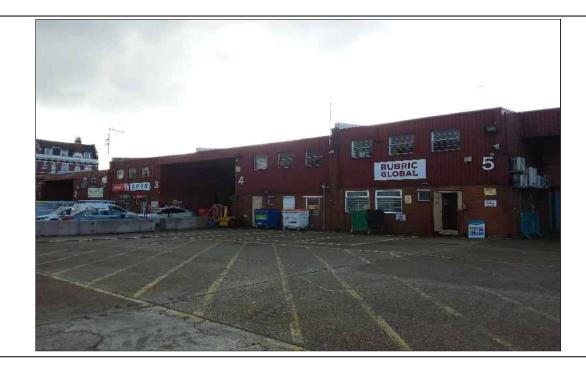
Analysis	Product Type	Surface Treatment	Condition	Accessibility
Chrysotile (1)	Asbestos Cement (1)	1	Low Damage (1)	Usually inaccessible or unlikely to be disturbed
Material Risk Score				
4			-

Material Risk Score	
Recommendation	Remove in accordance with CAR 2012
Comment	N/A
