# LAND CONTAMINATION REMEDIATION VERIFICATION REPORT

in connection with the proposed development at

254 KILBURN HIGH ROAD  
CAMDEN

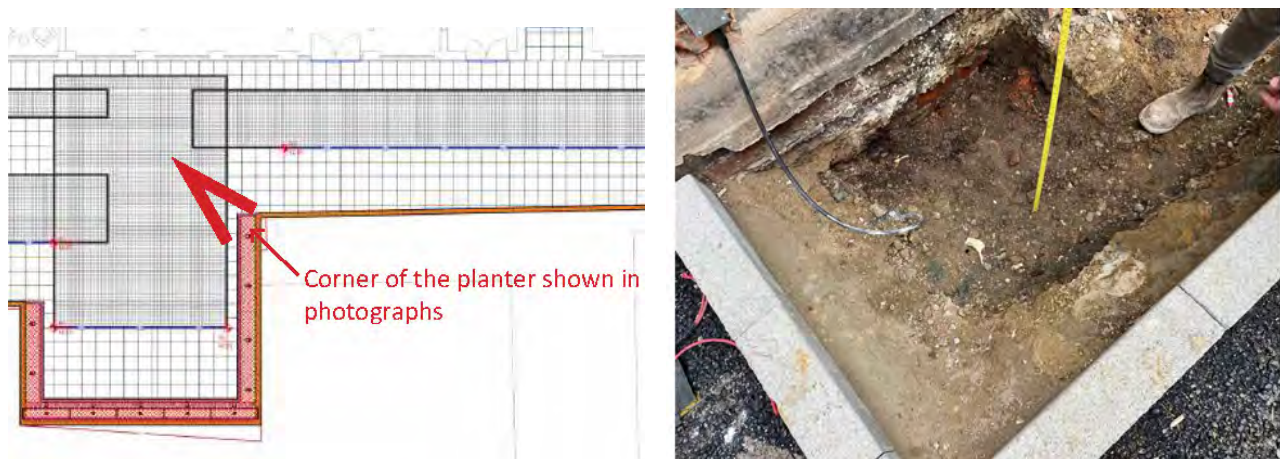
Evidence of removal of existing made ground soil to a depth of approximately 800mm in the area of the planter is provided in the photograph below (extracted from Appendix A).

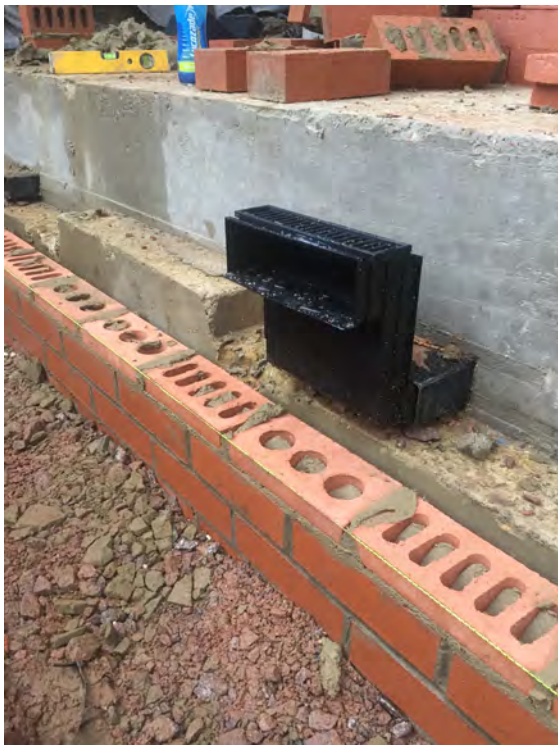
It should be noted that the Geoshield reports incorrectly assigned a score of 2 for the structural floor and 1.5 for the venting, whereas BS8485 Table 5 permits a maximum score of 1.5 for a reinforced cast in situ suspended floor slab and that BS8485 App B7 for polystyrene void formers permits a maximum score of 2 points for polystyrene shuttering with an equivalent clear void depth of less than 60mm and side ventilation openings meeting the requirements of BS8485 App B6, which for CS2 requires a minimum area of side ventilation of 1,500 mm<sup>2</sup>/m run of wall on at least two opposite sides.

SIDE VENTILATION

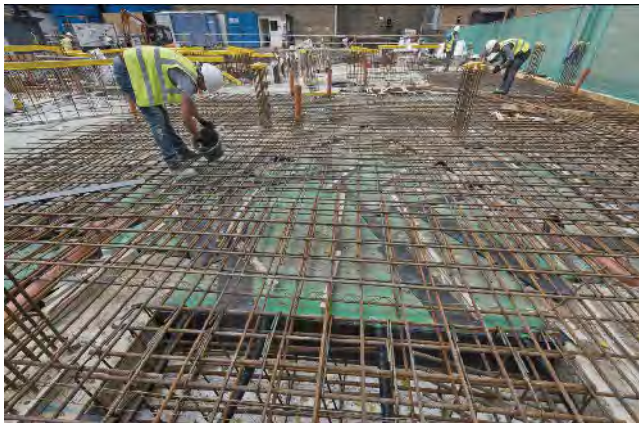
- Reinforced cast in situ suspended floor slab with minimal penetrations      SCORE 1.5
- Cordek Sub Cellvent 205 HX9/13 Sub-Floor Ventilation      SCORE 2.0

REINFORCED CAST IN SITU FLOOR SLAB

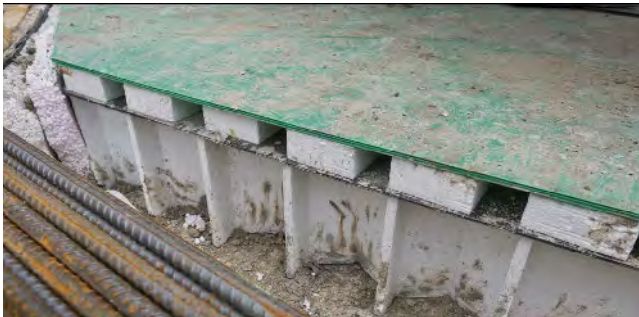
CORDEK Cellvent laid on heave protection

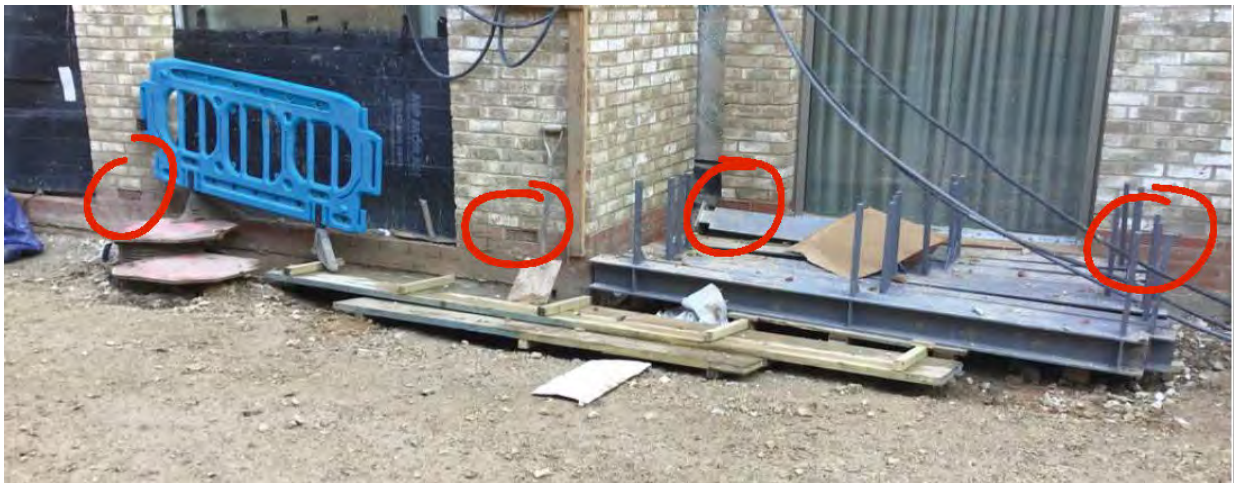
SUB-FLOOR VENTILATION POINTS

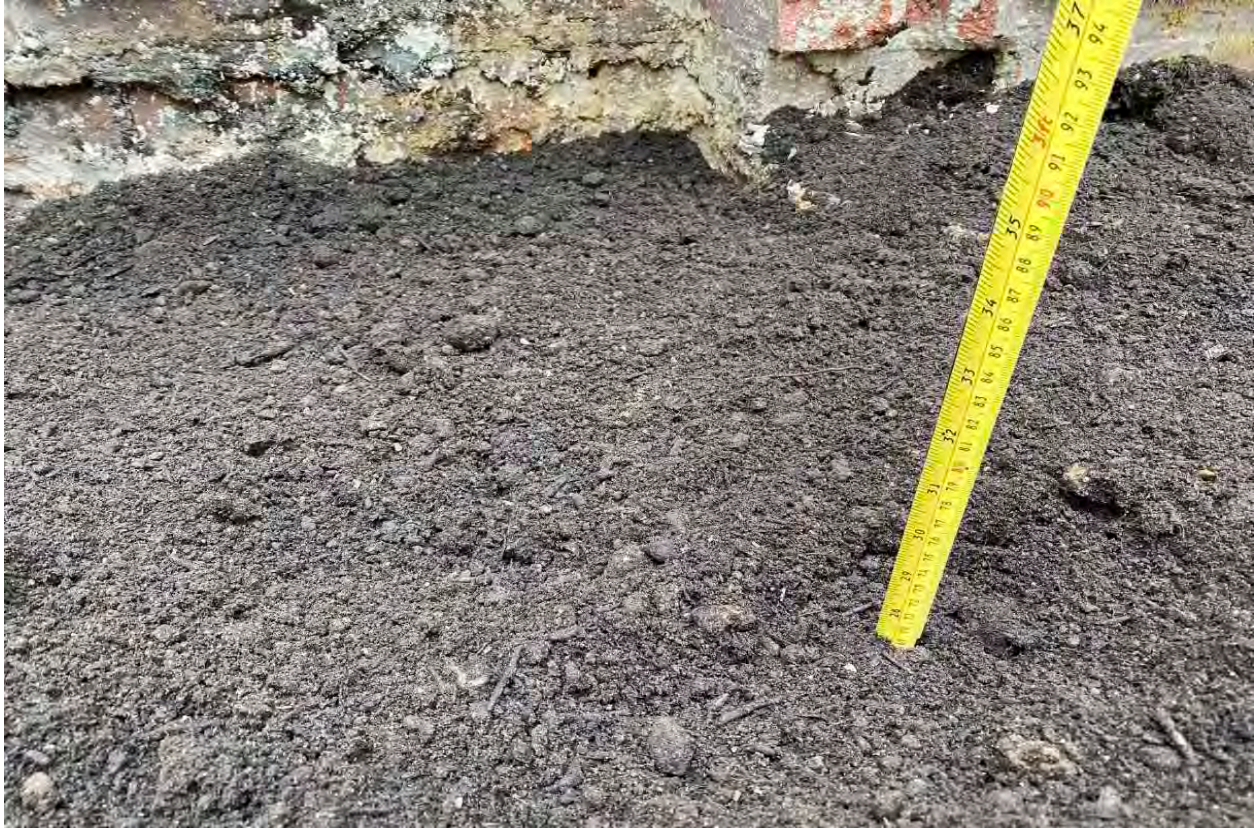
The photograph below (extracted from appendix C) provides evidence of filling of the planter with topsoil with a depth of topsoil in excess of the 600mm requirement in the approved Remediation Strategy.

It is noted that there is no evidence of a geotextile marker having been placed at the base of the assuredly clean soil. Although this detail was included in the approved remediation strategy it is considered unnecessary in the light of the extremely small scale of the soft landscaped area involved.

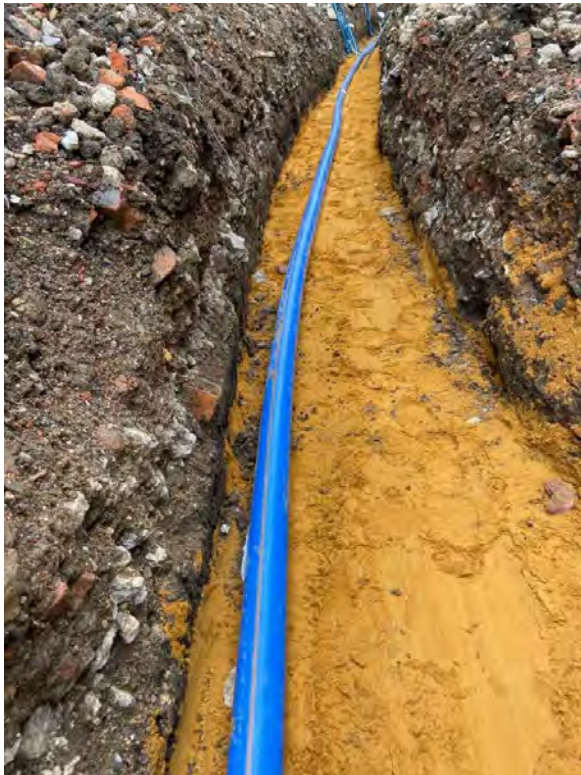
Photographic evidence of the use of Barrier Pipes is included in Appendix D and, as can be seen from the photos below extracted from Appendix D, it is identified as GPS PE Protecta-Line.

SITE PHOTO SHOWING BARRIER PIPE BEING INSTALLED

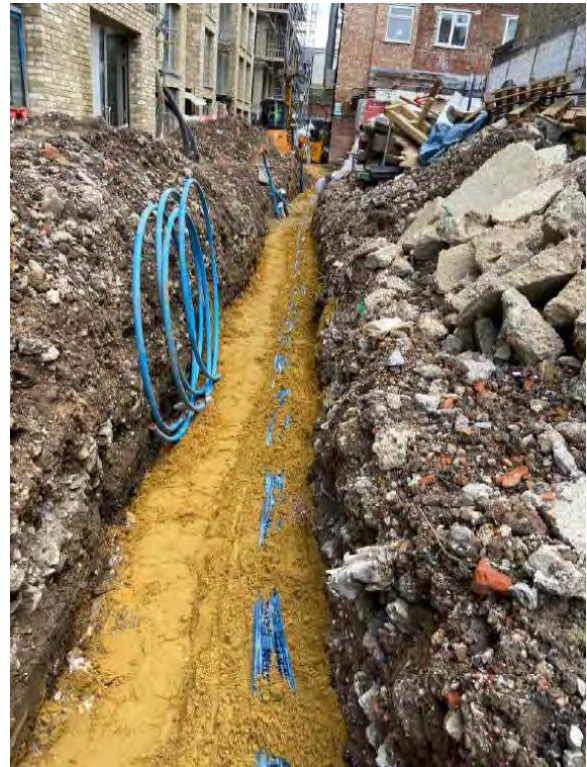
LOCATION VERIFICATION PHOTO SHOWING  
DEVELOPMENT ON LEFT

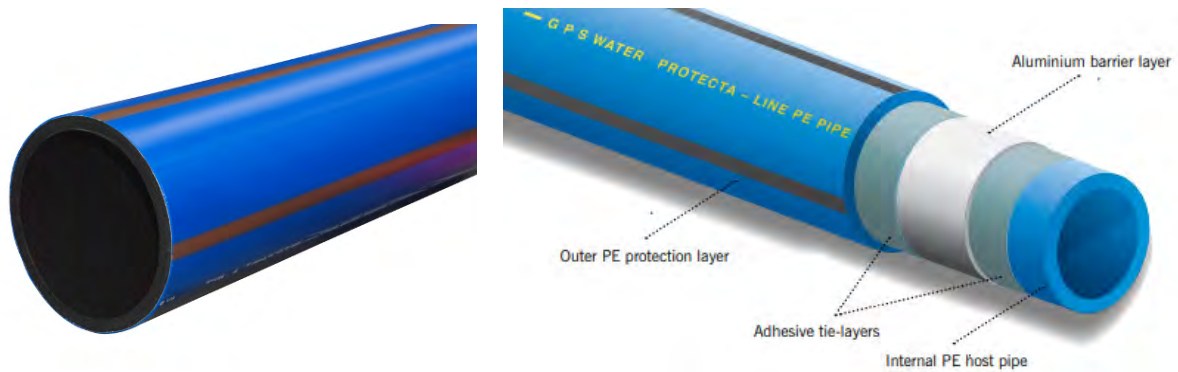
GPS PE Protecta-Line is usually accepted as a Barrier Pipe for the transportation of water through brownfield sites / contamination land and is understood to comply with BS 8588:2017 *Polyethylene pressure pipe with an aluminium barrier layer and associated fittings for potable water supply in contaminated land*.

GPS PE Protecta-Line Barrier Pipe
