TECHNICAL REPORT ON A SUBSIDENCE CLAIM

Brookfield Mansions (Freehold) Limited
25-56 Brookfield Mansions
5 Highgate West Hill
London
N6 6AT

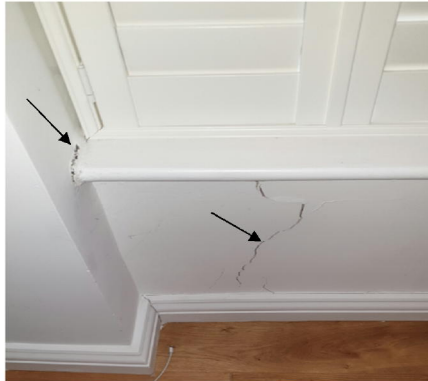
Crack to bay in flat 26.

- 3mm diagonal crack below the cill to right elevation of the south east bay.
- 0.5mm crack noted above head of the right elevation of the south east bay.
- 0.75mm crack below the cill to front elevation window of the south east bay.
- Cracking was noted to the junction between right and front elevations of the bay.
- Cracking was noted running along the cornice above bay.

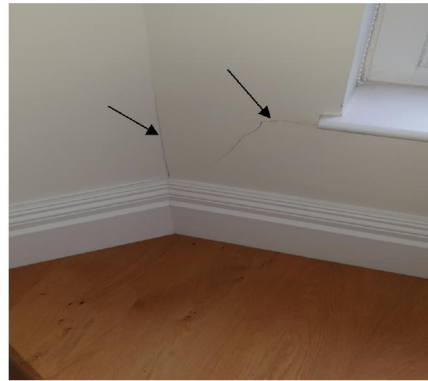
Crack to bay in flat 28

- 0.5mm crack below the cill to the right elevation window of the south east bay.
- 0.5mm crack at junction of right elevation and front elevation of the south east bay.
- 0.75mm crack below the cill to the front elevation window of the south east bay.
- Hairline cracks were noted over the window heads to front and right elevation and balcony door of the south east bay.

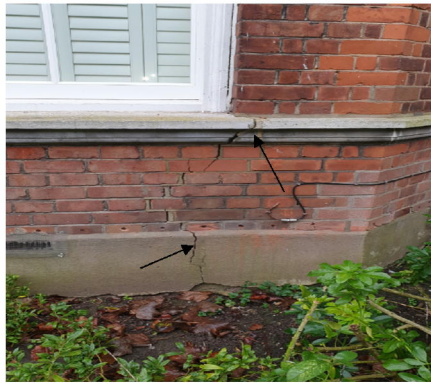
Cracking to ground floor bay (Right Elevation)

- 8mm stepped cracking was noted to the right elevation window radiating from cill down to ground level through render plinth.
- A separation gap was noted between the window frame and brickwork.
- The window sash was noticeably out of square.
- 1-2mm crack was noted above head of the right elevation window running from the arch to underside of the cill to the first floor window.
- 1mm crack was noted below the cill to the front elevation of the bay.
- 1mm crack was noted above the front elevation bay window.

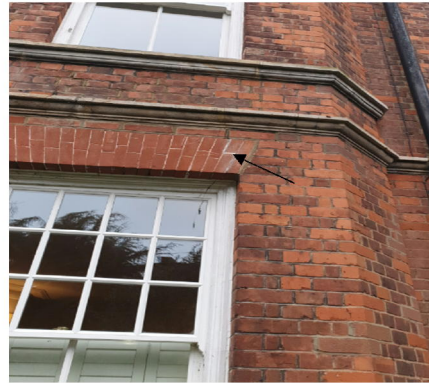
Cracking to first floor bay (Right Elevation)

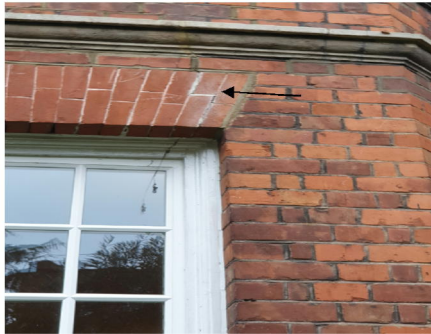
Close up of cracking to first floor bay (Right Elevation)

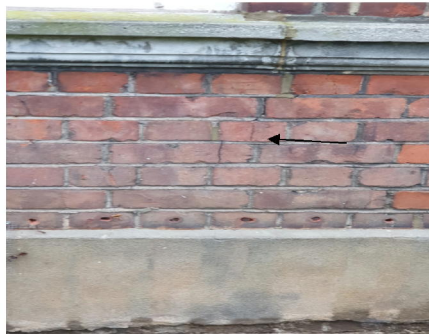
Cracking to ground floor bay (Front Elevation)

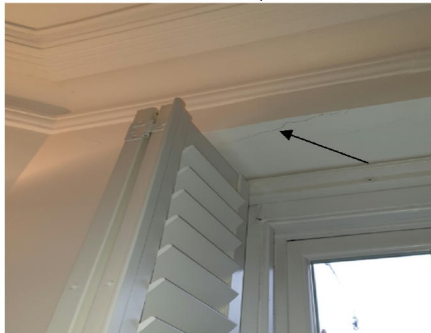
Crack to bay area of flat 26.

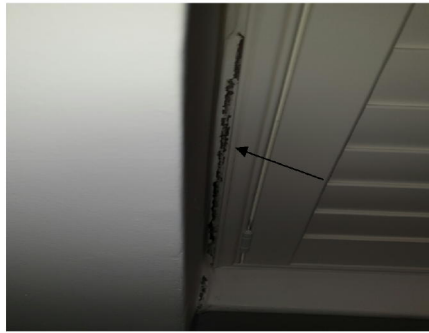
Crack to bay area of flat 26.

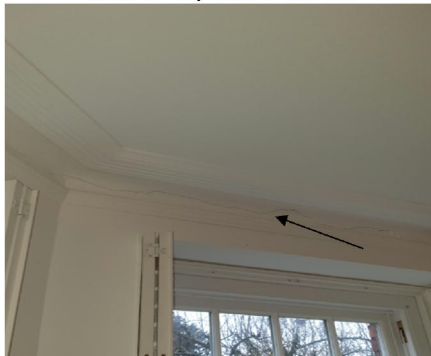
Crack to bay and cornice flat 26.

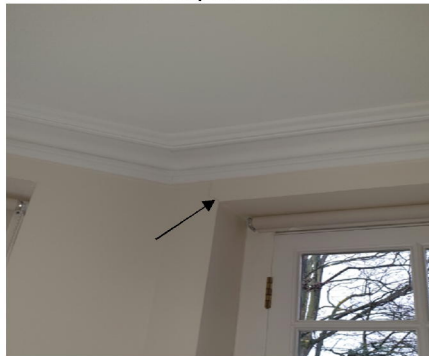
Crack to bay flat 28
