Photographic Audit with Heritage Survey of 37 Doughty Street

January 2021

This Report is to support the Heritage Statement and the Planning Application and Listed Building Application for the proposed internal and external alterations to 37 Doughty Street.

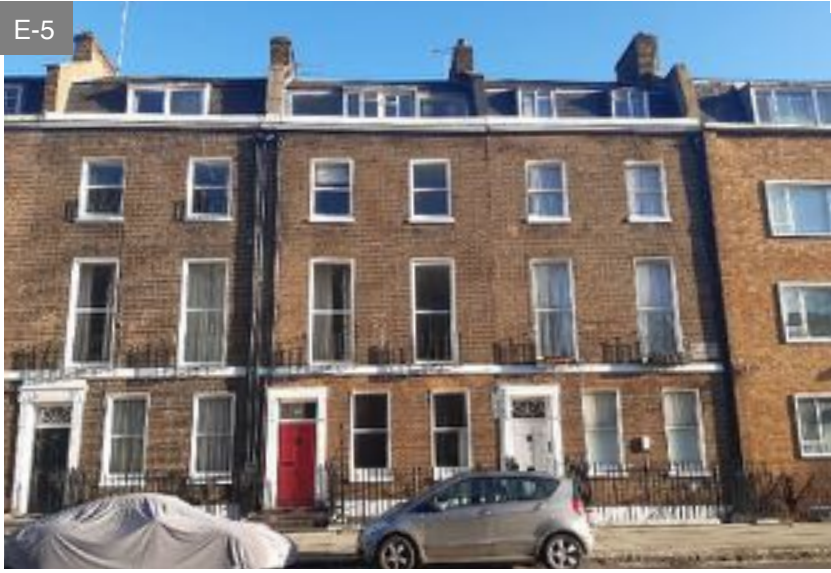
E-7

The brickwork to the front of the property looks in poor condition with patches of spalling (E-5). On close inspection the mortar is very rigid and pronounced and presumed to be cement based (E-7).
