# Design and Access Statement St Benet's Church, Lupton Street, Kentish Town

Project: Roof Drainage

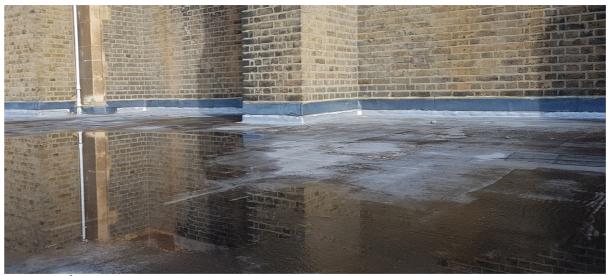
### **Lady of Walsingham Chapel**

This roof has a large flat surface and in addition it takes three downpipes discharging from the pitched roof above. It is probable that the roof has a slight sag in the centre and a fault in the asphalt has allowed water to get into the roof and leaks are noticed from time to time.

Note this roof has been repaired frequently within the last twenty years and there is a recent patch repair to the centre of the roof *(below right)* so a more radical remedy is required.

To remedy this it is proposed to create a central channel to draw water accumulating at this point to an additional outlet (there are only two and the one at the far corner has a history of blockages.) The new central outlet would have a matching hopper-head as the present one at the end which matches those at Bodley's eaves. This would be taken from the north elevation by the Sacristy door. In any case this cannot be seen from anywhere but the Vicar's garden. The replacement would be a new hopper head taken from the J and JW Longbottom castings. See below.

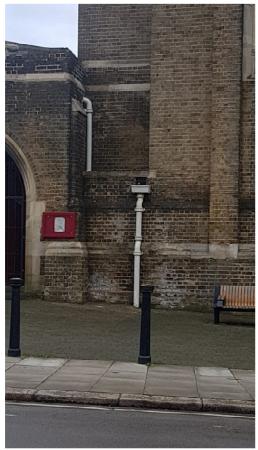
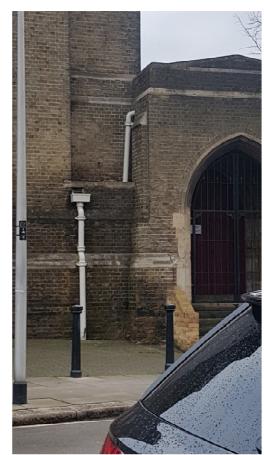
Both west porches have had past blockages causing damage to the ceiling. The ceiling came down in the north porch this Winter after the roof had been repaired in 2019. It is the complicated route of the outlet pipe that has let the water through. The proposal is to fill up the outlet hole and to revert to a traditional hopper-head outlet detail which allows the possibility to maintain and clean the outlets and with a *fail-safe* advantage that a blocked hopper-head will largely flood outwards.

Pipes from the porch flat roofs snake through the ceiling and back out to discharge on one of Hare's 'secret gutters' where they exit to hopper heads.

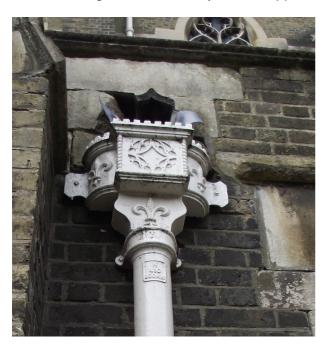
Sacristy hopper-head. It is proposed to place this on the visible south elevation where it will match the existing hopper-head and replace with the attached design from J and JW Longbottom Foundry.
