ADDENDUM TECHNICAL REPORT

9 Willoughby Road  
London  
NW3 1RT

Prepared for  
RSA - Commercial

13<sup>th</sup> January 2021

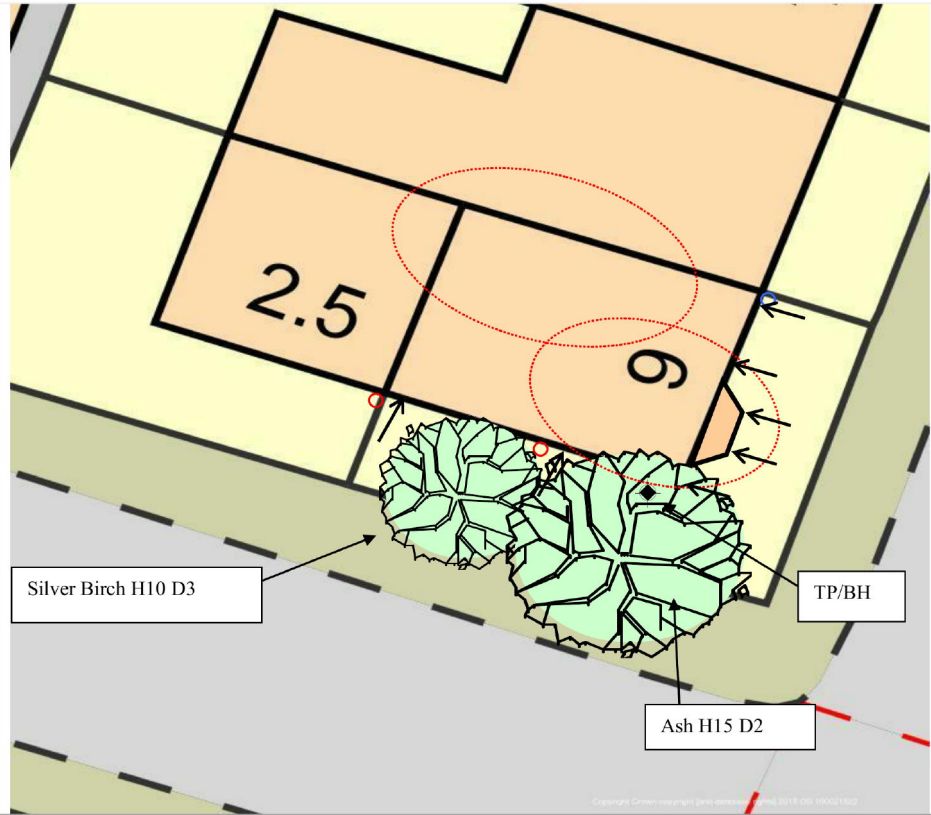
**Site Plan**

Area of Damage

A trial hole was excavated to expose the foundations - see site plan for location and the diagram below for details. Trial Hole 1 revealed a concrete strip footing founded at a depth of 1.2m below ground level which bears onto very stiff brown, grey veined silty CLAY.

A 50mm diameter hand auger was sunk - see site plan for location(s). Borehole 1 confirmed the continuation of the clay subsoil encountered within the trial pit, with roots to a depth of 2.0m below ground level. The borehole remained dry and open upon completion.
