TECHNICAL REPORT ON A SUBSIDENCE CLAIM

9 Willoughby Road
London
NW3 1RT

SUBSIDENCE CLAIM

DATE 14th November 2019

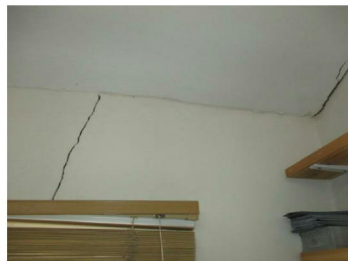
Cracking in flat d above rear window

Flat D - Stairs Area - 10mm tapering separation along right hand party wall, 6mm diagonal tapering cracking above and below rear window.

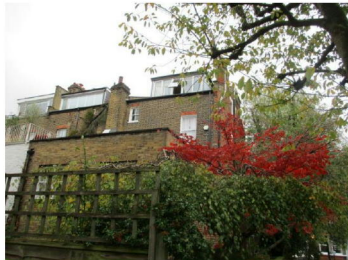
View of rear of property

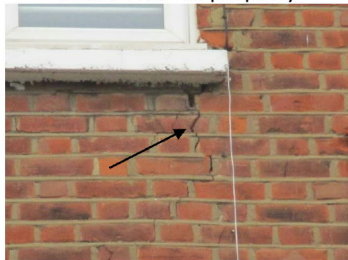
Front Elevation - Stepped crack below right hand side of top floor window.

Cracking to front elevation

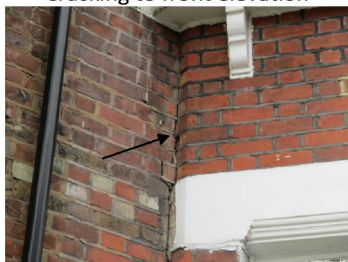
Front Bay - 7mm vertical crack below right hand side of ground floor middle window, tapering separation down left hand side bay junction at ground floor level, vertical cracking to lintel above 1st floor left hand window.

Cracking to front bay

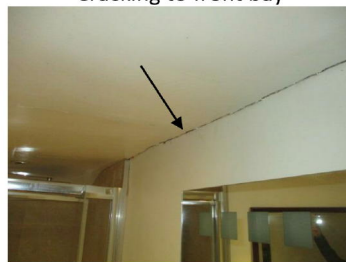
Bathroom - 5mm tapering separation along right hand party wall.

Cracking in flat D bathroom

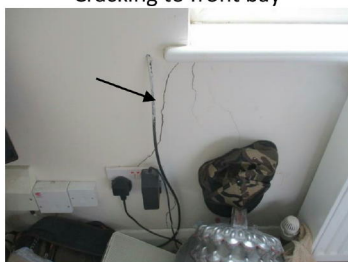
Front Bedroom - 2mm diagonal cracking above and below front window, cracking to ceiling.

Cracking in flat D front bedroom

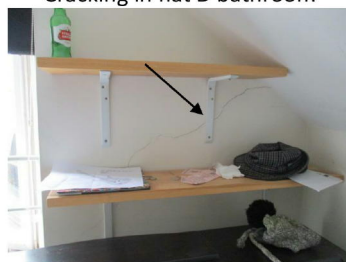
Cracking in flat D front bedroom
