# LAND CONTAMINATION REMEDIATION VERIFICATION REPORT

254 KILBURN HIGH ROAD  
CAMDEN

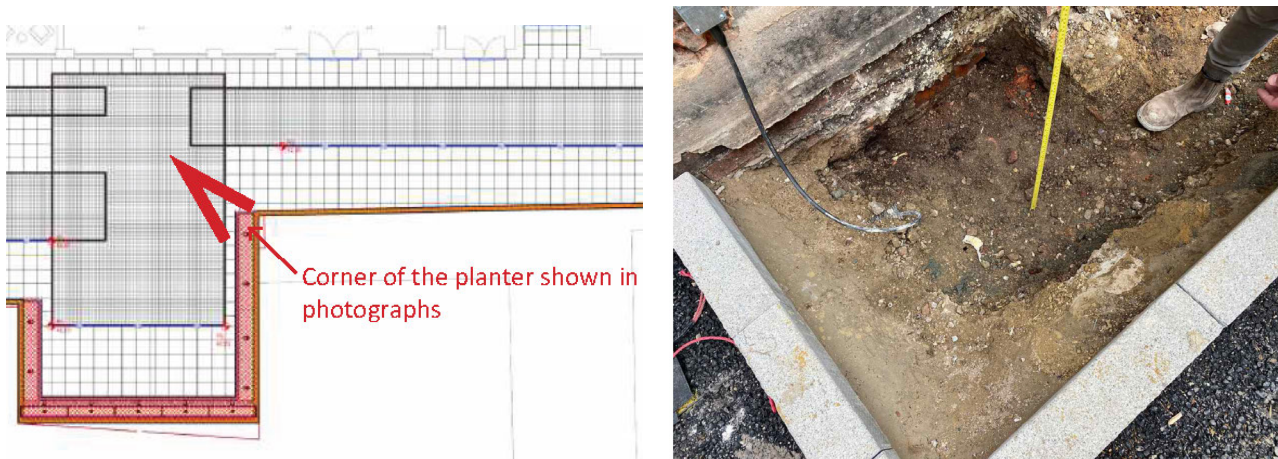
Evidence of removal of existing made ground soil to a depth of approximately 800mm in the area of the planter is provided in the photograph below (extracted from Appendix A).

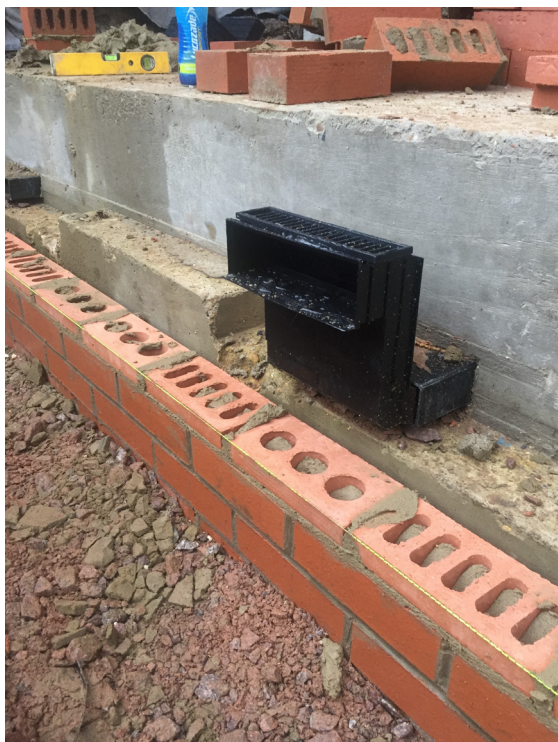
SIDE VENTILATION

- Reinforced cast in situ suspended floor slab with minimal penetrations      SCORE 1.5
- Cordek Sub Cellvent 205 HX9/13 Sub-Floor Ventilation      SCORE 2.0

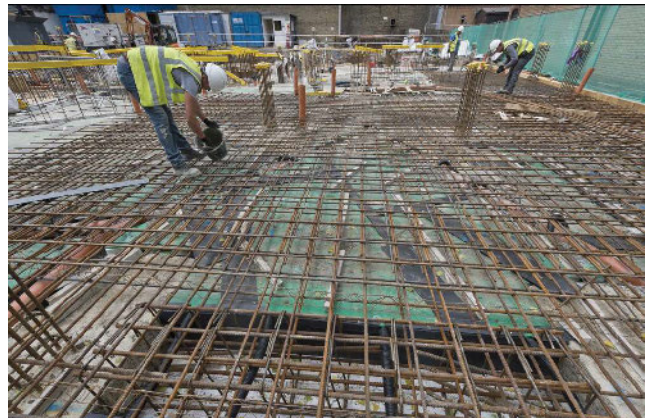
REINFORCED CAST IN SITU FLOOR SLAB

BS8485 Table 5 permits a maximum score of 1.5 for a reinforced cast in situ suspended floor slab.

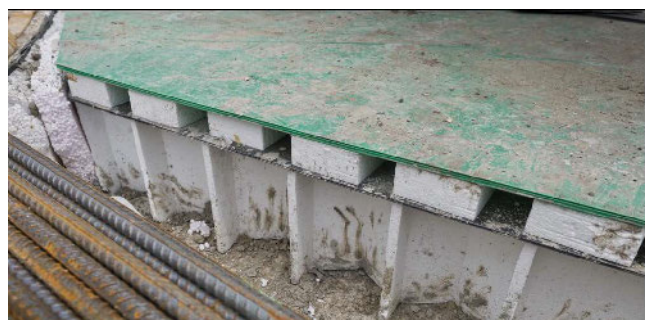
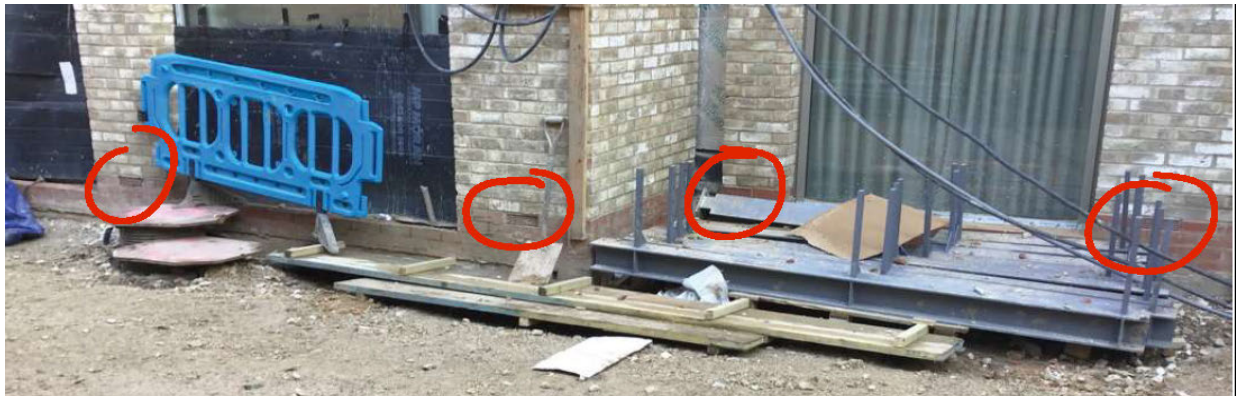
SUB-FLOOR VENTILATION POINTS

BS8485 App B7 for polystyrene void formers assigns a score of 2 points for polystyrene shuttering with an equivalent clear void depth of less than 60mm and side ventilation openings meeting the requirements of BS8485 App B6, which for CS2 requires a minimum area of side ventilation of 1,500 mm<sup>2</sup>/m run of wall on at least two opposite sides.

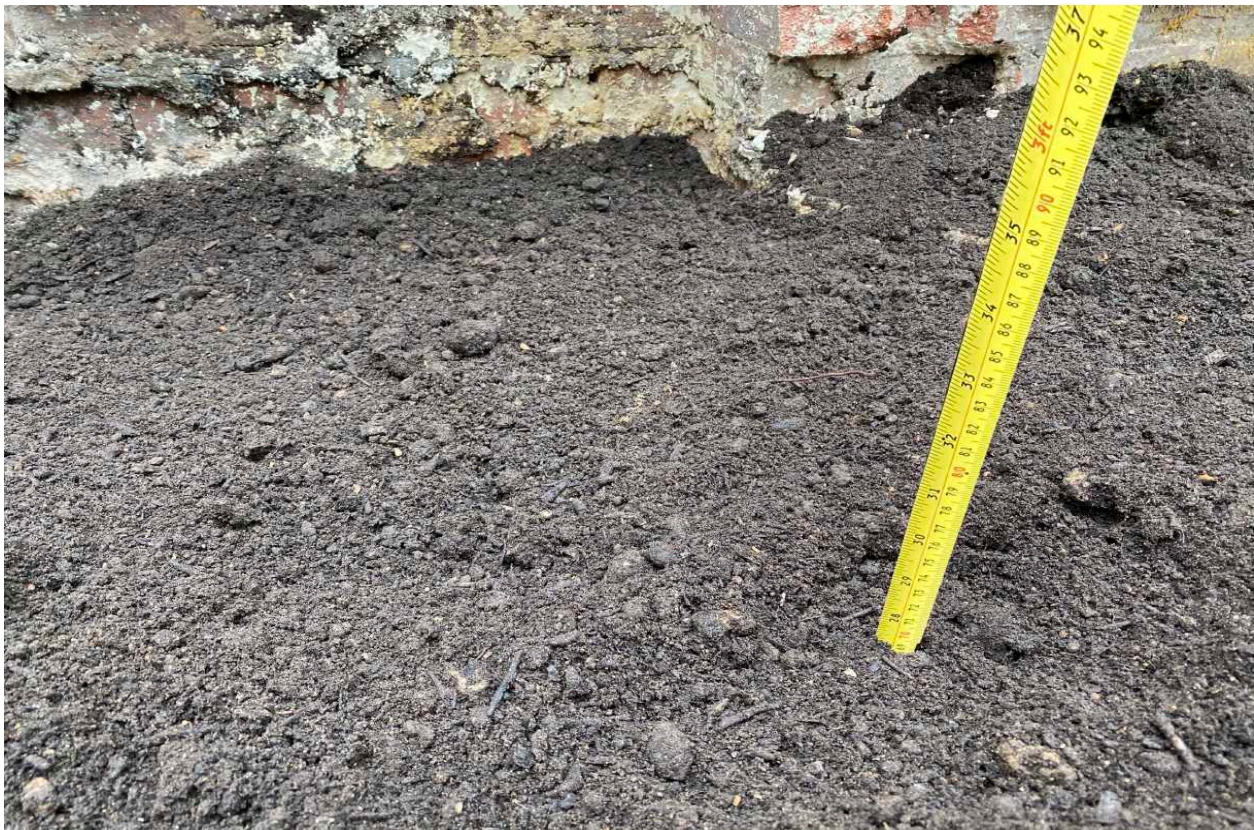
The photograph below (extracted from appendix C) provides evidence of filling of the planter with topsoil with a depth of topsoil in excess of the 600mm requirement in the approved Remediation Strategy.

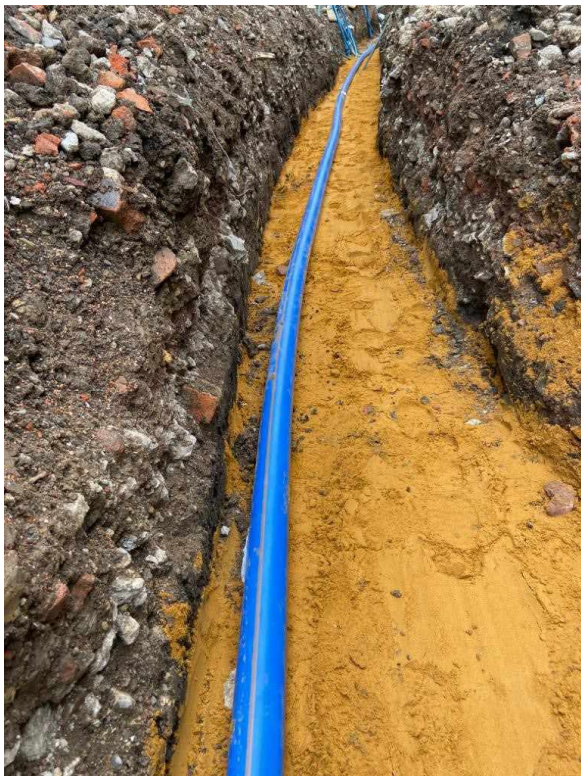
Photographic evidence of the use of Barrier Pipes is included in Appendix D and, as can be seen from the photos below extracted from Appendix D, it is identified as GPS PE Protecta-Line.

SITE PHOTO SHOWING BARRIER PIPE BEING INSTALLED

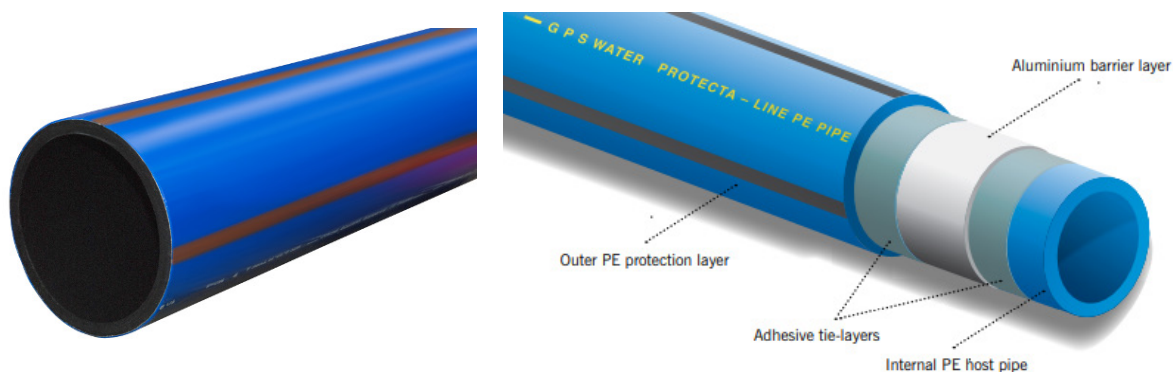
GPS PE Protecta-Line is usually accepted as a Barrier Pipe for the transportation of water through brownfield sites / contamination land and is understood to comply with BS 8588:2017 *Polyethylene pressure pipe with an aluminium barrier layer and associated fittings for potable water supply in contaminated land*.

GPS PE Protecta-Line Barrier Pipe
