greenwillows associates ltd

RE: Dead Oak Tree at Athlone House, Hampstead Lane, Highgate, London

As instructed, Greenwillows Associates arboriculturist, Ian Lorman attended the site on 8th January 2021 to assess a dead oak tree and a holm oak in poor condition.

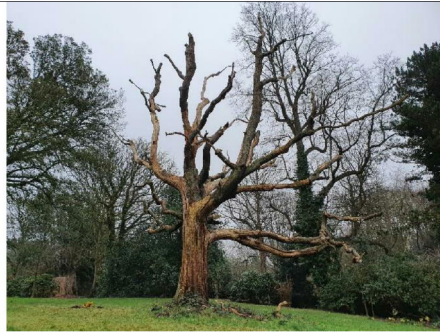
It is clear from the condition of T1 that it has been dead for many years and that honey fungus (*Armillaria* sp.) was almost certainly the cause. The estate manager suggested it has been dead at least fifteen years. Most of the bark has detached, leaving the underlying sapwood exposed, which has now completely degraded due, principally, to saproxylic fungal activity and then exacerbated by other flora and fauna. The sapwood that remains wrapped around the trunk and branches crumbles away readily in the hand. Beneath this ephemeral layer of crumbling sapwood is the core, or heartwood, of the tree. The core samples taken confirm that the heartwood has not decayed to any visible degree. The auger required a very firm action to gain traction into the material and the extracted cores possessed impressive compressive and tensile properties with a noticeable moisture content, consistent with what one would expect from a healthy oak tree. The cores imparted no fungal or mouldy odour, but that of freshly cut, tannin-rich, healthy timber. The branch structure is typical of an open-grown oak, lacking apical dominance, with an even, wide, spread. At its greatest extent, the south west side of the crown reaches eight and a half metres from the trunk. All fine twigs have long since been shed. Bark and pieces of sapwood continue to fall from branches.

The oak tree, T1, is not in imminent danger of partial or whole collapse. It would stand for several decades, albeit in a modified form following pruning. For this tree to be retained as a standing dead wood habitat whilst virtually eliminating risk to person and property, preventative tree surgery works will be required. The purpose of the tree surgery would be to minimise the sail area against wind forces to greatly reduce the lever arm and the fulcrum at the root plate (at ground level) whilst maintaining a recognisable tree form (rather than just a standing trunk). This can be achieved by truncating the branches to a suitable distance from the main trunk, leaving them around three to three-and-a-half metres in length. Appendix Three indicates the approximate points of cut using red lines. This should be undertaken within twelve months.

It is recommended that T1 be inspected at least once every five years to undertake a repeat assessment.

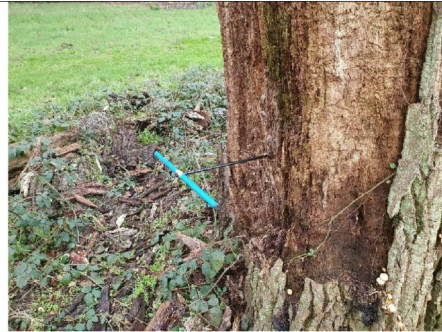
Four core samples of five millimetres diameter were taken from T1 at approximately one metre above ground level at the four cardinal points (north, east, south and west) using a Hagl f increment borer. The core sample depth was approximately one-hundred millimetres (sufficient because hollowing of the trunk is not suspected).

Core sampling of T1

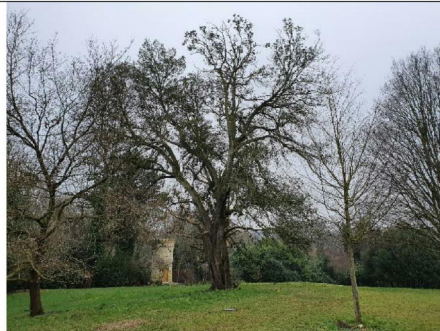
The crown weight of T2 is heavily biased to the west due to the previous removal of a co-dominant trunk on the east side, which had died. Branch structure is very open, with at least one large phototropic branch on the west side. Foliage is sparse throughout, especially at the top and north sides. There are watershoots throughout the major branches, which are

spontaneous vertical shoots emanating from latent buds beneath the bark due to stress and/or exposure of previously shaded bark to sunlight. Suckers are growing at the base of the trunk.

It is considered that T2, a live holm oak, presents a much greater risk to health and safety than T1, mainly due to the symptoms and form predisposing it to major branch shedding. Branch shedding is likely to result directly from the tree retrenching and shutting off the massive, uneconomical branches whilst it attempts to regenerate a healthy crown at a lower height rather than resourcing large branches that are not generating a net gain through photosynthesis.

For the holm oak, T2, it is recommended to undertake a heavy crown reduction, reducing the crown down to a height of approximately ten metres. This should be undertaken within twelve months.

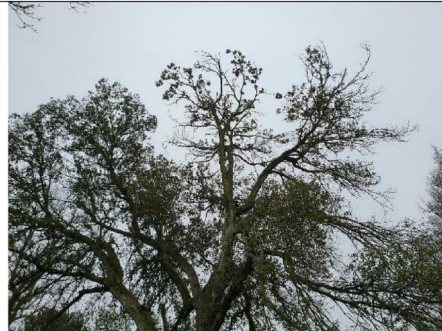
T2 showing sparse upper and north sides
