# *The Heath & Hampstead Society*

## **To London Borough of Camden, Tree Preservation Team**

**Planning Ref:** 2020/5783/T  
**Address:** Camden Arts Centre  
**Case Officer:** Tree Allocation Team  
**Date:** 5<sup>th</sup> February 2021

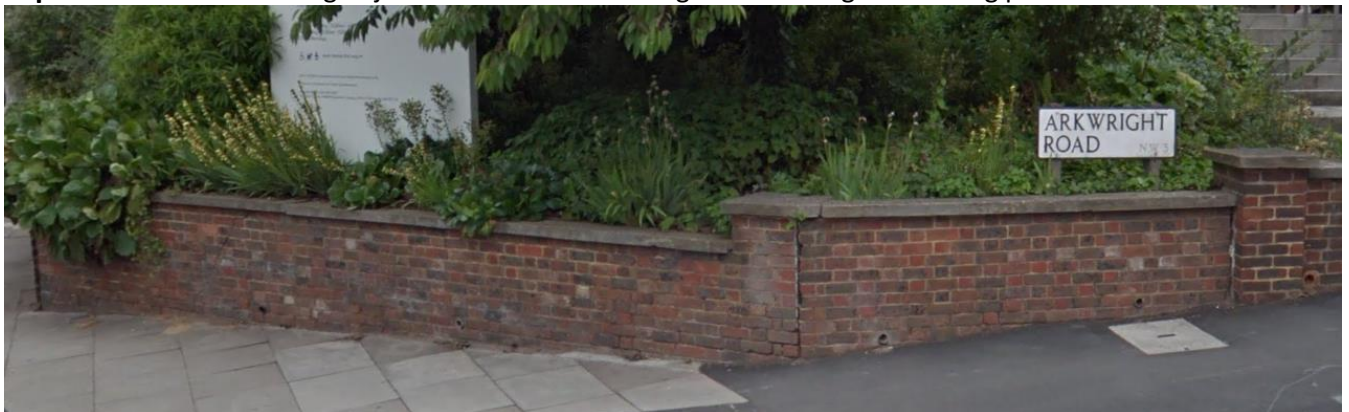
**September 2017** Cracking at joints each end of the diagonal retaining wall - being pushed downhill

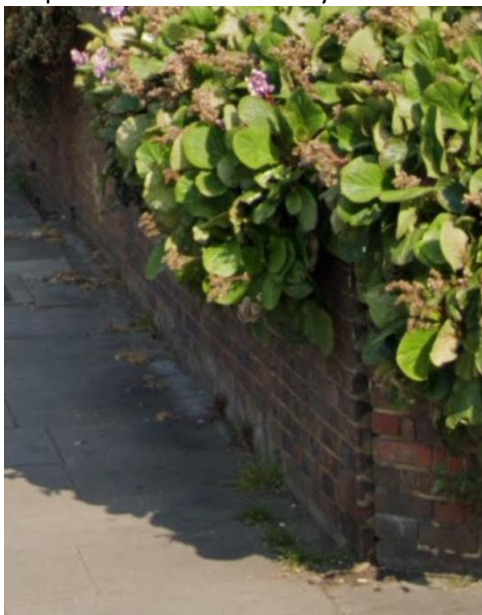
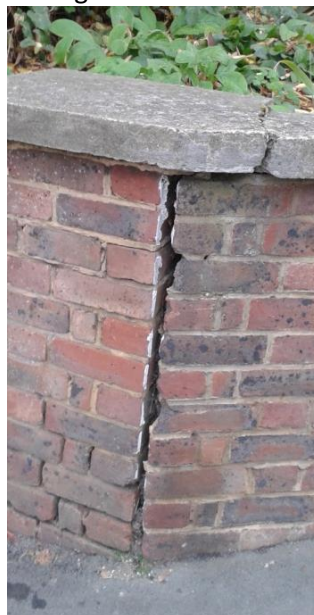
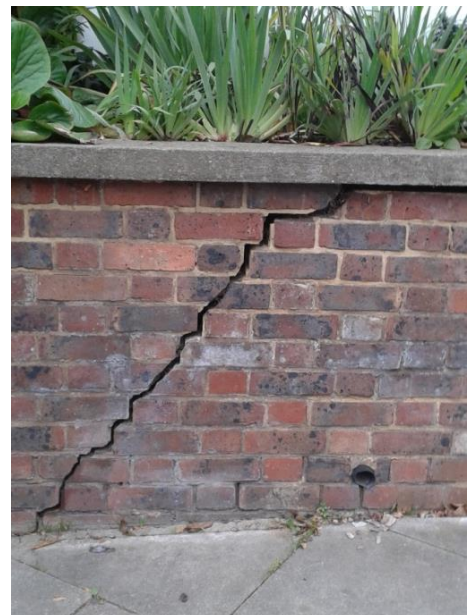
**November 2019** Finchley Road wall slightly moved out/over; Arkwright corner joint further open; Old crack reopened near the Finchley Road end of the diagonal wall:

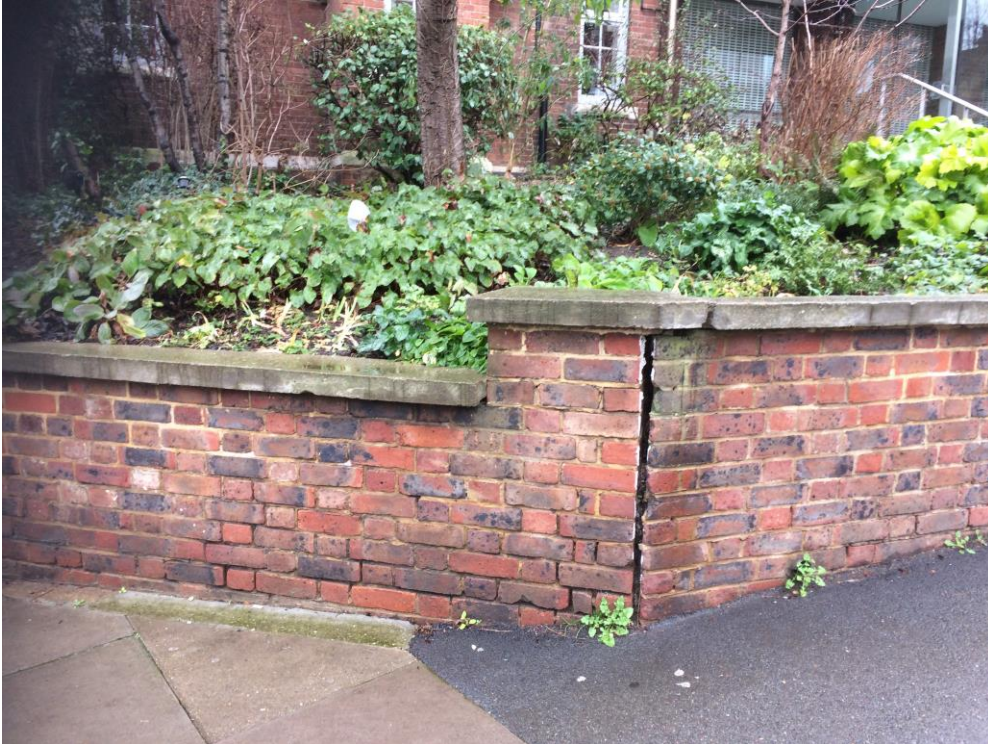
**January 2021** Crack in the joint at the Arkwright Road end of the diagonal wall has opened further

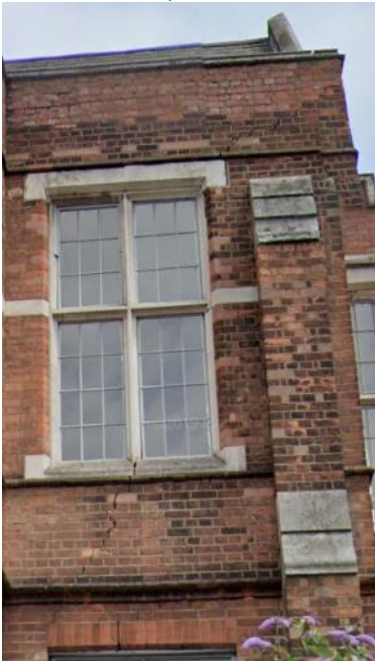
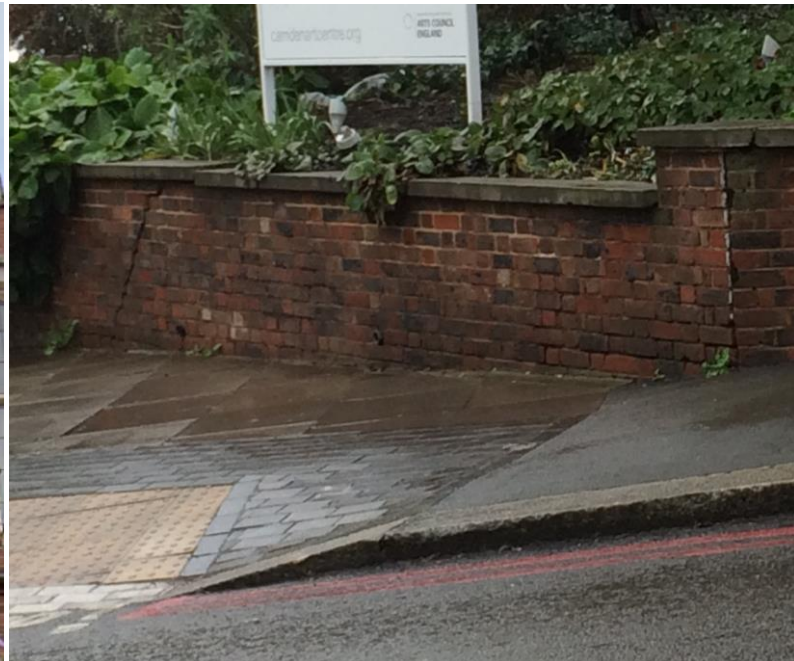
Extended crack, far right front window; New subsidence, main part diagonal wall – silt erosion?  
(N.B. the dampness here is snow melt)

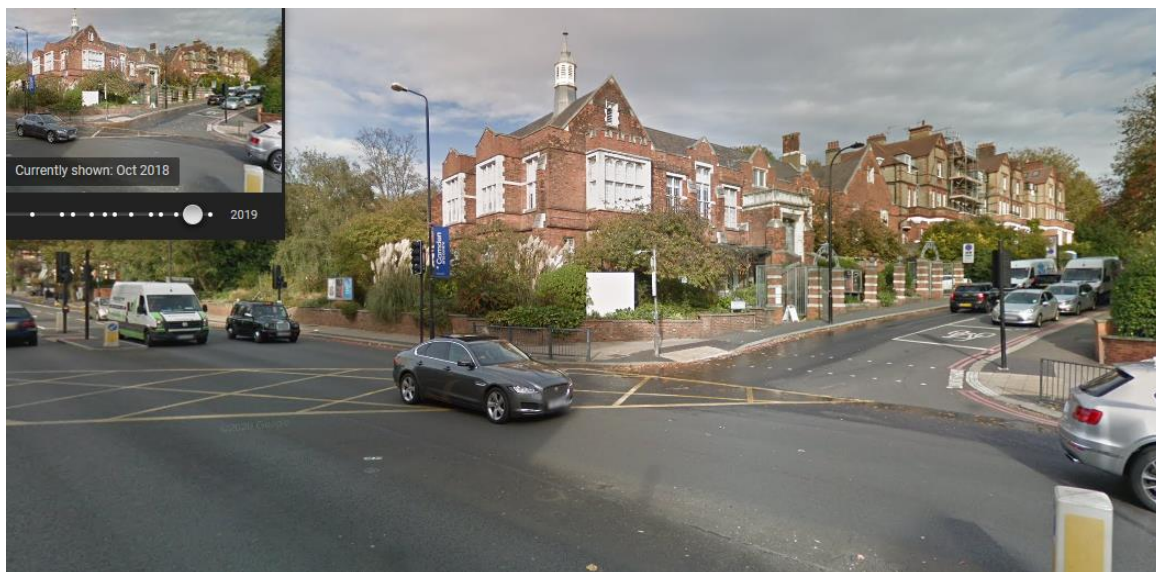
These are on-going and likely to continue, only making matters worse.

It is only occasionally that the many mains water bursts causing water to pour down Arkwright Road, and attested to by staff at Camden Arts Centre, coincide with the passing of the Street View cars and their cameras as happened here in October 2018. Unfortunately there have been no Street View records since July 2019 to record further incidents.

Of course such vegetation will have a small effect on the ground's volume, but something needs doing to help the building resist the eroding effect of mains water bursts and groundwater surges following storms on the ground beneath the building. It needs its foundations stabilising to cope with the ground's memory of the hill toe being cut back in the 60s and past ground release from the basements to the south of the site, and to cope with the present effects of vibration as fire engines, construction lorries etc accelerate down Arkwright Road hill to beat the lights and crash down onto Finchley Road. Far more urgent than felling trees that are at least helping in their own small way to bind the hill. If they are getting in the way of some sensible underpinning-type work to the building that's as may be. Camden Arts Centre can be trusted to replace them with appropriate trees and shrubs to help stabilise the hill and mop up the excess water.

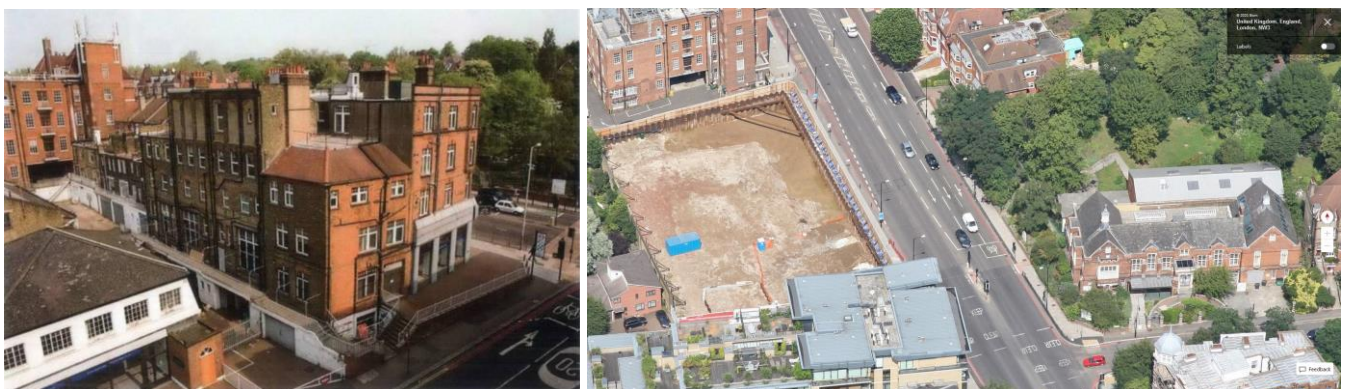
### Demolition and dig out, releasing weight on the ground at hill base
