Addendum Arboricultural Report

Subsidence Damage Investigation at:

9 Willoughby Road
London
NW3 1RT

CLIENT:	Crawford & Company
CLIENT REF:	[REDACTED]
MWA REF:	[REDACTED]
MWA CONSULTANT:	Steve Swinburne
INITIAL REPORT DATE:	02/12/2019
REV01 REPORT DATE:	19/03/2020
REV02 REPORT DATE:	27/01/2021

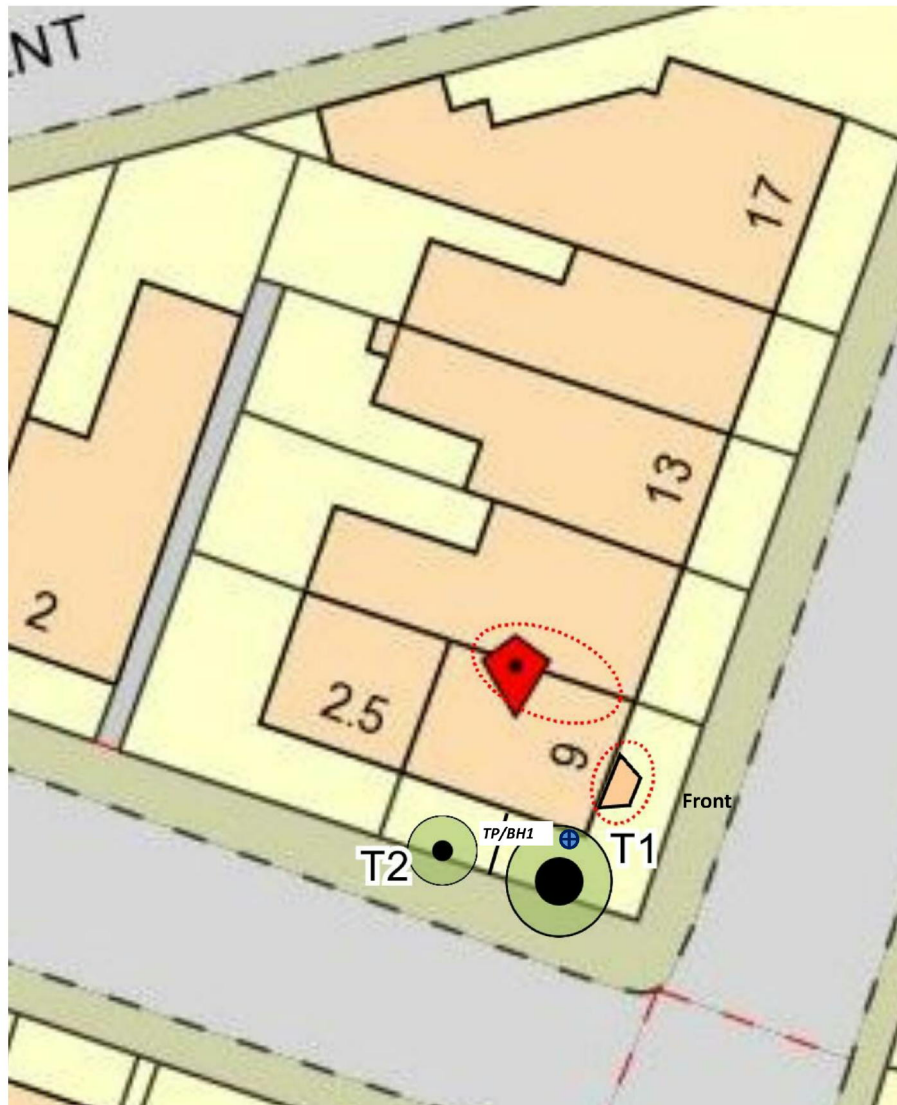
Site Plan

Approximate areas of damage

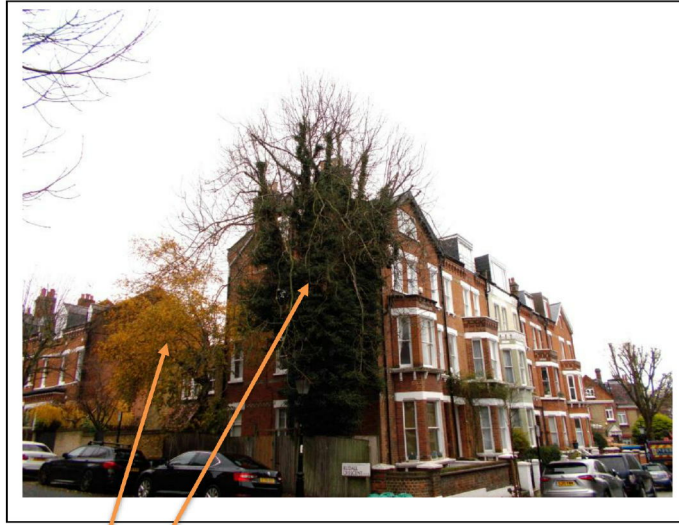
Based on the technical reports currently available, engineering opinion and our own site assessment we conclude the damage is consistent with shrinkage of the clay subsoil related to moisture abstraction by the ash T1.

View of T2 and T1

If an arboricultural solution is to be implemented to mitigate the influence of the tree considered to be responsible for the damage we recommend that T1 is removed.

Tree No.	Species	Ht (m)	Dia (mm)	Crown Spread (m)	Dist. to building (m)	Age Classification	Ownership
T2	Birch	7.5	300	9	4.5	Younger than Property	Policyholder
Management history		No recent management noted.					
Recommendation		Reduce height by 2m and crown radius by 1m leaving balanced crown. Prune on a triennial cycle to maintain at broadly reduced dimensions.

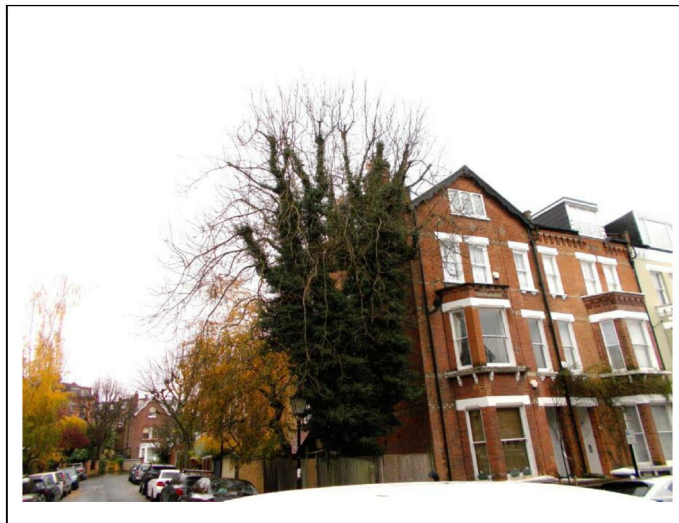
Alternative view of T1 and T2

Tree No.	Species	Ht (m)	Dia (mm)	Crown Spread (m)	Dist. to building (m)	Age Classification	Ownership
T1	Ash	16*	650*	12*	2.5	Younger than Property	Policyholder
Management history		No recent management noted.					
Recommendation		Remove (fell) to near ground level and treat stump to inhibit regrowth.
