Tree Condition Survey

**Site Address:
College Francais Bilingue de Londres
87 Holmes Road
London
NW5 3AX**

Ref: RMT561
Site Inspection Date: 15th December 2020
Date Report Published: 1st February 2021

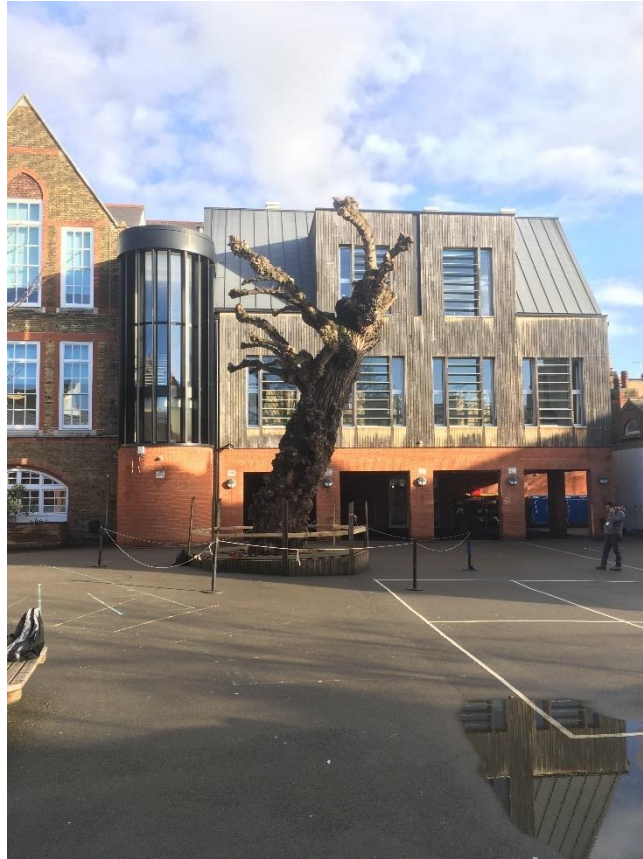
T1 viewed from a westerly direction and the canopy has been heavily reduced (pollarded)

- Remove tree to ground level and grind stump.
- Plant a replacement tree (if practical).

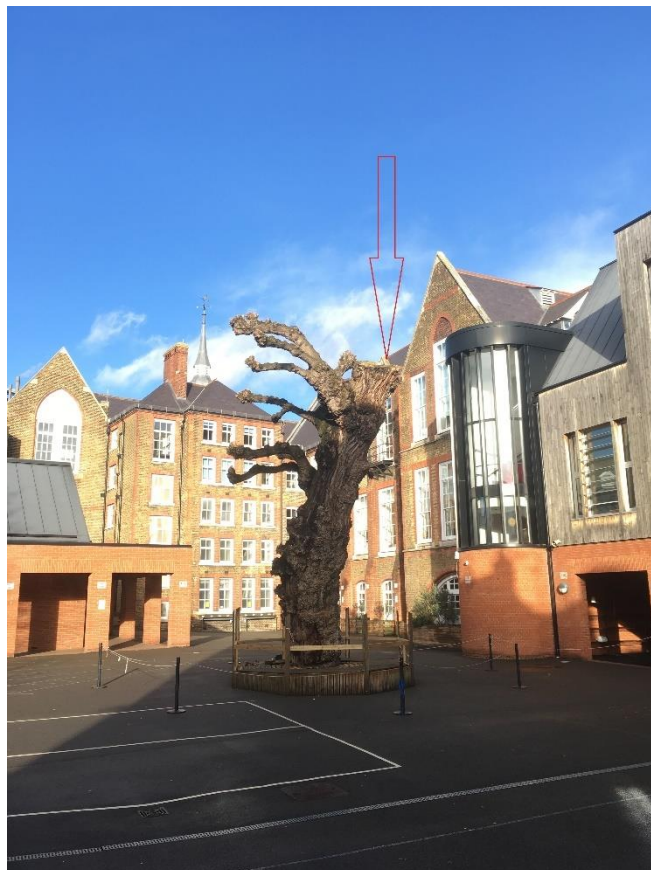
- The explanation for the fruiting bodies being so far up the stem is that the cavity extends some distance down the tree which could be indicated by the various water runs. The cavity has filled with organic matter which has created ideal conditions for the Honey Fungus rhizomorphs to spread. The previous pruning works in 2017 have exposed the fungus to external elements causing it to fruit.

T1 viewed from a southerly direction with the location of the cavity indicated by the red arrow.

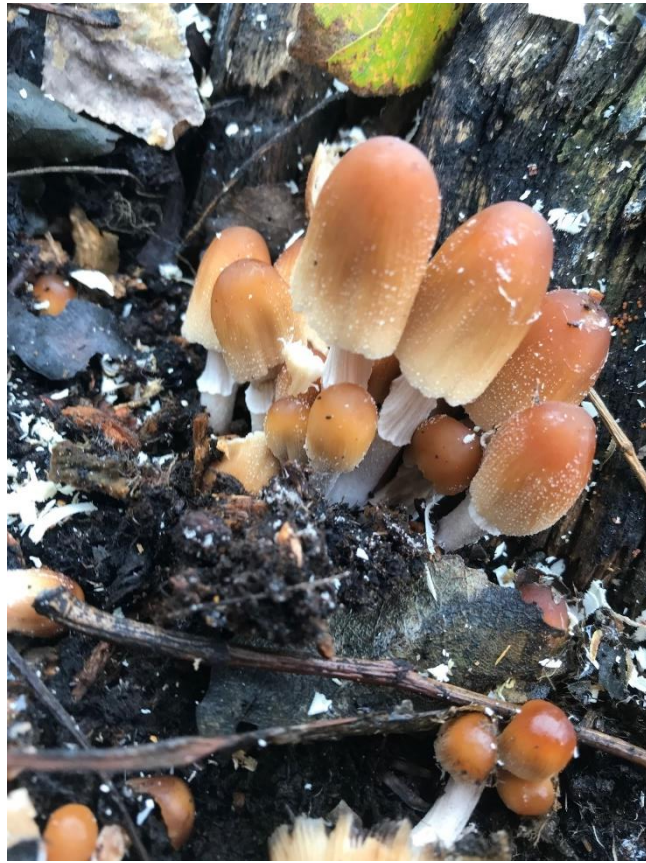
- Photographic evidence from a climbing inspection carried out in October 2020 indicates the presence of the decay fungus Honey Fungus (*Armillaria* spp.). Honey Fungus is generally found around the buttressing and rooting area of infected trees however on occasion it has been recorded much higher up main stems. The toadstools appear to be developing the characteristic collar below the cap associated with this fungus. The toadstools appear to be immature and this would be consistent with their time of fruiting in autumn.

- Honey Fungus is a decay fungus which in advanced cases leads to root failure of the host tree. Additionally, this fungus can invade the cambium (vascular system just under the bark) resulting in areas of necrotic bark.

Immature Honey Fungus fruiting bodies growing in the cavity in October 2020.

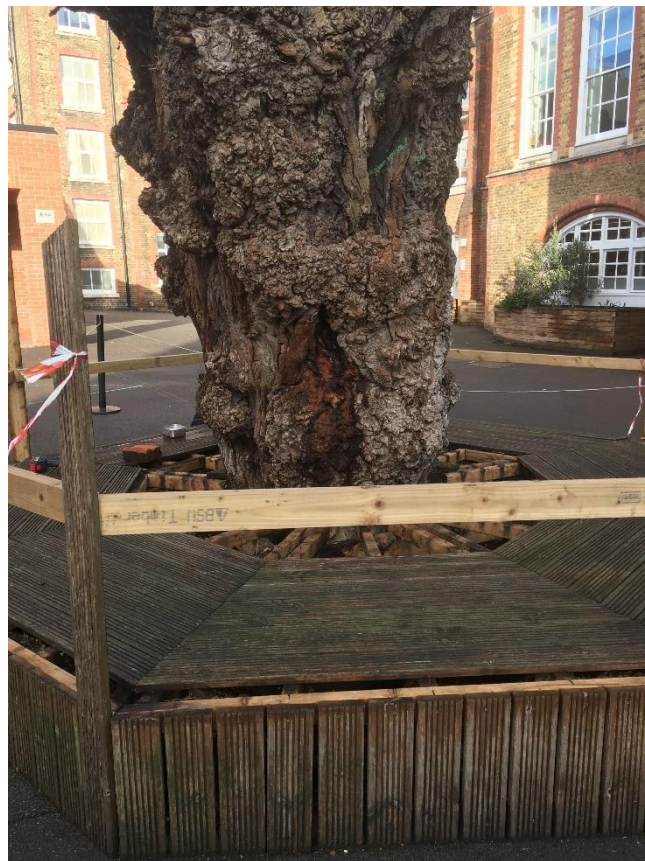
One of several water runs observed on the main stem.

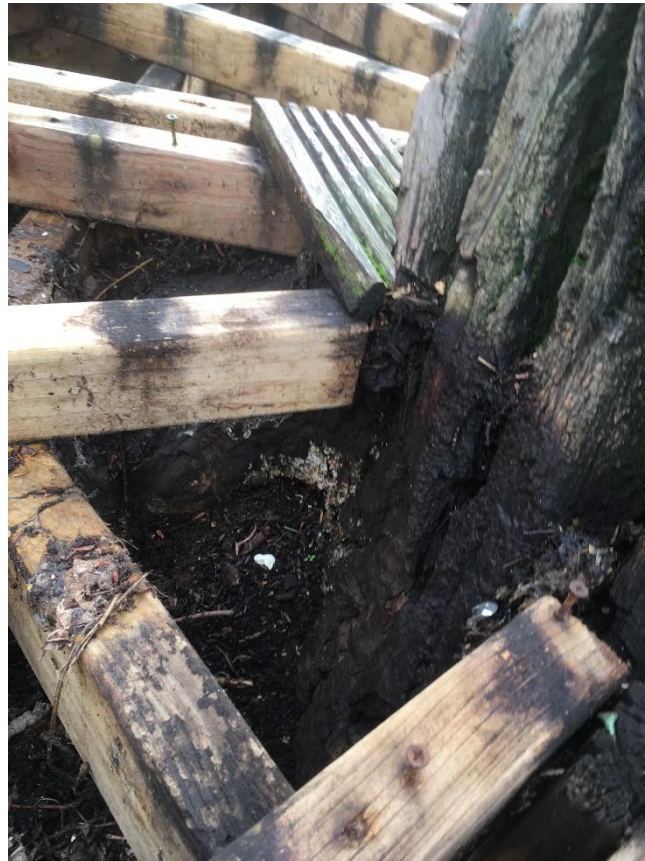
Slimy white and light brown residue on north-eastern buttress at c100mm agl is consistent with recently removed or decayed fungal fruiting body.

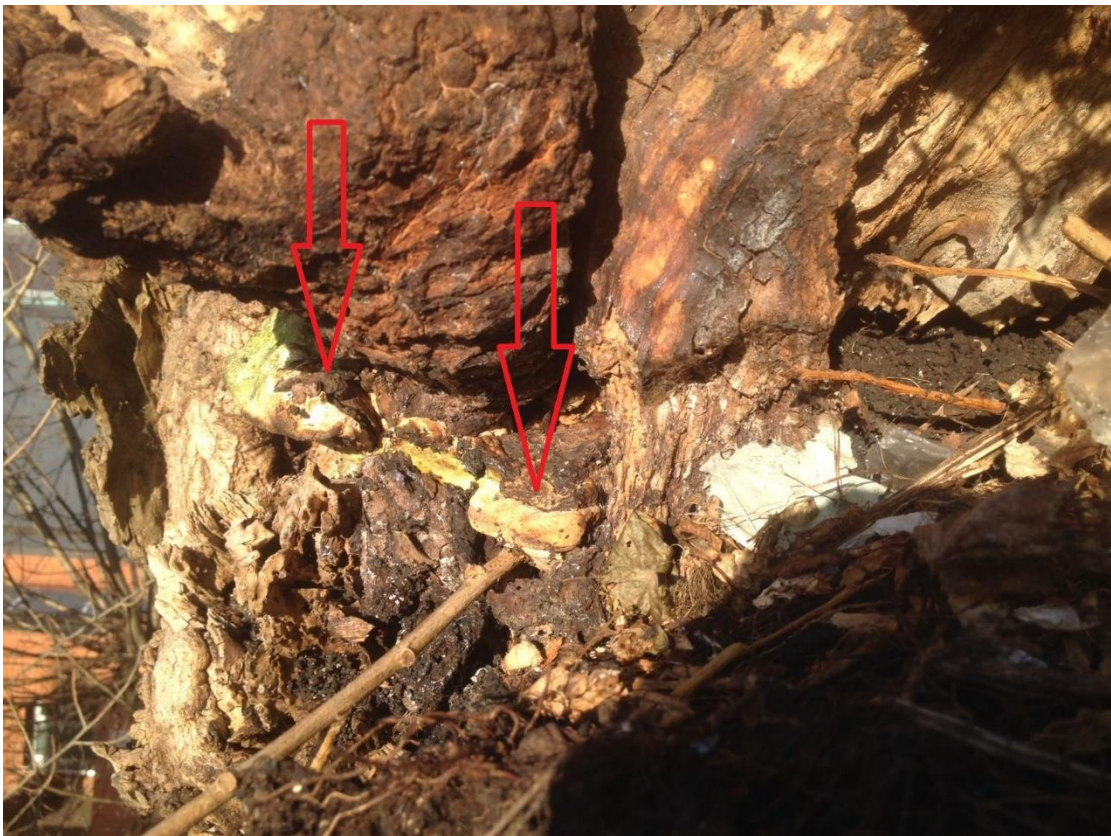
- Photos taken from a previous climbing inspection carried out in 2017 indicates the present of the white rot decay fungus *Perenniporia fraxinea* on the upper main stem. The intense decay of this fungus results in cavity formation and can lead to brittle fracture. Brittle fracture occurred in 2017 with a large section of the main stem failing.

Perenniporia fraxinea bracket on main stem (photo from 19th January 2018).

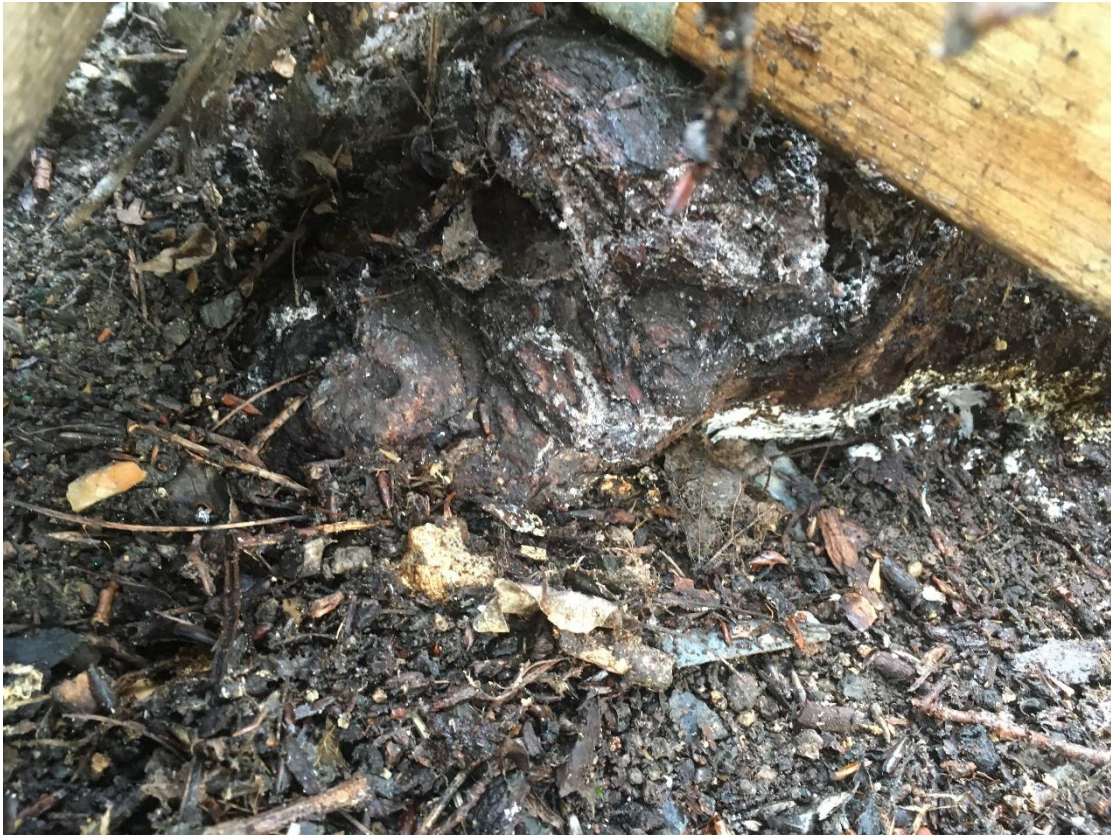
Severed root on western side at c400mm from main stem.
