ARBORICULTURAL ASSESSMENT REPORT

For:	Client:	QuestGates Ltd
	Insurer:	
Site:	Policyholder:	
	Risk Address:	20 Churchill Road, London, NW5 1AN
Refs:	PRI Ref:	131044
	Client Ref:	QG1T1074537
	Insurer Ref:

Arborist Name:	Ross Lane	Date:	22/05/2019
QC:	Margaret MacQueen	Date:	23/05/2019

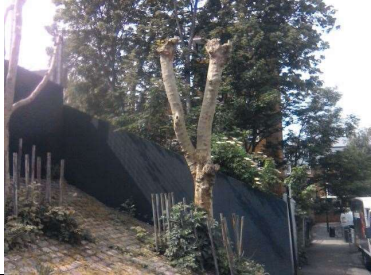
T1 - Plane (London)	T2 - Plane (London)

Tree No	Common Name	Age Class	Condition	Height (m)	Crown Spread (m)	Stem diam. (mm)	Dist to bldg. (m)	Roots Implicated	Pruning history	Recommendation	Tree work constraints	Notes	Owner address	Owner
T1	Plane (London)	Mature	Fair	5.5	1.50	470	20.8	N	Subject to recent management. Pollarded back to previous pruning points.	No work required.			Camden Borough Council	LA
T2	Plane (London)	Mature	Fair	5.5*	3.0	270	21.5	N	Subject to recent management. Pollarded back to previous pruning points.	No work required.			Camden Borough Council	LA
T3	Plane (London)	Mature	Fair	5.5	0.8	500	17.8	N	Subject to recent management. Pollarded back to previous pruning points.	No work required.			Camden Borough Council	LA
T4	Plane (London)	Mature	Fair	5.5	3.0	570	14.4	Y	Subject to recent management. Pollarded back to previous pruning points.	Fell and treat stump.			Camden Borough Council	LA

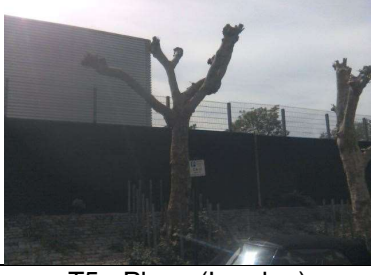
T5 - Plane (London)	T6 - Plane (London)

Tree No	Common Name	Age Class	Condition	Height (m)	Crown Spread (m)	Stem diam. (mm)	Dist to Bldg. (m)	Roots Implicated	Pruning history	Recommendation	Tree work constraints	Notes	Owner address	Owner
T5	Plane (London)	Mature	Fair	6	3.50	510	15	Y	Subject to recent management. Pollarded back to previous pruning points.	Fell and treat stump.			Camden Borough Council	LA
T6	Plane (London)	Mature	Fair	5.5	3.0	500	17	N	Subject to recent management. Pollarded back to previous pruning points.	No work required.			Camden Borough Council	LA
T7	Plane (London)	Mature	Fair	5.5	3.0	570	20	N	Subject to recent management. Pollarded back to previous pruning points.	No work required.			Camden Borough Council	LA
T8	Plane (London)	Mature	Fair	5.8	3.50	690	26.5	N	Subject to recent management. Pollarded back to previous pruning points. Old stem wound at rear of tree. vandalism evident, apparent minor fire damage. Stem base not visible due to debris	No work required.			Camden Borough Council	LA

Tree No:	Species	Works Required
T4	Plane (London)	Fell and treat stump.
T5	Plane (London)	Fell and treat stump.

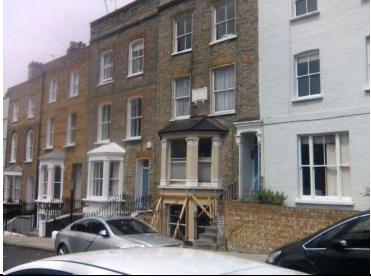
Risk address. Neighbouring vegetation to right hand side is in pots
