ROGER MEARS ARCHITECTS

8 February 2021

RE: Grade II*-listed former Anglican Church of Christ Church Albany Street / St George's Cathedral, 1-3 Redhill Street, London NW1

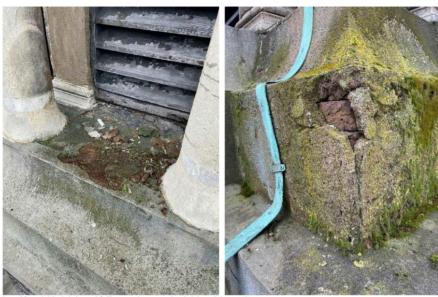
Tower: Location C

Img 13 and 14; debris and failing render exposing brickwork beneath

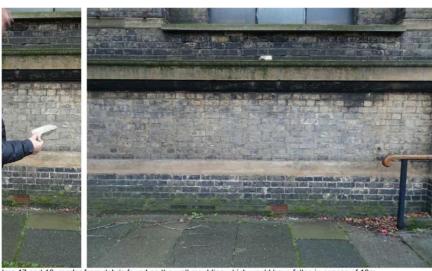
Cornice: Location D

Img 17 and 18; render from debris found on the wall moulding which would have fallen in excess of 10m.

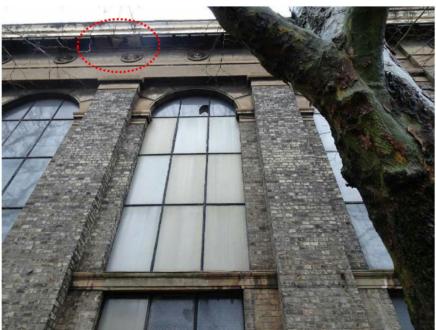
Img 19; rendered cornice on north elevation (liturgical) showing historic failure of rendered 'mutules' (circled)
