*Porch of 26 Leighton Road before erection of crash deck*

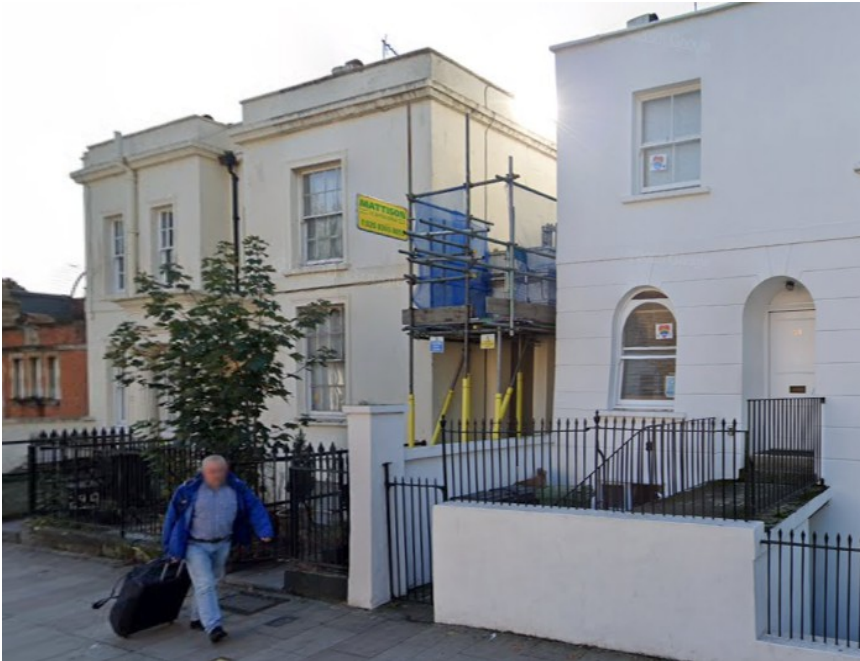
*View towards no. 26 showing crash deck scaffolding in place*

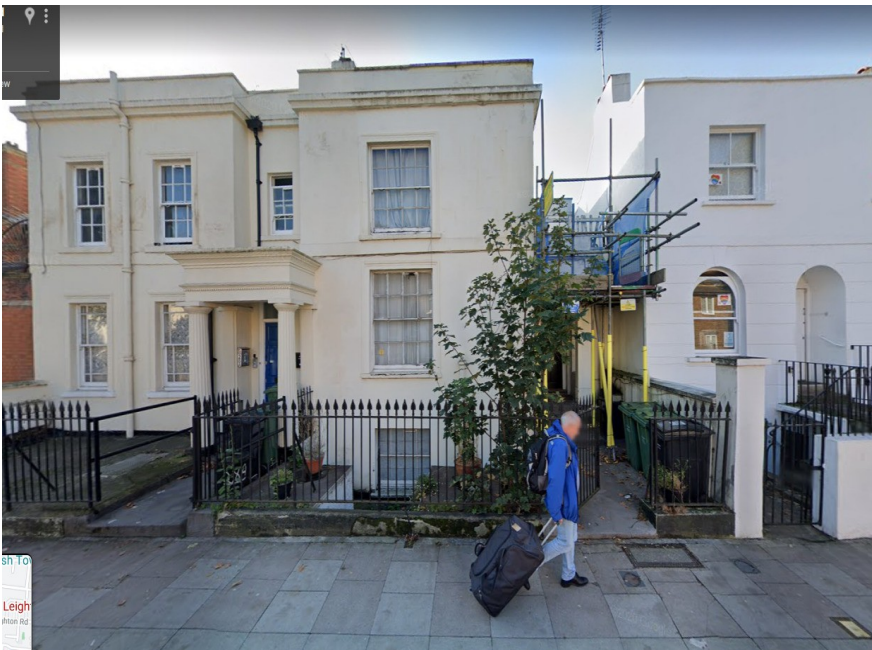
*Front view, no. 26 on right of image*

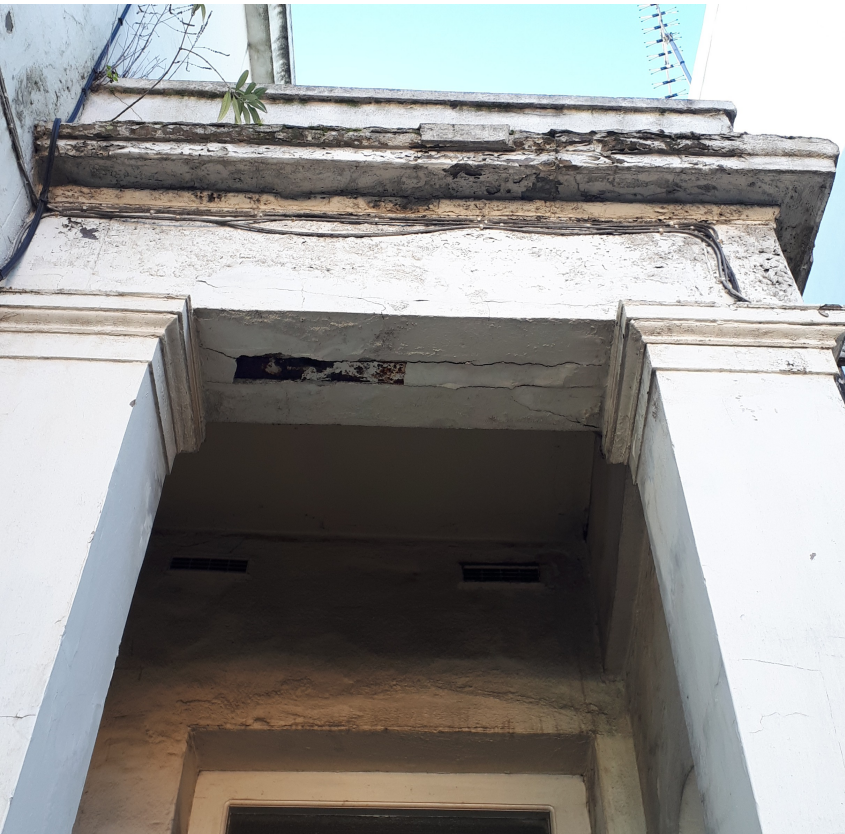
*Underside of porch entablature showing spalled render prior to opening up*

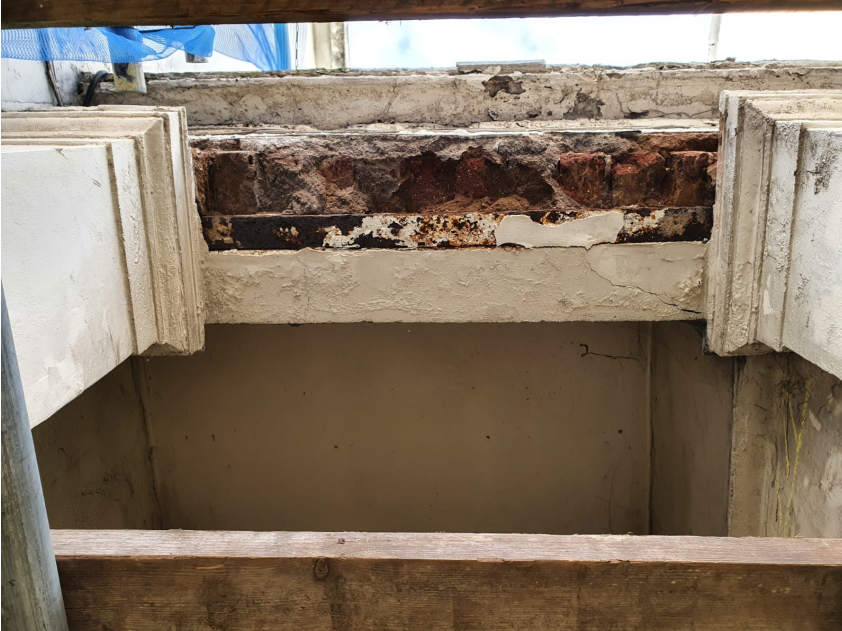
*Underside of iron flat following removal of spalled render*

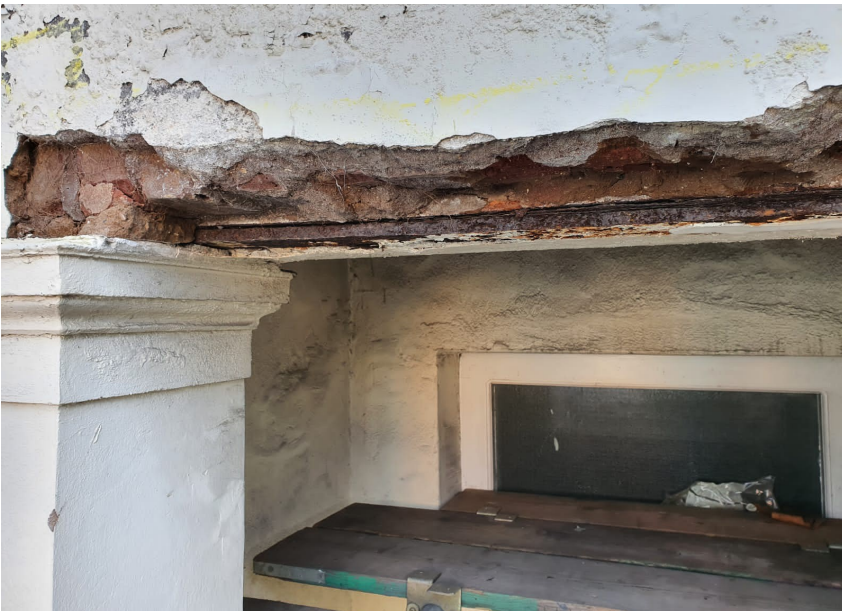
*Exposed iron flat showing brickwork above*

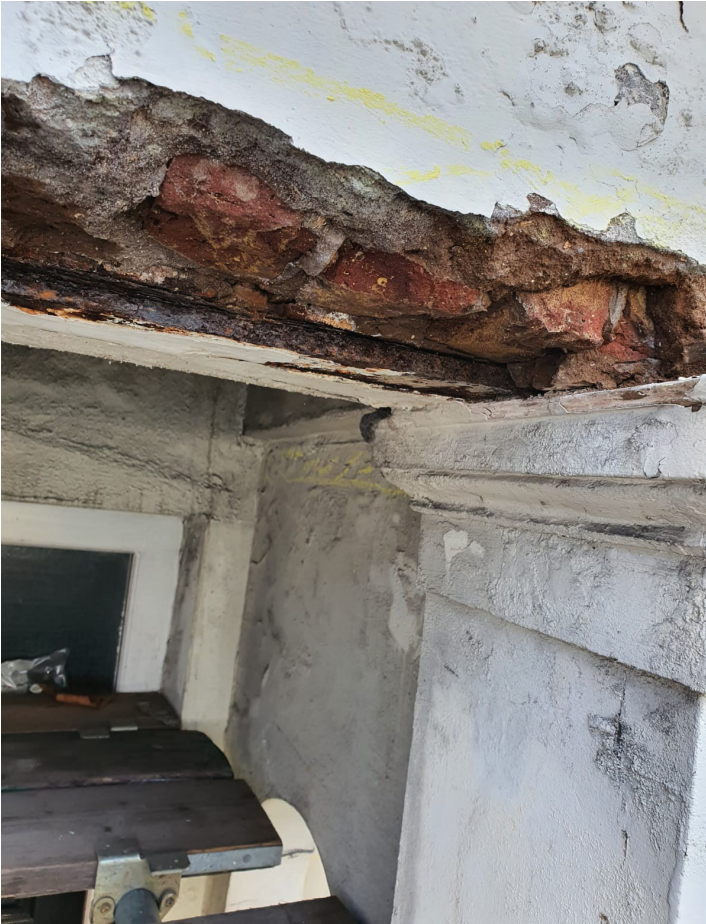
*Exposed iron flat showing bearing to column*

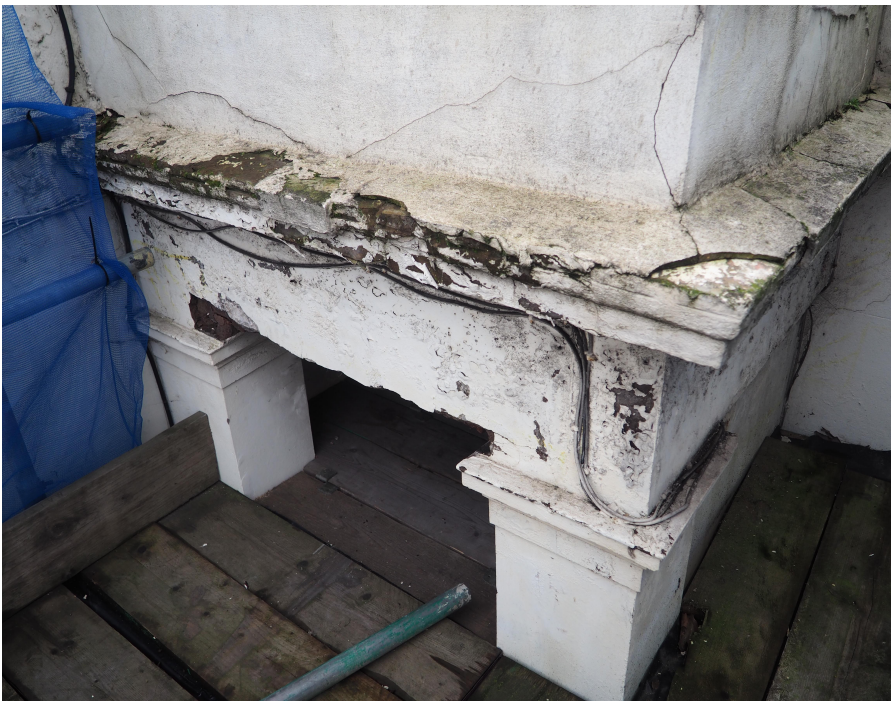
*Projecting course showing moulded stonework to left and presumed concrete work to corner section, with spalled and missing render*

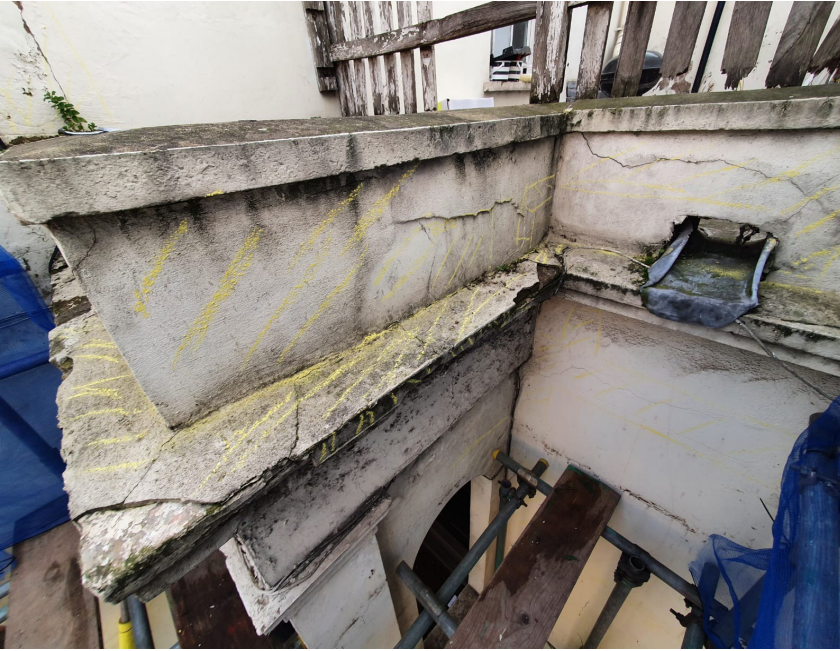
*Side view of porch parapet with damaged render*

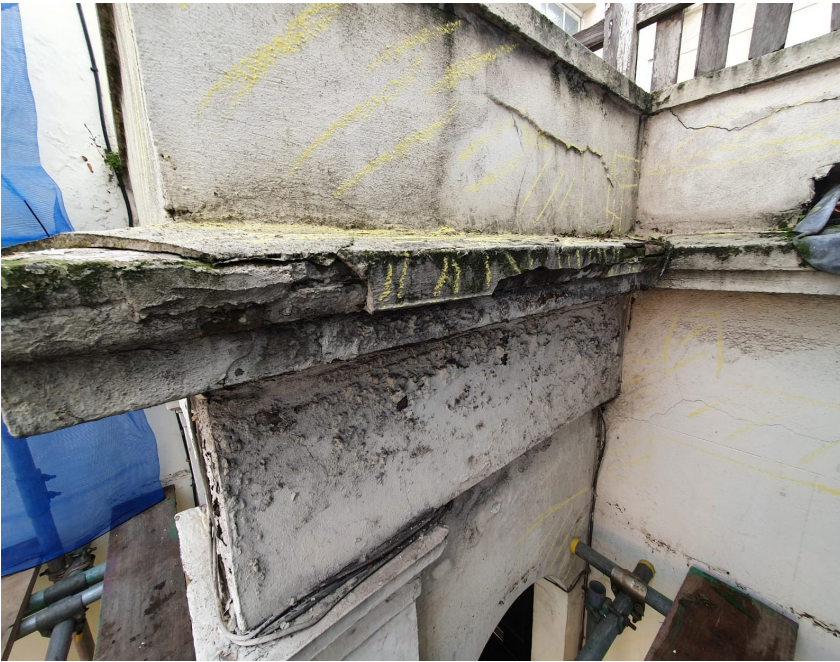
*View of porch parapet with damaged render to projecting concrete work*

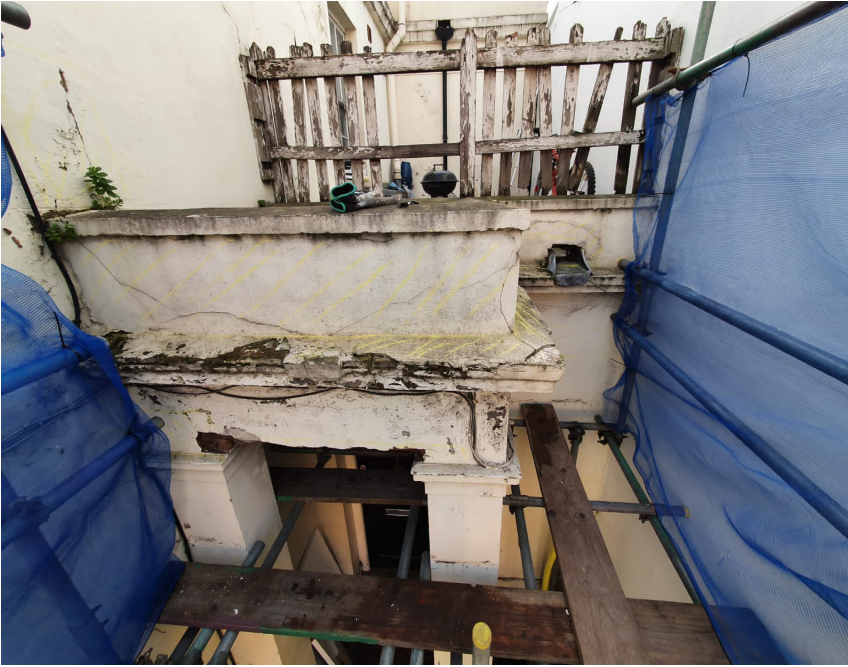
*Front view of porch parapet showing concrete coping*

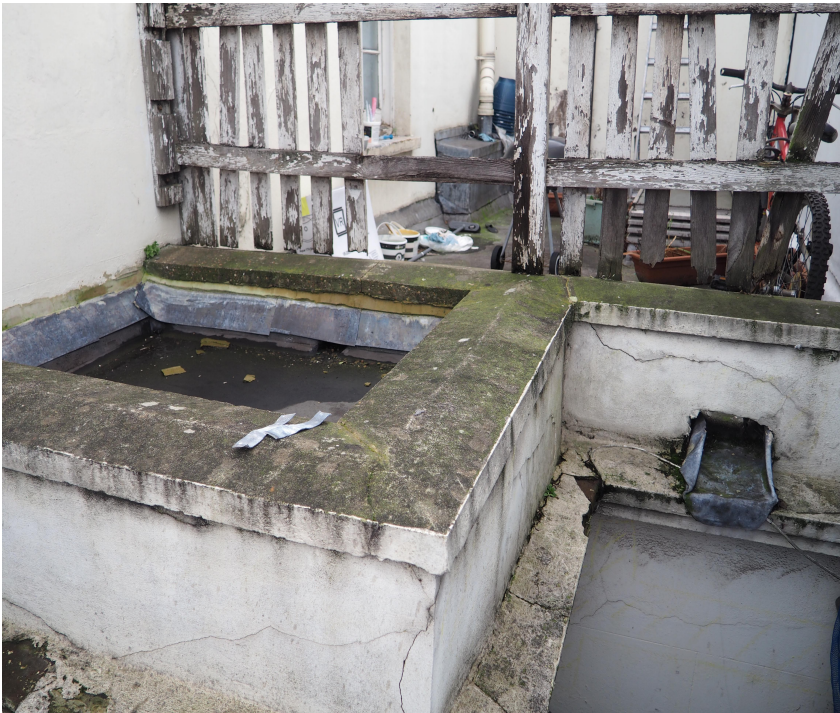
*View from above showing asphalt roofing and unclipped flashing*
