Ref. 19124-Lei-c210205-cl03

PROPERTY: 26 LEIGHTON ROAD, LONDON NW5 2QE

We confirm our brief given in recent works instruction from yourselves, to visit the above Property on to meet with Delaney Gordon of Wates and Contractors to observe opening up works to the plate supporting the front brickwork at the front portico of No. 26 Leighton Road. The site visit occurred on February 2021 in-front of the property. The meeting follows on from our report dated 15th January 2021.

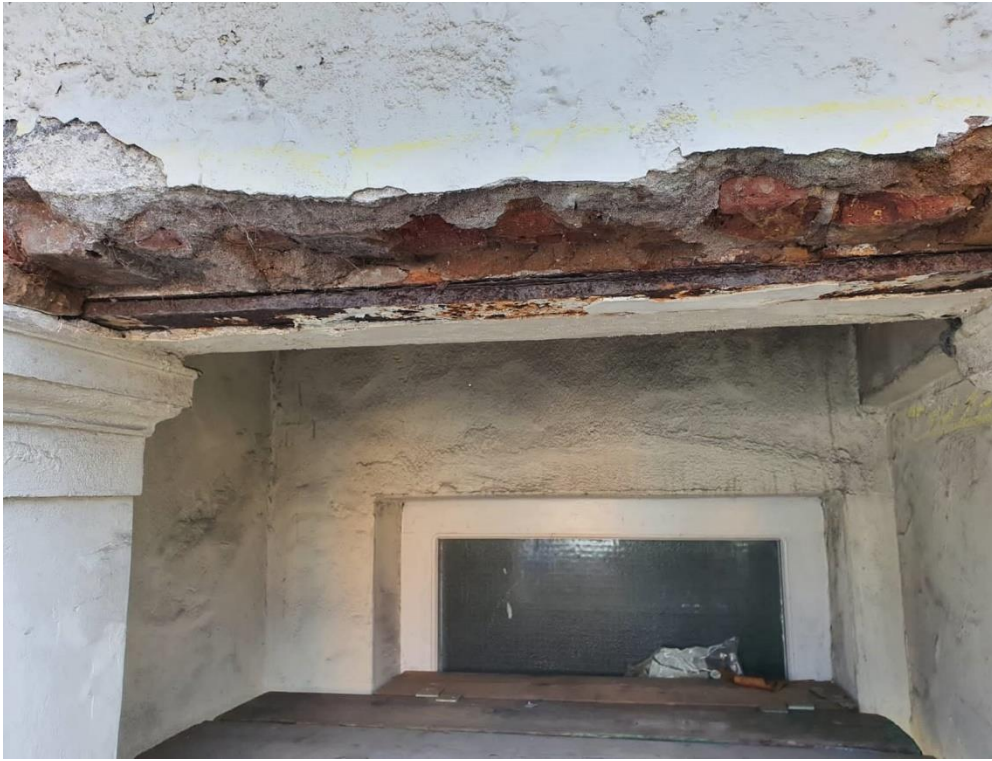
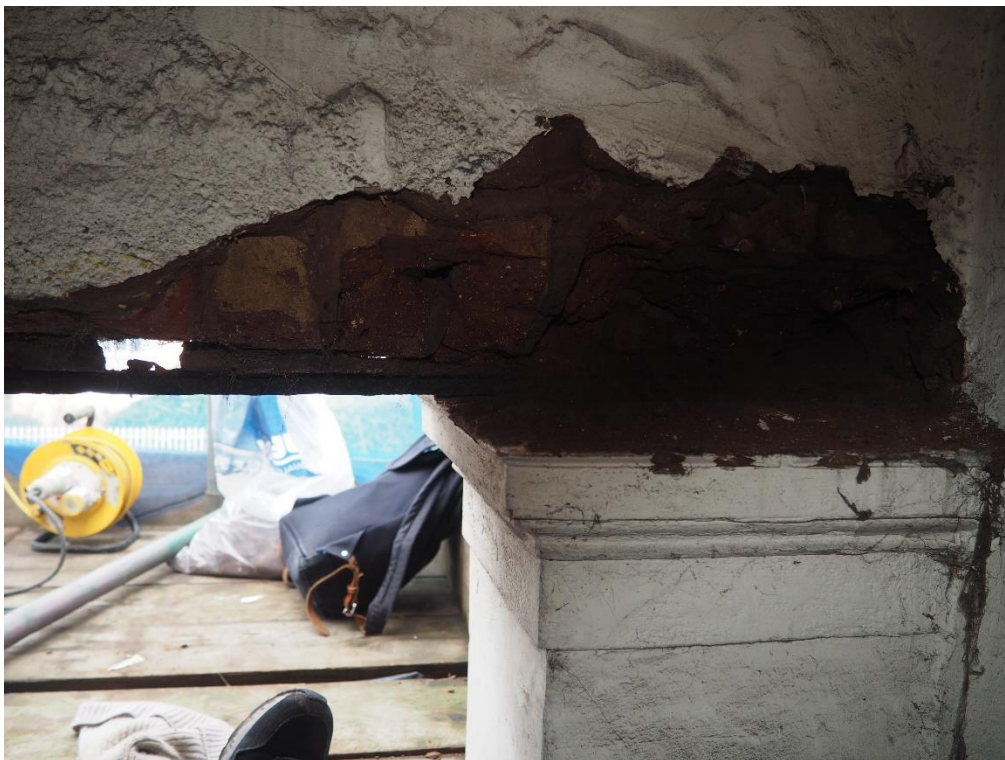
- 2.2 The plate has visible rust but generally appears to be solid with minimal reduction in overall size due to oxidation.
- 2.3 There is evidence of a relatively new flat roof having been installed over the Portico. The plasterboard on the underside of the roof (ceiling of portico) has no cracks or discolouration. The plasterboard suggests that the roof is likely to be timber construction.

- 4.1 The support plate appears to have a substantial structural thickness. In light and the building being a Grade 2 Listed Building we believe that it is viable to keep the plate. Remedial works will need to be undertaken to the plate which will involve cleaning the rust and providing a protective coating. This will then allow the brickwork and render to be re-instated as required. The render will need to be agreed with the Architect and Conservation officer.

Plate 4a&b: Exposed Rusted Plate

- 5.1.1 We have provided a drawings for the remedial structural works to the plate. This is provided in drawing 19124-spec01. In this we recommend that the following specification be adopted for cleaning and providing a protective coating on to the existing plate:

Surface preparation of plate to Swedish standard SA 3.0. This can be undertaken using a brass hand brush to remove aggressive areas of rust. This is to be followed by sanding down of the surface with emery paper taking care to remove all rust. The plate should then be thoroughly cleaned of all rust, dirt, grease to leave a clean surface. Power towels should only be used by trained technicians which have expertise in cleaning this type of ironwork otherwise this should be limited to hand tools to prevent damage.

Two coats of rich Zinc based Primer.
One coat of micaceous iron oxide.

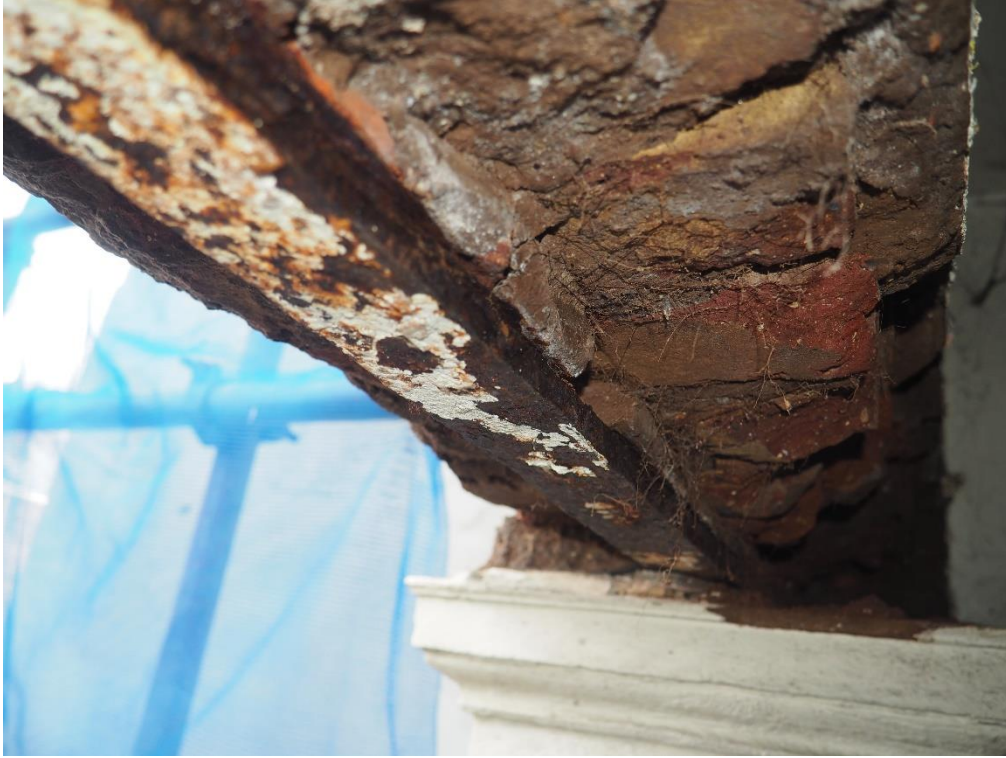
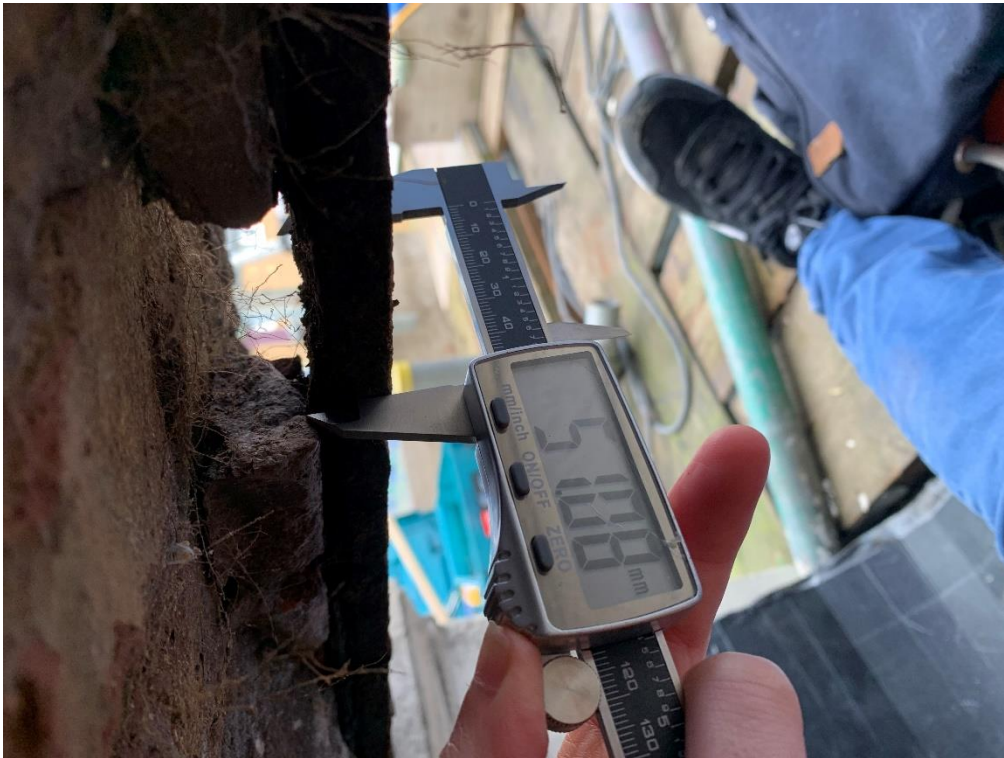
Plate 5a&b: Exposed Rusted Plate

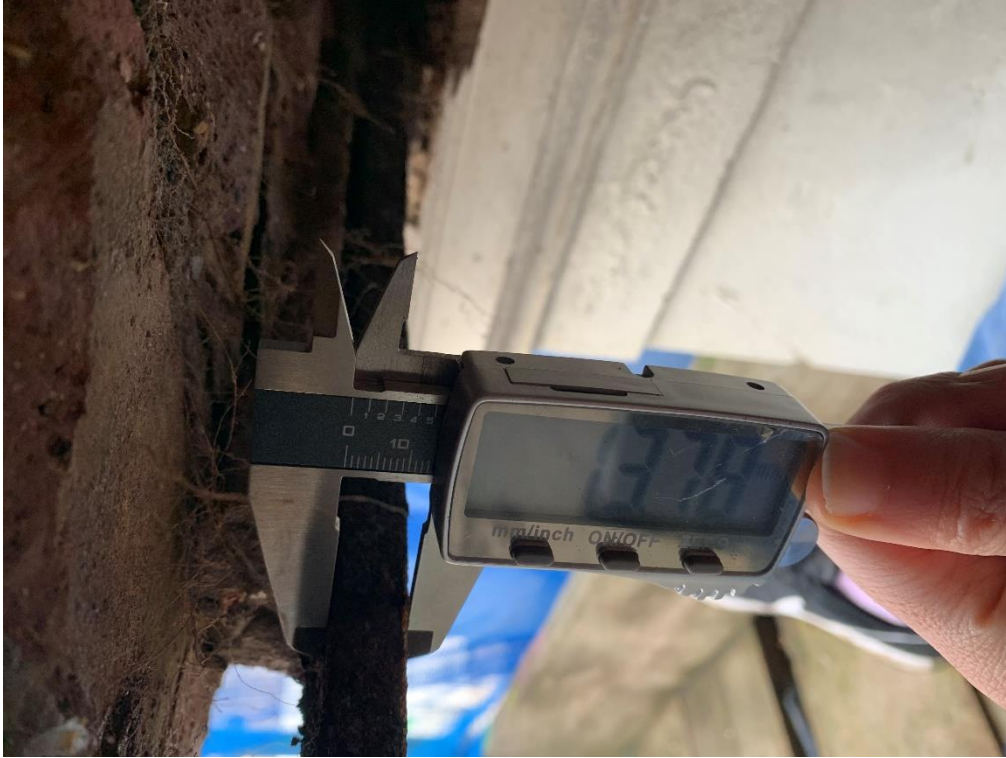
- 2.0 OBSERVATIONS (During opening up works dated 4th February 2021)
- 2.1 The opening up works determined that there is a 51mm (2") thick by 13mm (1/2") plate that supports 290mm of rendered brickwork above. The plate spans over the 880mm opening in the portico.

Plate 6: Thickness of exposed plate.

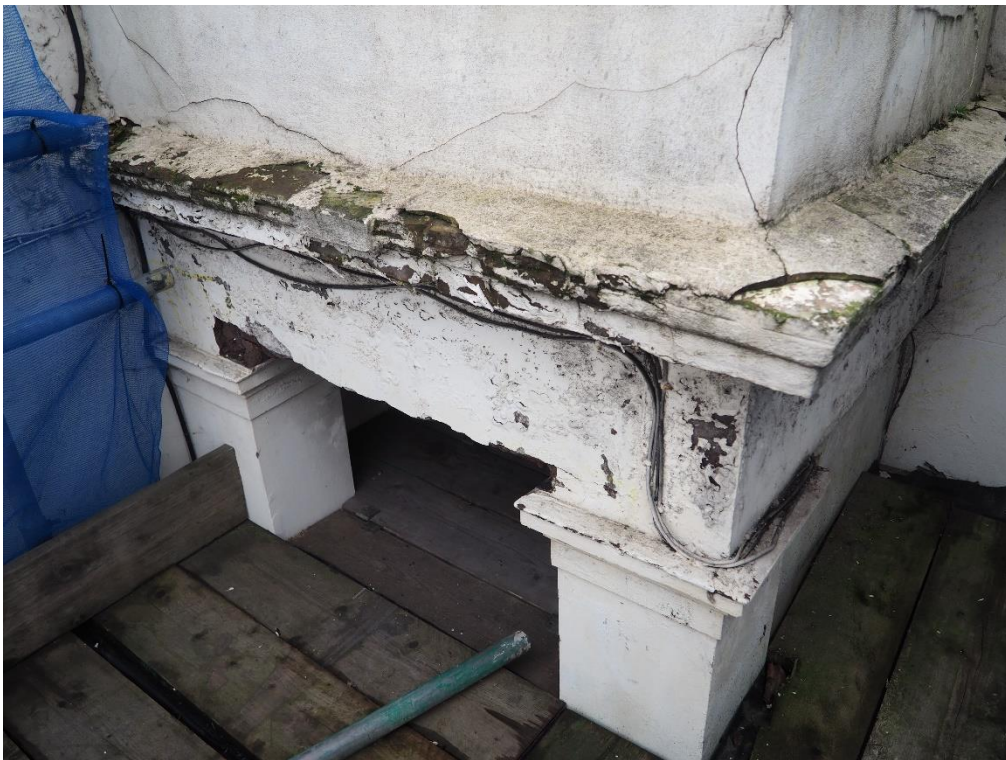
- 2.4 We note that there is some vegetation growing to the left-hand side of the portico adjacent with the flank wall of the building.
- 2.5 There are cracks to the render which appear to be historic and were noted on our previous reports.

Plate 7: Cracked render

- 5.1.2 We recommend that once the plate has been cleaned and painted that the brickwork is reinstated locally with a mortar mix to best match the original. We note that the render above is significantly cracked and will require remedial works which we understand will be undertaken by the Architect. Following on from this the portico will require redecorating.
