Marcus Foster Arboricultural Design & Consultancy

Arboricultural Survey (BS5837:2012) & Impact Assessment

19 Well Road London NW3 1LH

AIA/MF/0108/18

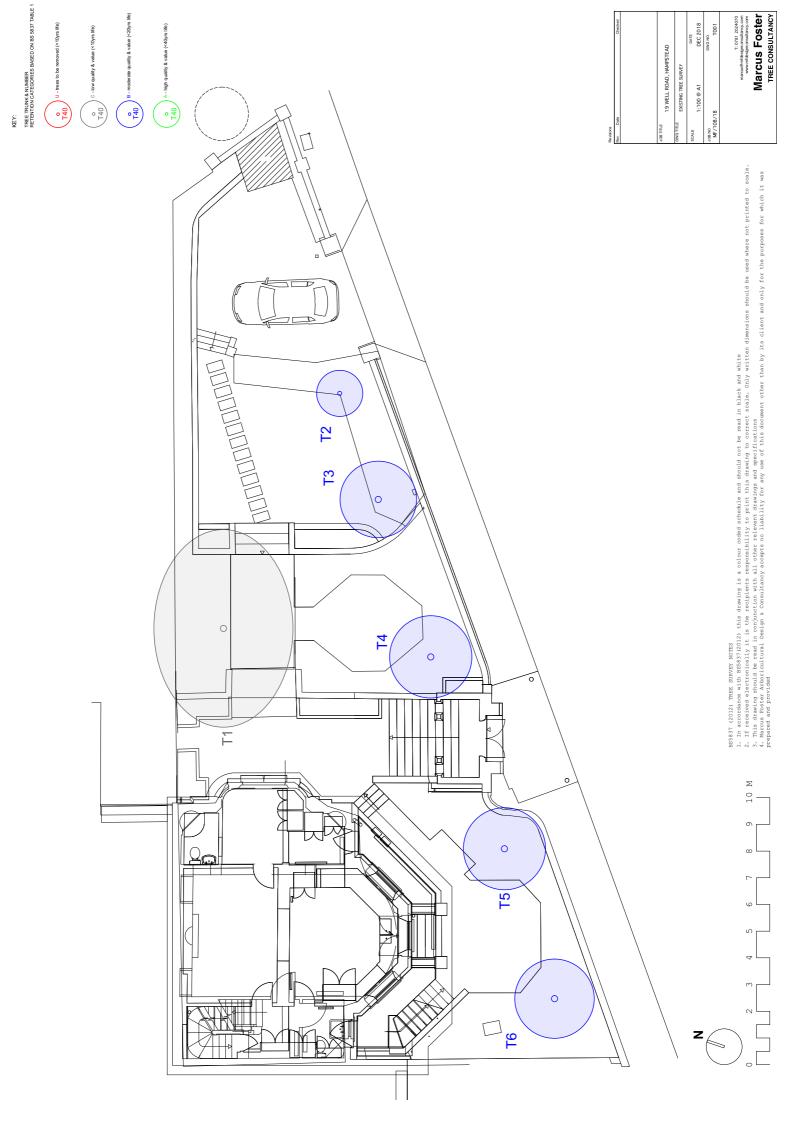
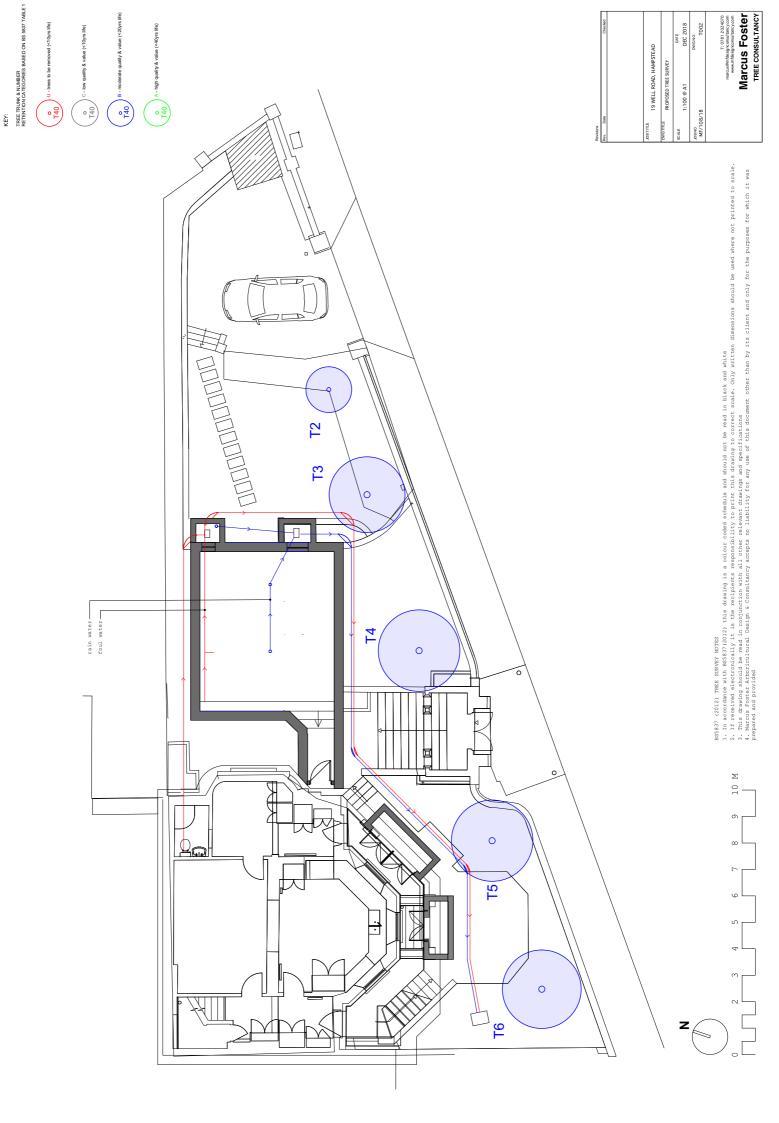
T001 Existing Tree Survey T002 Proposed Tree Survey T003 Tree Constraints Plan

- 1.5 The trees located within the site are shown in site plans T001-T003, Appendix B, and these correspond to the tree survey results table, Appendix A.

- 5.1 The proposed development comprising implementation of basement within the garden area requires tree protection measures for trees T2-T6 for associated construction site activities only. In summary the arboricultural impact as highlighted within T003 (Tree Constraints Plan) are as follows:
 - 5.1.1 Loss of 1 x 'C' category tree without impact on proposed development of basement. This removal is requiring replacement within final landscape phase of development
 - 5.1.2 Tree protection measures required for protection of retained trees for T2 T6 during development process
- 5.2 Therefore the following tree protection and mitigation measures will be required:

- Tree protection measures to protect the main stems of T2-T6 must be provided to provide a Construction Exclusion Zone (CEZ) where construction site activities are shown to new within the areas of these trees.
- This protection is recommended as Basal Shuttering specified within Appendix E.2
